Summary table								
Site Name:	Land to east of Newgate Lane East								
Project reference:	547								
Site Address:	and to east of Newgate Lane East, Fareham								
Nearest Postcode:	PO13 0SG	-							
Central Grid reference:	SU 57439 03669								
Local Planning Authority:	Fareham Borough Council	areham Borough Council							
Relevant planning policies:	infrastructure, biodiversity and geological design. Development Sites & Policio DRAFT Fareham Local Plan 2037: N biodiversity and the local ecological	Fareham Local Development Plan Core Strategy 2011: CS4 - Green infrastructure, biodiversity and geological conservation; CS17 - High quality design. Development Sites & Policies: DSP13 - Nature conservation. DRAFT Fareham Local Plan 2037: NE1 Protection of nature conservation, biodiversity and the local ecological network; NE2 - Biodiversity net gain; NE6 - Trees, woodland and hedgerows; NE9 - Green infrastructure; D1 - High quality design and placemaking.

SECTION 1: SUMMARY, SITE DETAILS & SURVEY FINDINGS

SECTION 4: TREE SURVEY SCHEDULE & SITE IMAGES

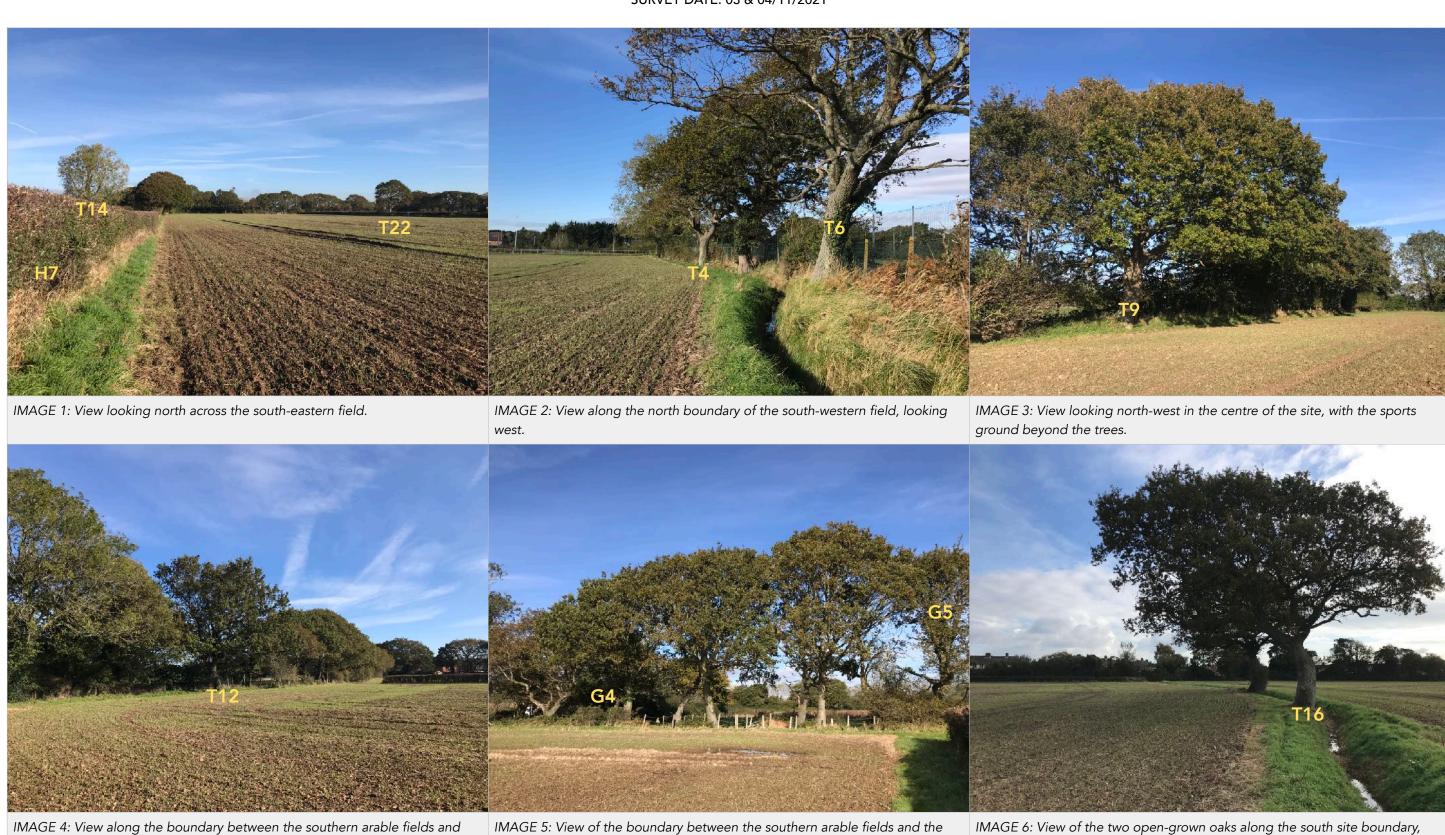
looking east.

north pasture field, looking north from H5.
