Report to Planning Committee

Subject: TREE PRESERVATION ORDER No 695 (2014) – 14 & 17 St

Edmund Close, Titchfield Common.

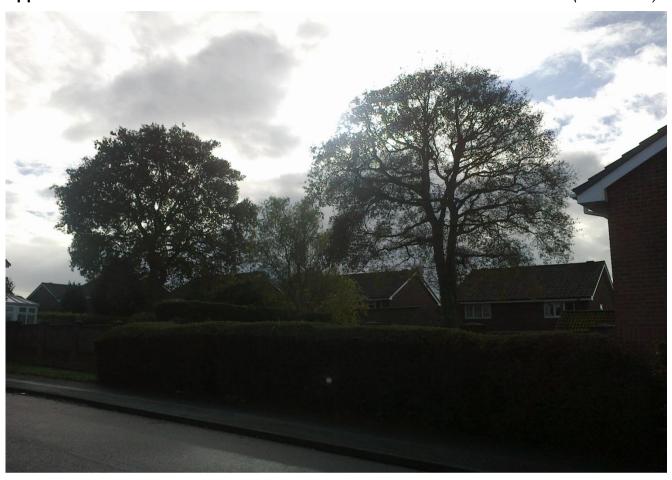
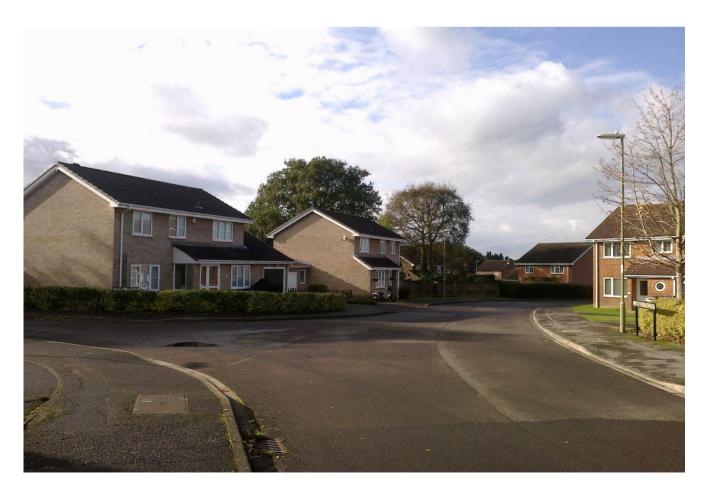
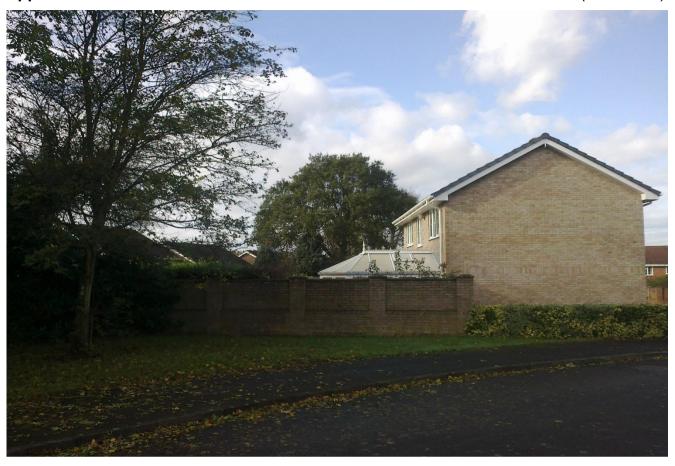
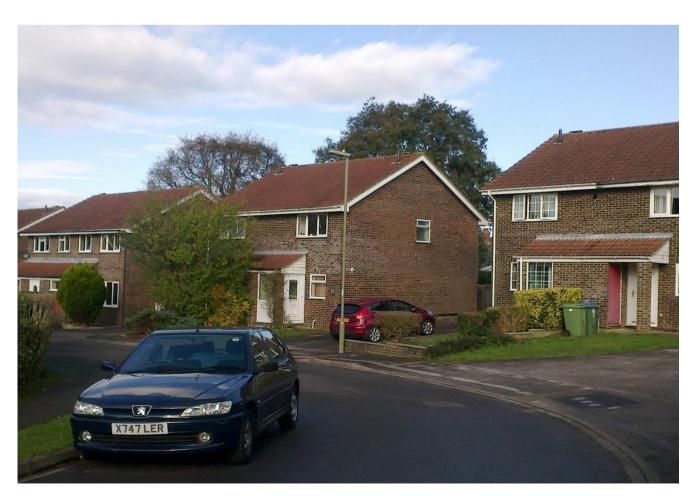
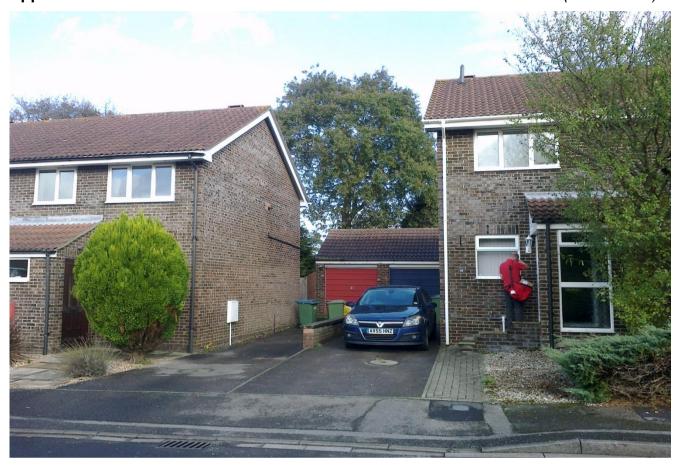
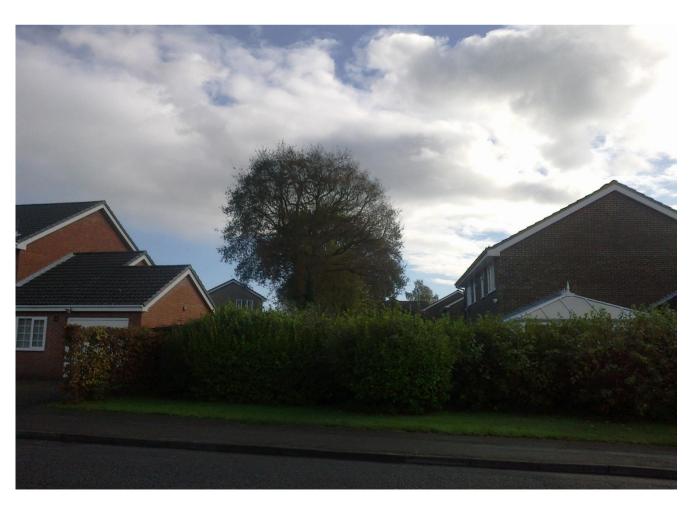
29. Both the oak trees T1 & T2 are clearly visible from Abshot Road - northwest, Clarendon Crescent - north and Oriel Drive - east and partially visible from St Edmund Close — southeast / south and Abshot Road west. Both trees are prominent in the landscape and contribute significant public amenity to the surrounding residential development (Photos at Appendix B).

Appendix B: Clarendon Crescent - T1 & T2 view from north and northeast. (Photo 1&2)

Appendix B: T2 view from Oriel Drive. T1 & T2 view from St Edmund Close. (Photo 3&4)

Appendix B: T2 view from St Edmund Close. T1 view from Abshot Road. (Photo 5 & 6)

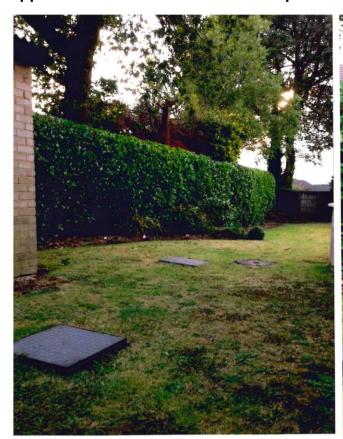
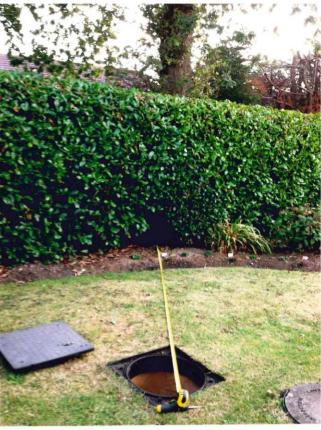
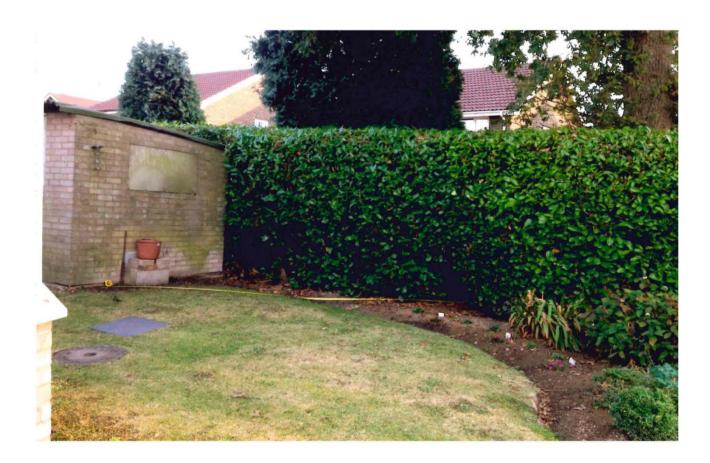
- The oak T2 is 5.8 metres from the dwelling and 5.1 metres from a foul sewer, which serves several properties in Clarendon Crescent and St Edmund Close.

- 18. The shed is situated approximately 5 metres from oak T2 and therefore the potential for direct damage is low. The immediate soil type on which the concrete slab has been cast is very stony and therefore the potential for indirect damage is also low. Given the age of the structure and its simple construction officers suggest that after 30 years the structure may be considered to have reached the end of its useful life. Any new structure could be designed with appropriate foundations to take account of the soil conditions and the proximity of the adjacent oak tree.

Appendix C – 2 Clarendon Crescent proximity of brick shed and sewer to oak T2

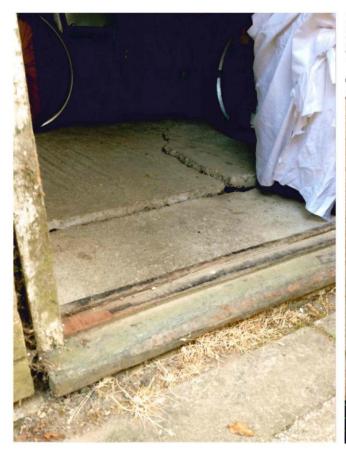
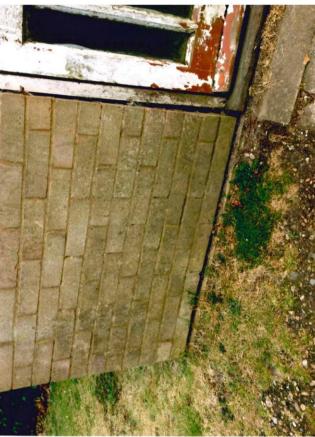
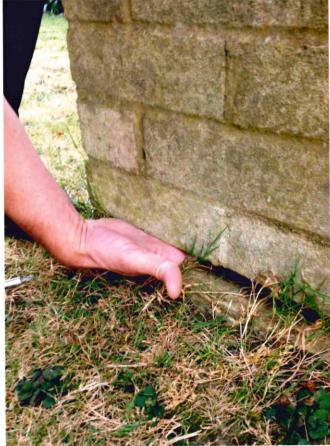
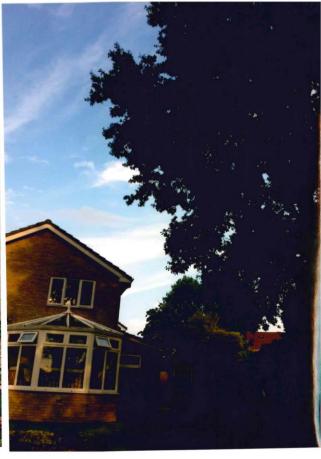
- Roots from oak T2 have caused extensive damage to the foundation of an existing brick shed located approximately 5 metres from the tree. Damage to the shed is severe and it will have to be demolished in the near future.

- 17. The brick built shed situated in the rear garden of 22 Clarendon Crescent appears to have been constructed when the house was built 30 years ago. The structure is of traditional construction single skin brick walls with a flat roof built on a concrete slab foundation cast at ground level. The concrete base is cracked in several places with significant disturbance to the levels. The base appears to be constructed in sections and there was no evidence of a steel reinforcement mesh having been used. The single skin brick walls remain intact with no evidence of cracking or distortion. (Photos at Appendix C).

Appendix C: Damage to brick shed at 2 Clarendon Crescent
