LAND AT NEWGATE LANE (SOUTH) FAREHAM

TREE REPORT

(Tree Survey and
Constraint Advice)

BARGATE HOMES LTD

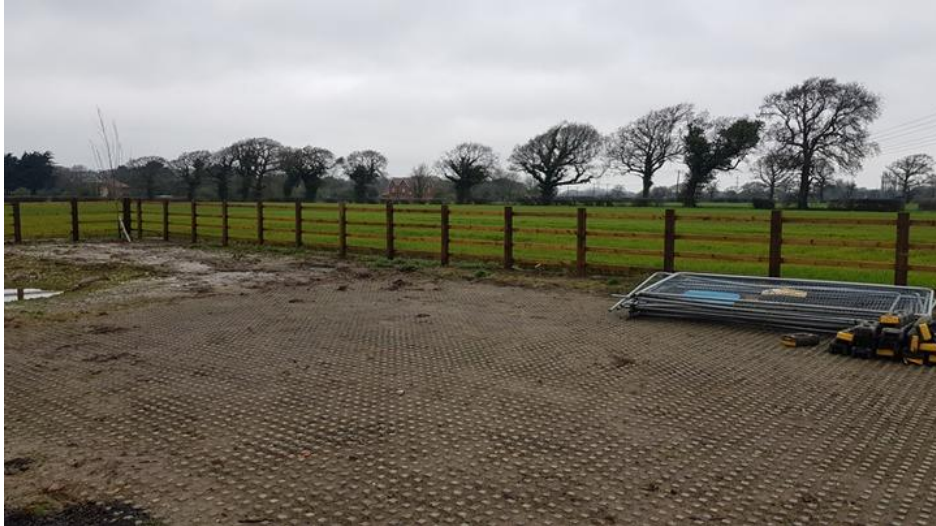
G2 Mature Oak trees

| No. | Name | Ht (crown) | Dia (stems) | Canopy spread N E S W | | | | Life stage | ERC | Comments & preliminary recommendations | BS Cat |
|---|---|---|---|---|---|---|---|---|---|--|---|
| G2 | Common Oak | 14 | 750 | 8 | 8 | 8 | 8 | M | 40+ | Group of trees planted on linear row along hedge line. High individual quality and landscape value. Ivy in crowns. | A2 |

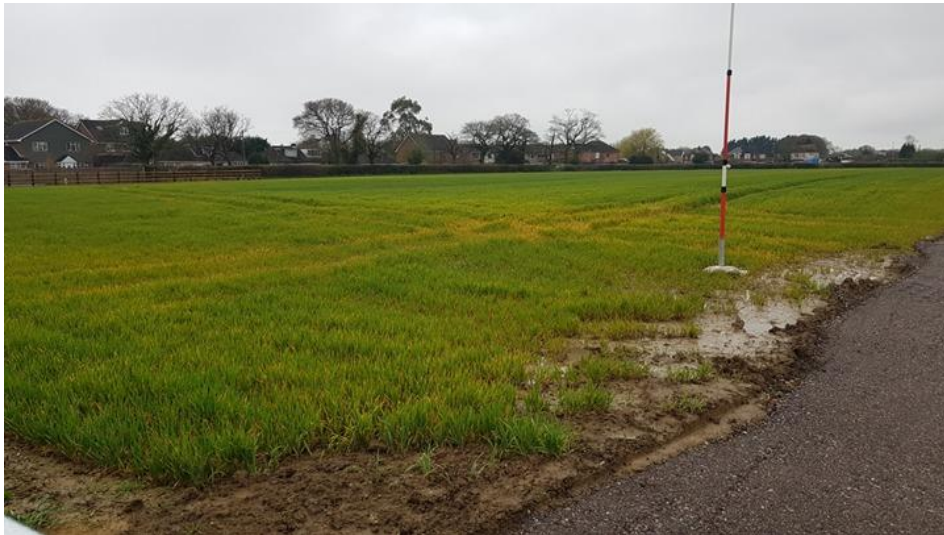
View of southern boundary with H2 hedge and G1 mature Oak trees

| No. | Name | Ht (crown) | Dia (stems) | Canopy spread N E S W | | | | Life stage | ERC | Comments & preliminary recommendations | BS Cat |
|---|---|---|---|---|---|---|---|---|---|--|---|
| H2 | Hawthorn, Elder, Field Maple, Dogwood | 2 | <150 | 2 | 1.5 | 1.5 | 1.5 | EM | 40+ | Mixed species hedge | C2 |
| G1 | Common Oak | 14 | 750 | 6 | 6 | 6 | 6 | M | 20+ | Group of trees at front of adjacent properties. Landscape value. Previous tree surgery works carried out. | B2 |

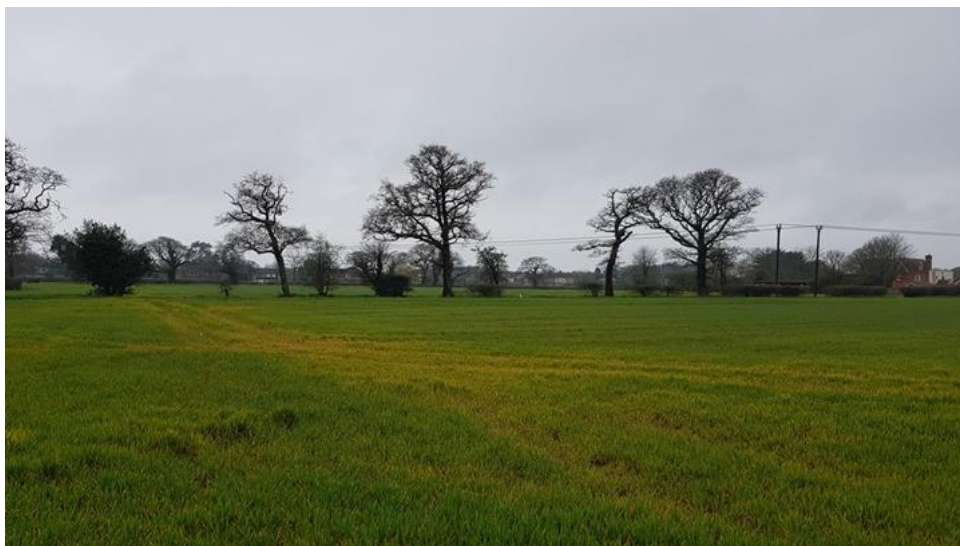
Trees 21 - 25

| No. | Name | Ht (crown) | Dia (stems) | Canopy spread N E S W | | | | Life stage | ERC | Comments & preliminary recommendations | BS Cat |
|---|---|---|---|---|---|---|---|---|---|---|---|
| T21 | Common Oak | 11 | 450 | 5 | 5 | 5 | 5 | EM | 40+ | | B2 |
| T22 | Common Oak | 16 | 750 | 8 | 8 | 8 | 8 | M | 40+ | | A2 |
