Our ref: GE16226/GR02.2/171018

RE: Downend Road, Portchester

Further to the request received via Odyssey and your subsequent instruction, we write to present the findings of the supplementary permeability testing undertaken on this site. The site location is shown on Figure 1 enclosed. This letter includes a minor revision from letter ref. GE16226/GR02/170217 in that the enclosed Figures 2 and 3 reflect the revised site extent as indicated on TOR Drawings ref. 2495-01/PP-002 Aug 2017 and 2495-01/SK-013 Rev C Oct 2017. These drawings should be referred to for the definitive red line boundary and the proposed development layout.

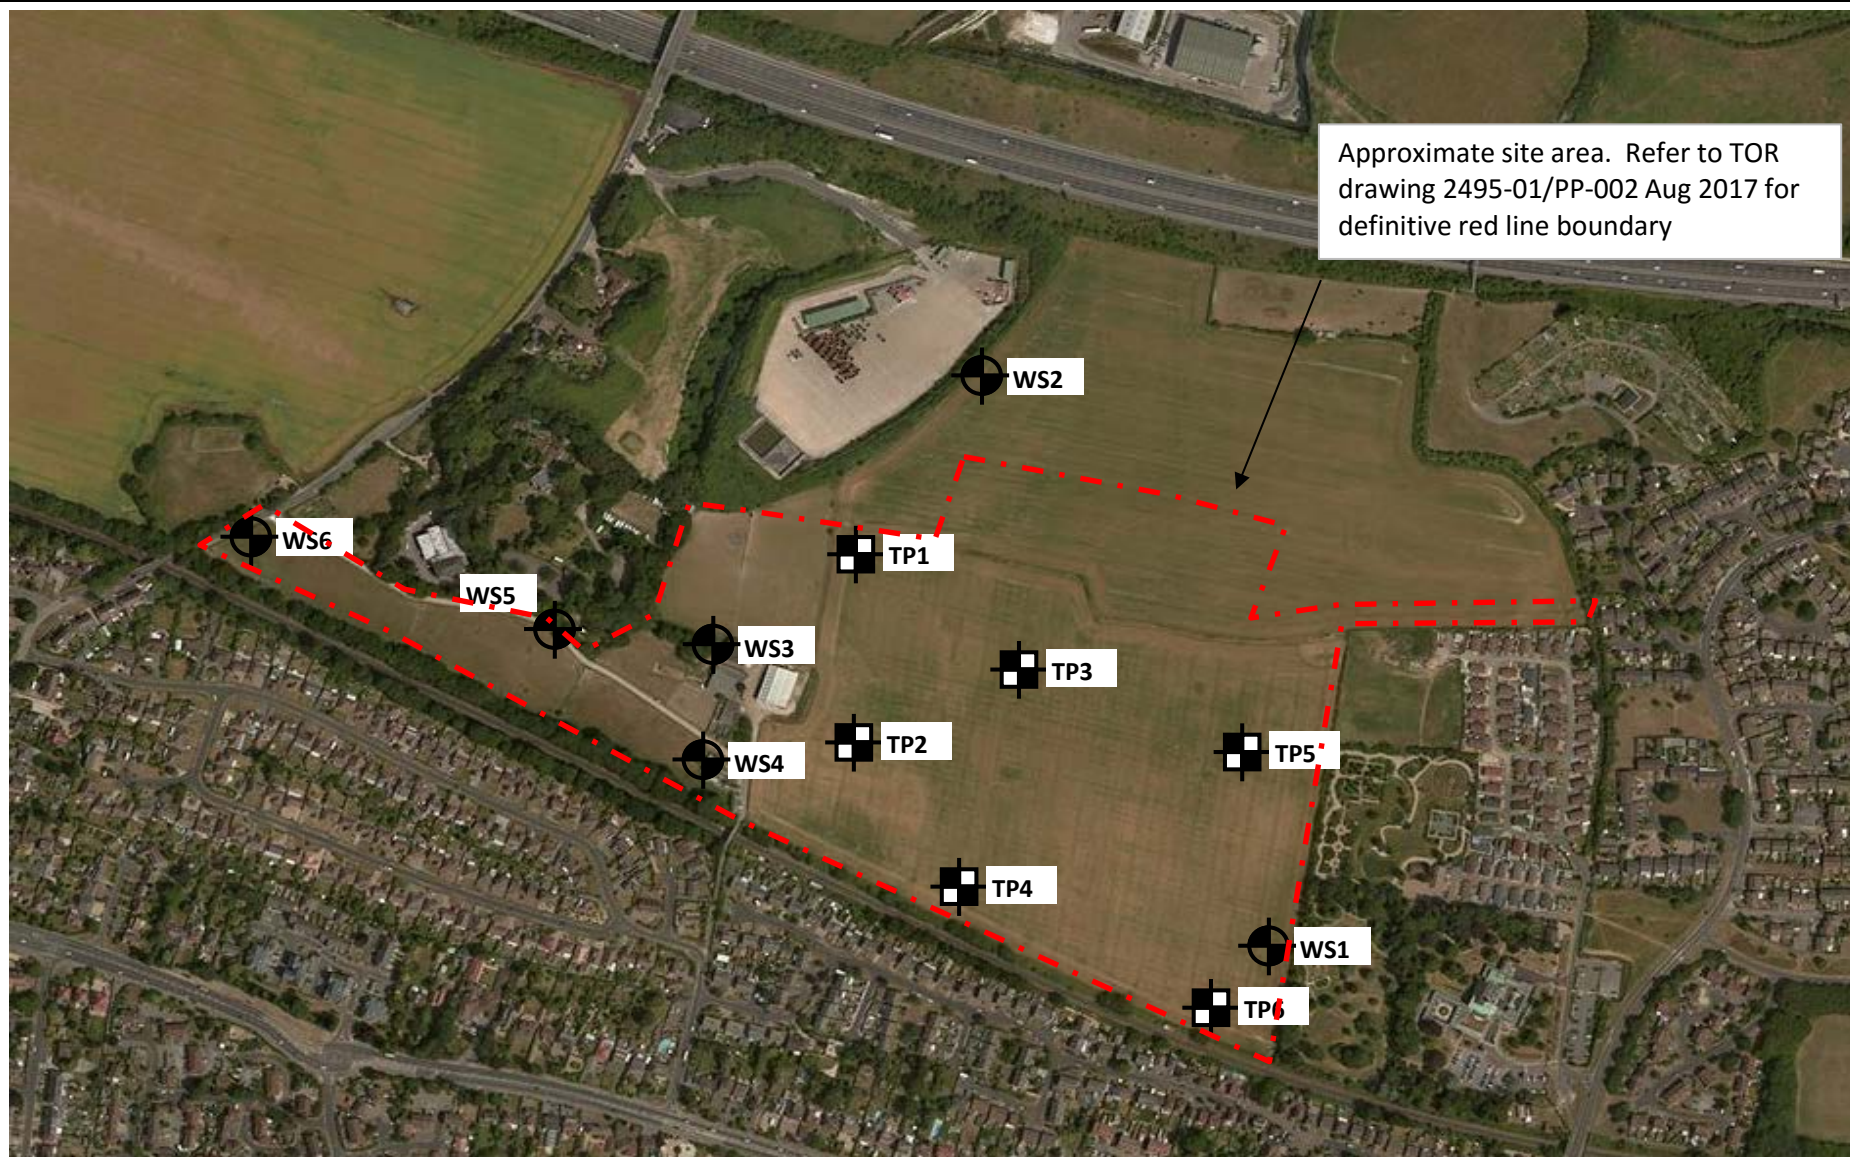
Project:	Land off Downend Road, Portchester PO16 8PX			Title	Exploratory Hole Location Plan (preliminary investigation)		
Client:	Miller Homes			Geo-Environmental Services Ltd Unit 7 Danworth Farm, Cuckfield Road Hurstpierpoint, West Sussex BN6 9GL +44(0)1273 832972 www.gesl.net

Geo-Environmental	
Ref No:	GE16226	Revision:	1.1				
Drawn:	GR	Date:	11/10/2017				
Figure:	2	Scale:	Not To Scale

from the previous phase of investigation are shown on Figure 2 and positions from the supplementary investigation are shown on Figure 3 enclosed herein.

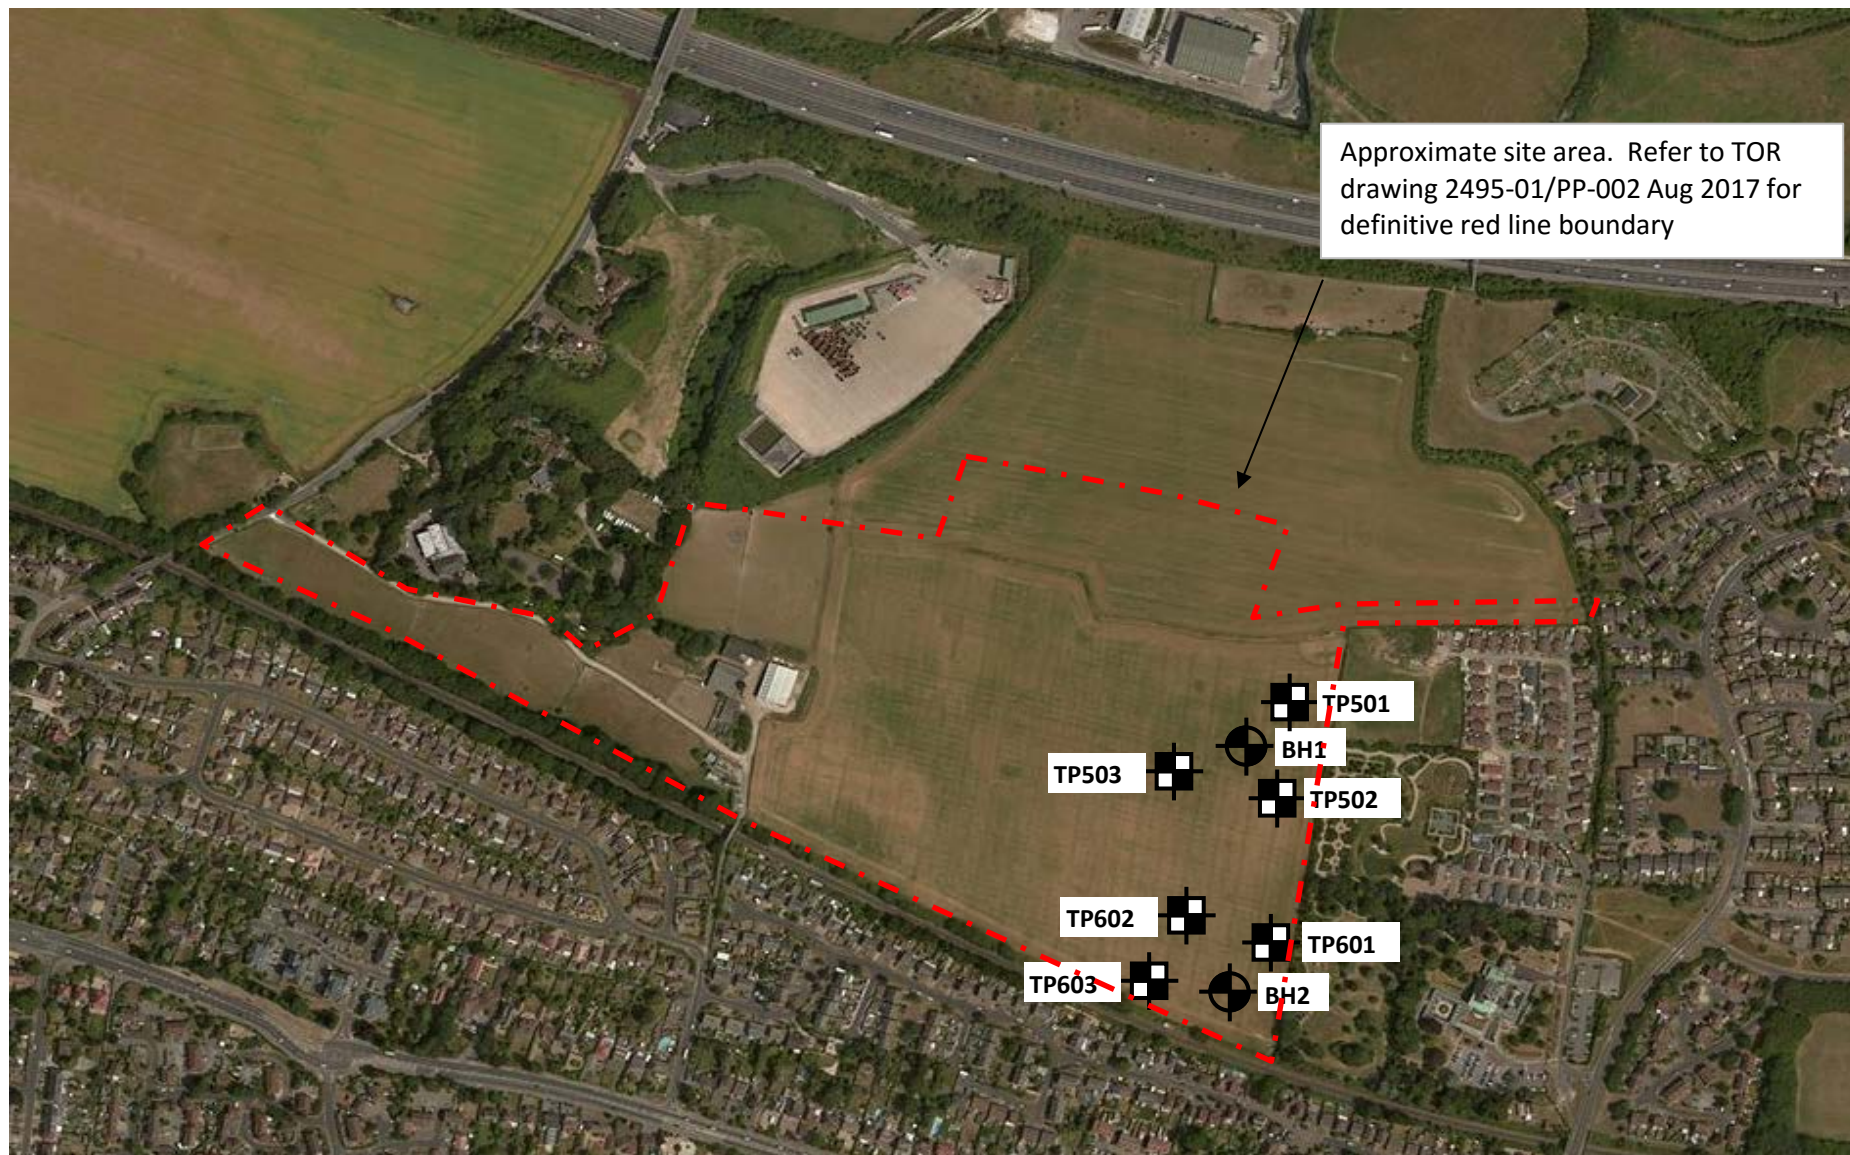
Project:	Land off Downend Road, Portchester PO16 8PX			Title	Exploratory Hole Location Plan (Supplementary investigation)		
Client:	Miller Homes			<div><div><div>Geo-Environmental Services Ltd</div><div>Unit 7 Danworth Farm, Cuckfield Road</div><div>Hurstpierpoint, West Sussex BN6 9GL</div><div>+44(0)1273 832972 www.gesl.net</div></div><div>

<div>Geo-Environmental</div></div></div>			
Ref No:	GE15996	Revision:	1.1				
Drawn:	GR	Date:	11/10/2017				
Figure:	3	Scale:	Not To Scale

The exploratory holes were located in the vicinity of the previous trial pits TP5 and TP6, with BH1 and TP501-TP503 located in the vicinity of TP5; and BH2 and TP601-TP603 located in the vicinity of TP6. Exploratory hole locations

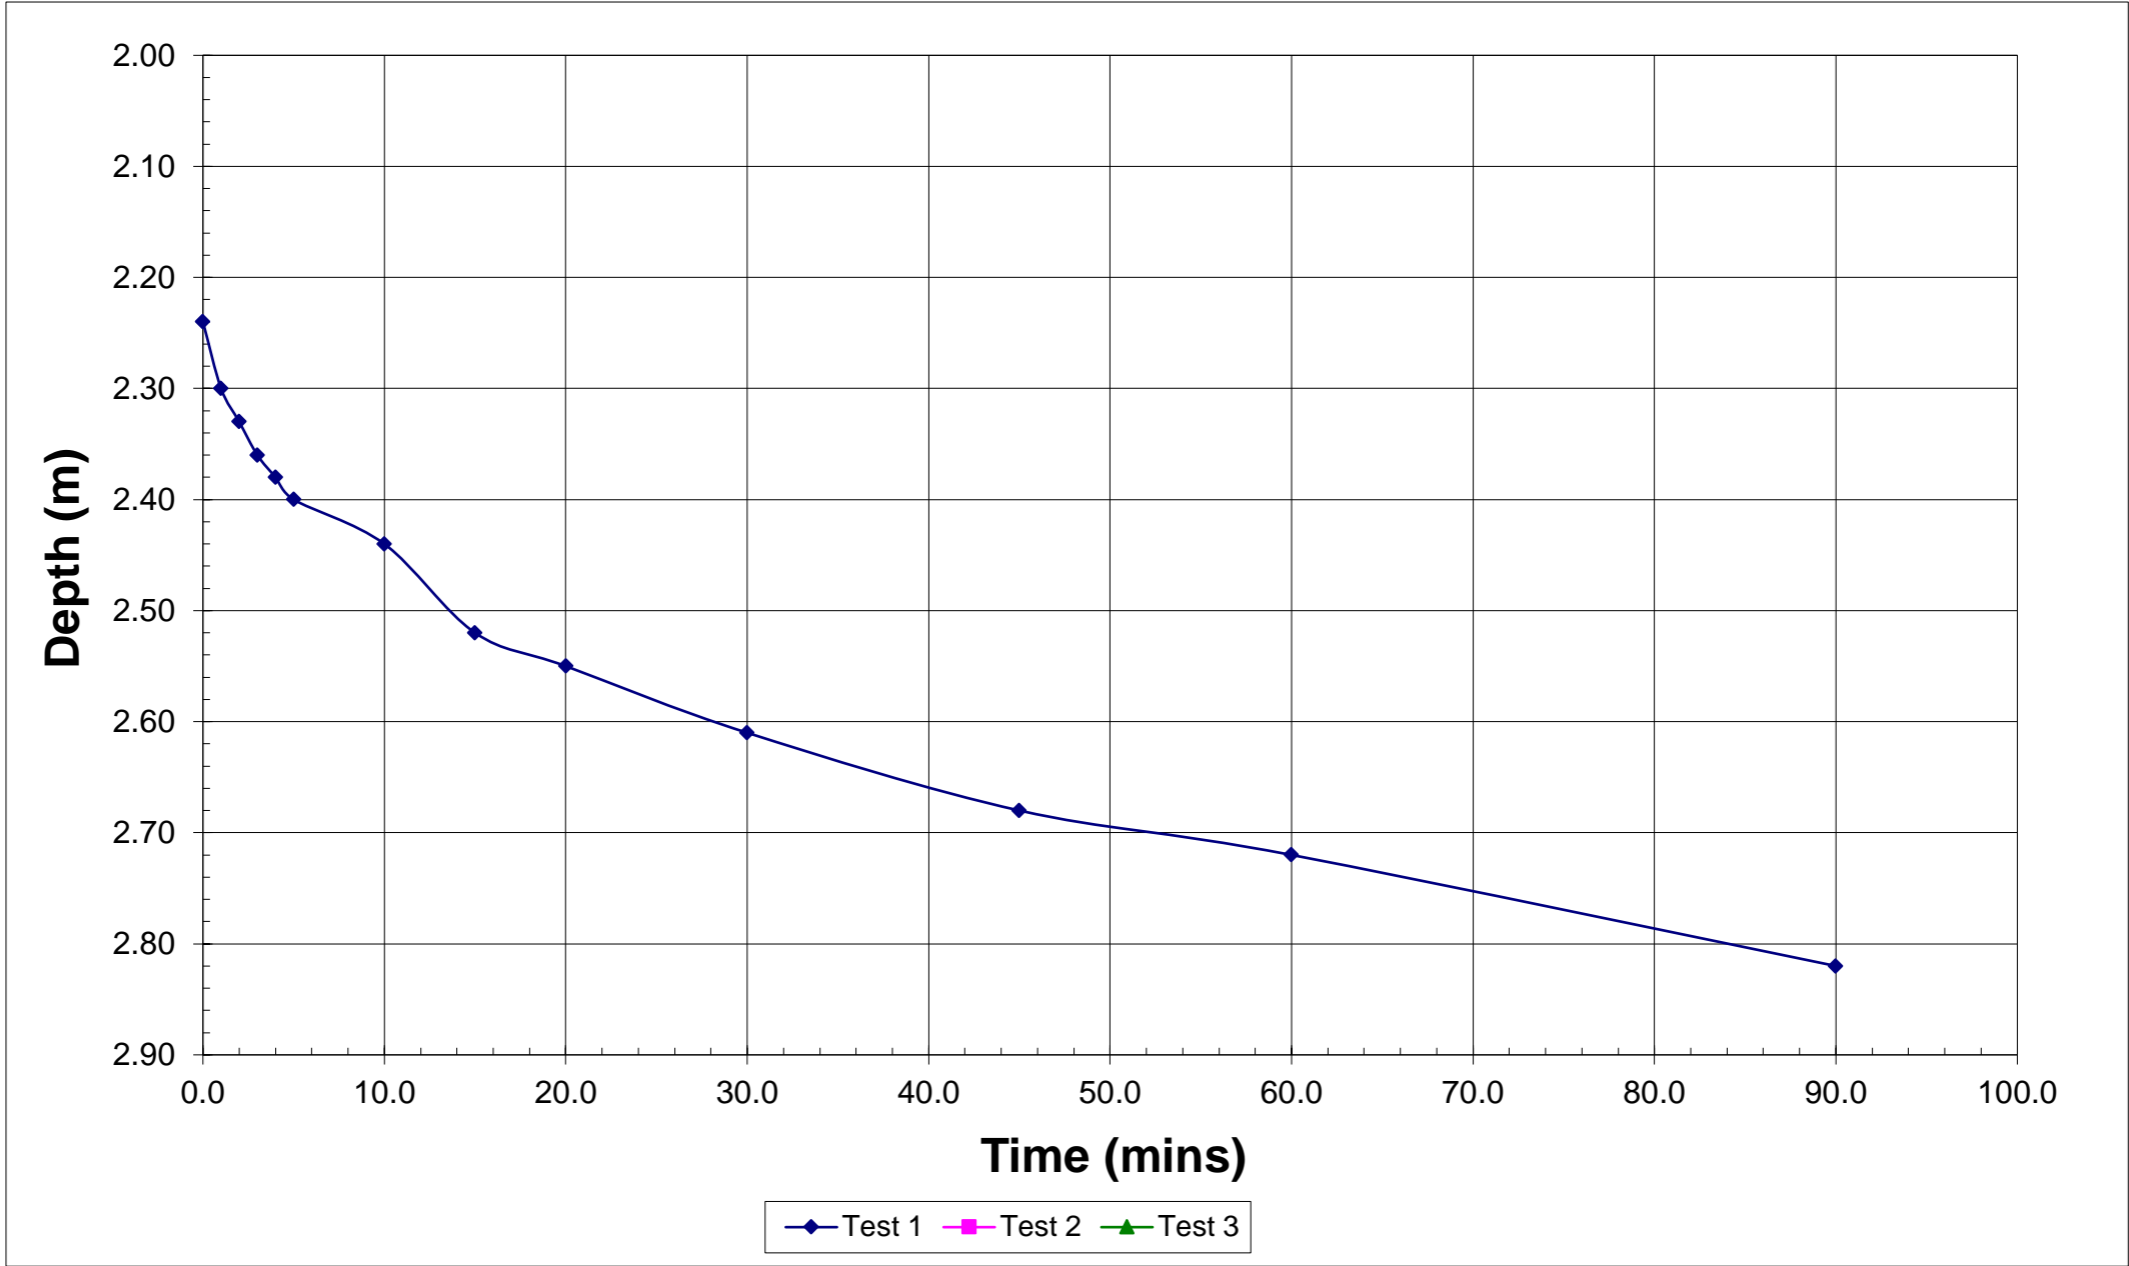
Max. depth (m)	3.00	3.00	3.00
Effective depth (m)	0.76	3.00	3.00
75% effective depth (m)	2.43	0.75	0.75
50% effective depth (m)	2.62	1.50	1.50
25% effective depth (m)	2.81	2.25	2.25
t75 (min)	12.00		
t50 (min)	32.00		
t25 (min)	88.00		
Vp 75-25	0.33	1.29	1.29
ap 50	2.4008	6.948	6.948
tp 75-25	76.00	0.00	0.00

Soil infiltration rate (m/s)	3.0E-05	#DIV/0!	#DIV/0!
Soil infiltration rate (mm/hr)	1.07E+02	#DIV/0!	#DIV/0!

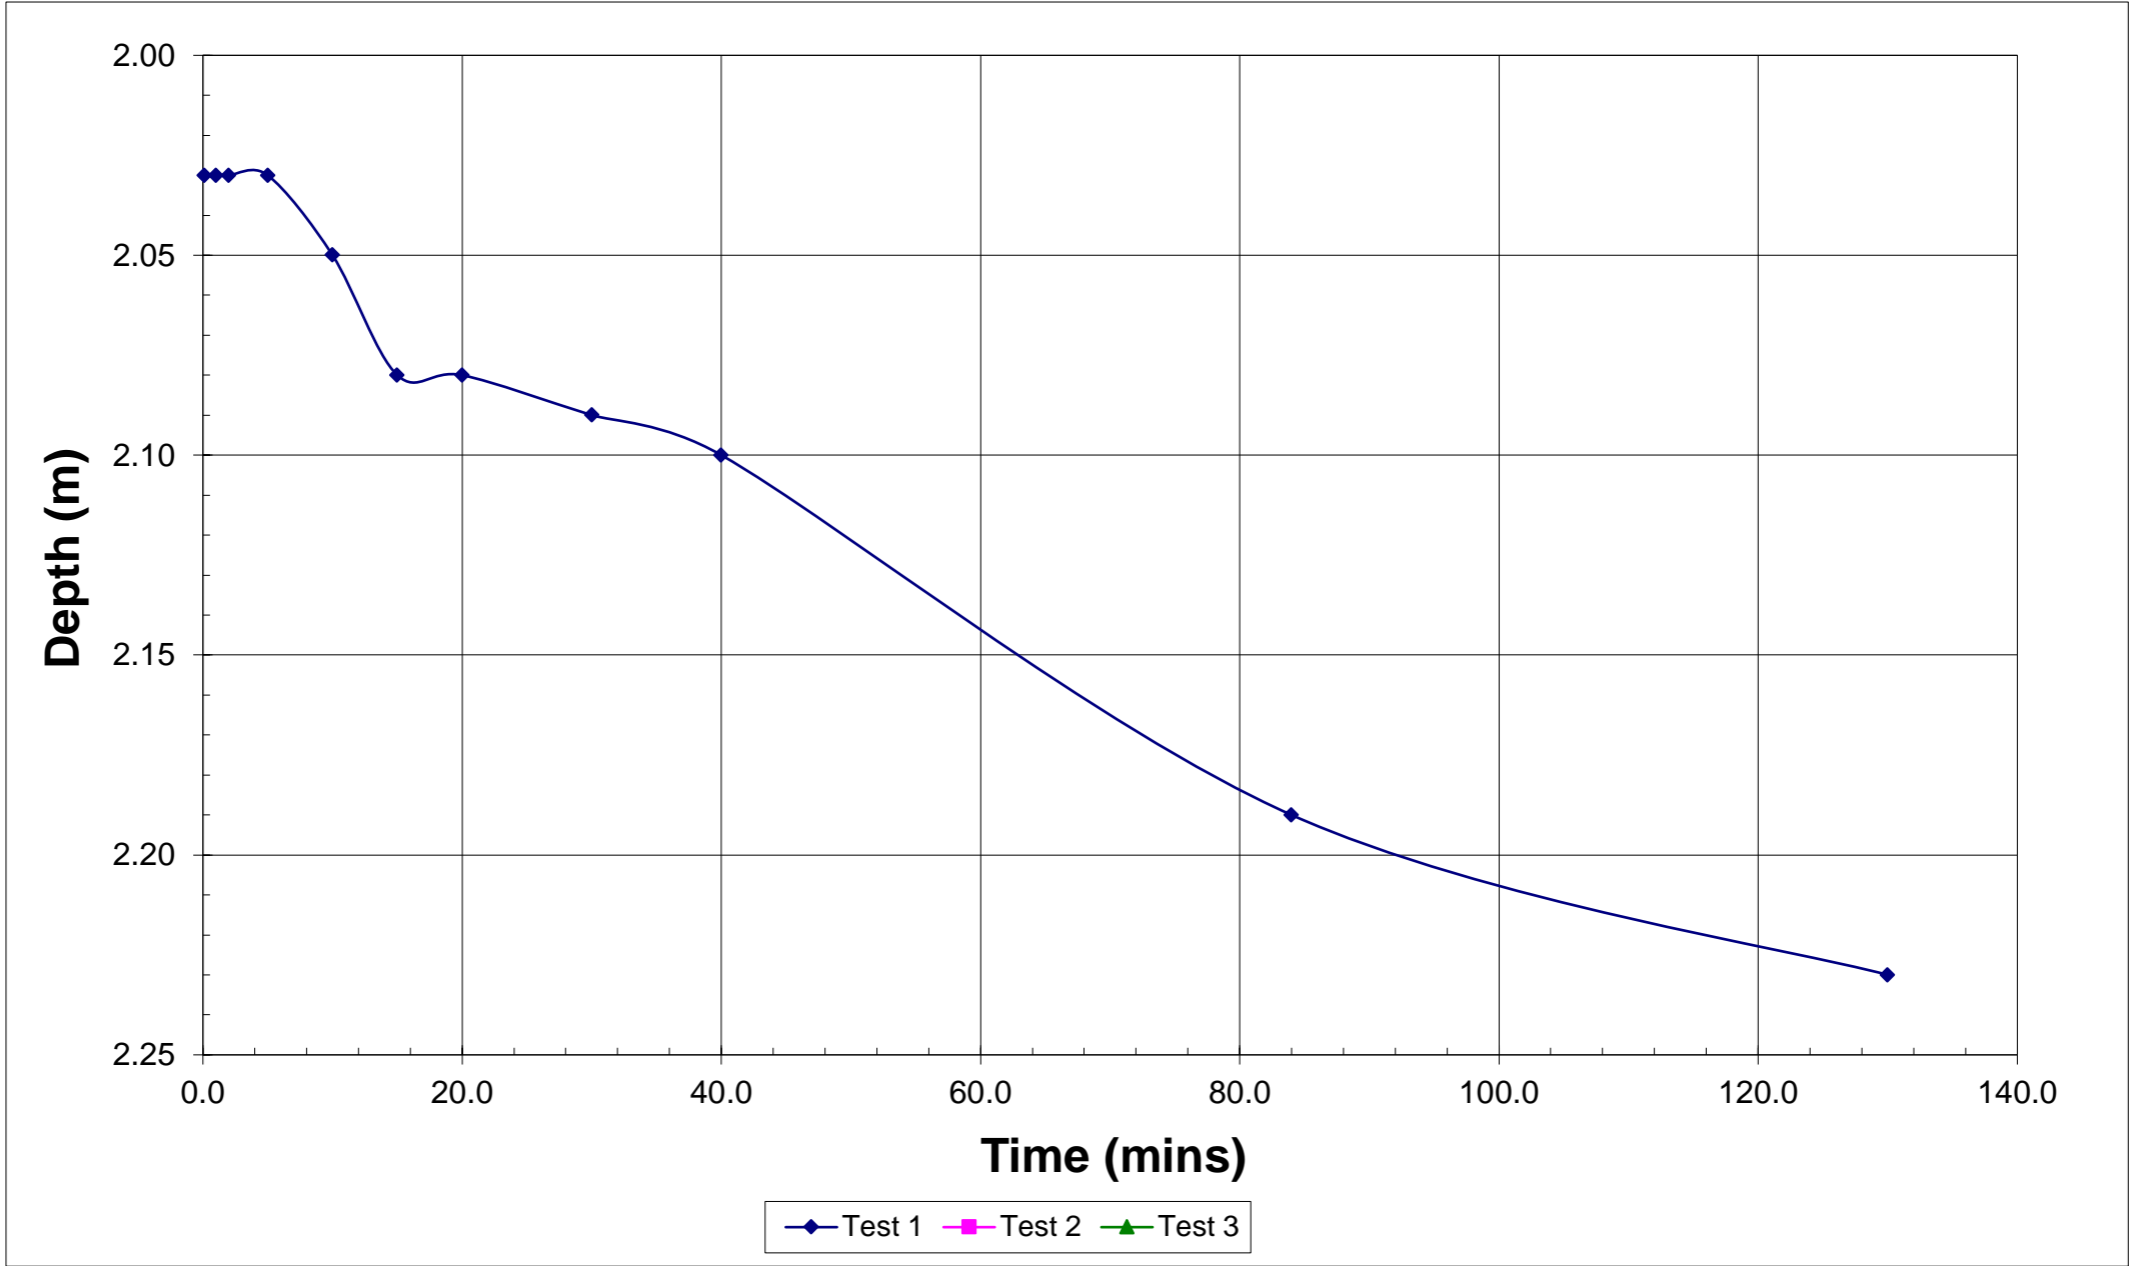
Max. depth (m)	3.00	3.00	3.00
Effective depth (m)	0.97	3.00	3.00
75% effective depth (m)	2.27	0.75	0.75
50% effective depth (m)	2.52	1.50	1.50
25% effective depth (m)	2.76	2.25	2.25
t75 (min)			
t50 (min)			
t25 (min)			
Vp 75-25	0.52	1.62	1.62
ap 50	3.408	8.28	8.28
tp 75-25	0.00	0.00	0.00

Soil infiltration rate (m/s)	#DIV/0!	#DIV/0!	#DIV/0!
Soil infiltration rate (mm/hr)	#DIV/0!	#DIV/0!	#DIV/0!

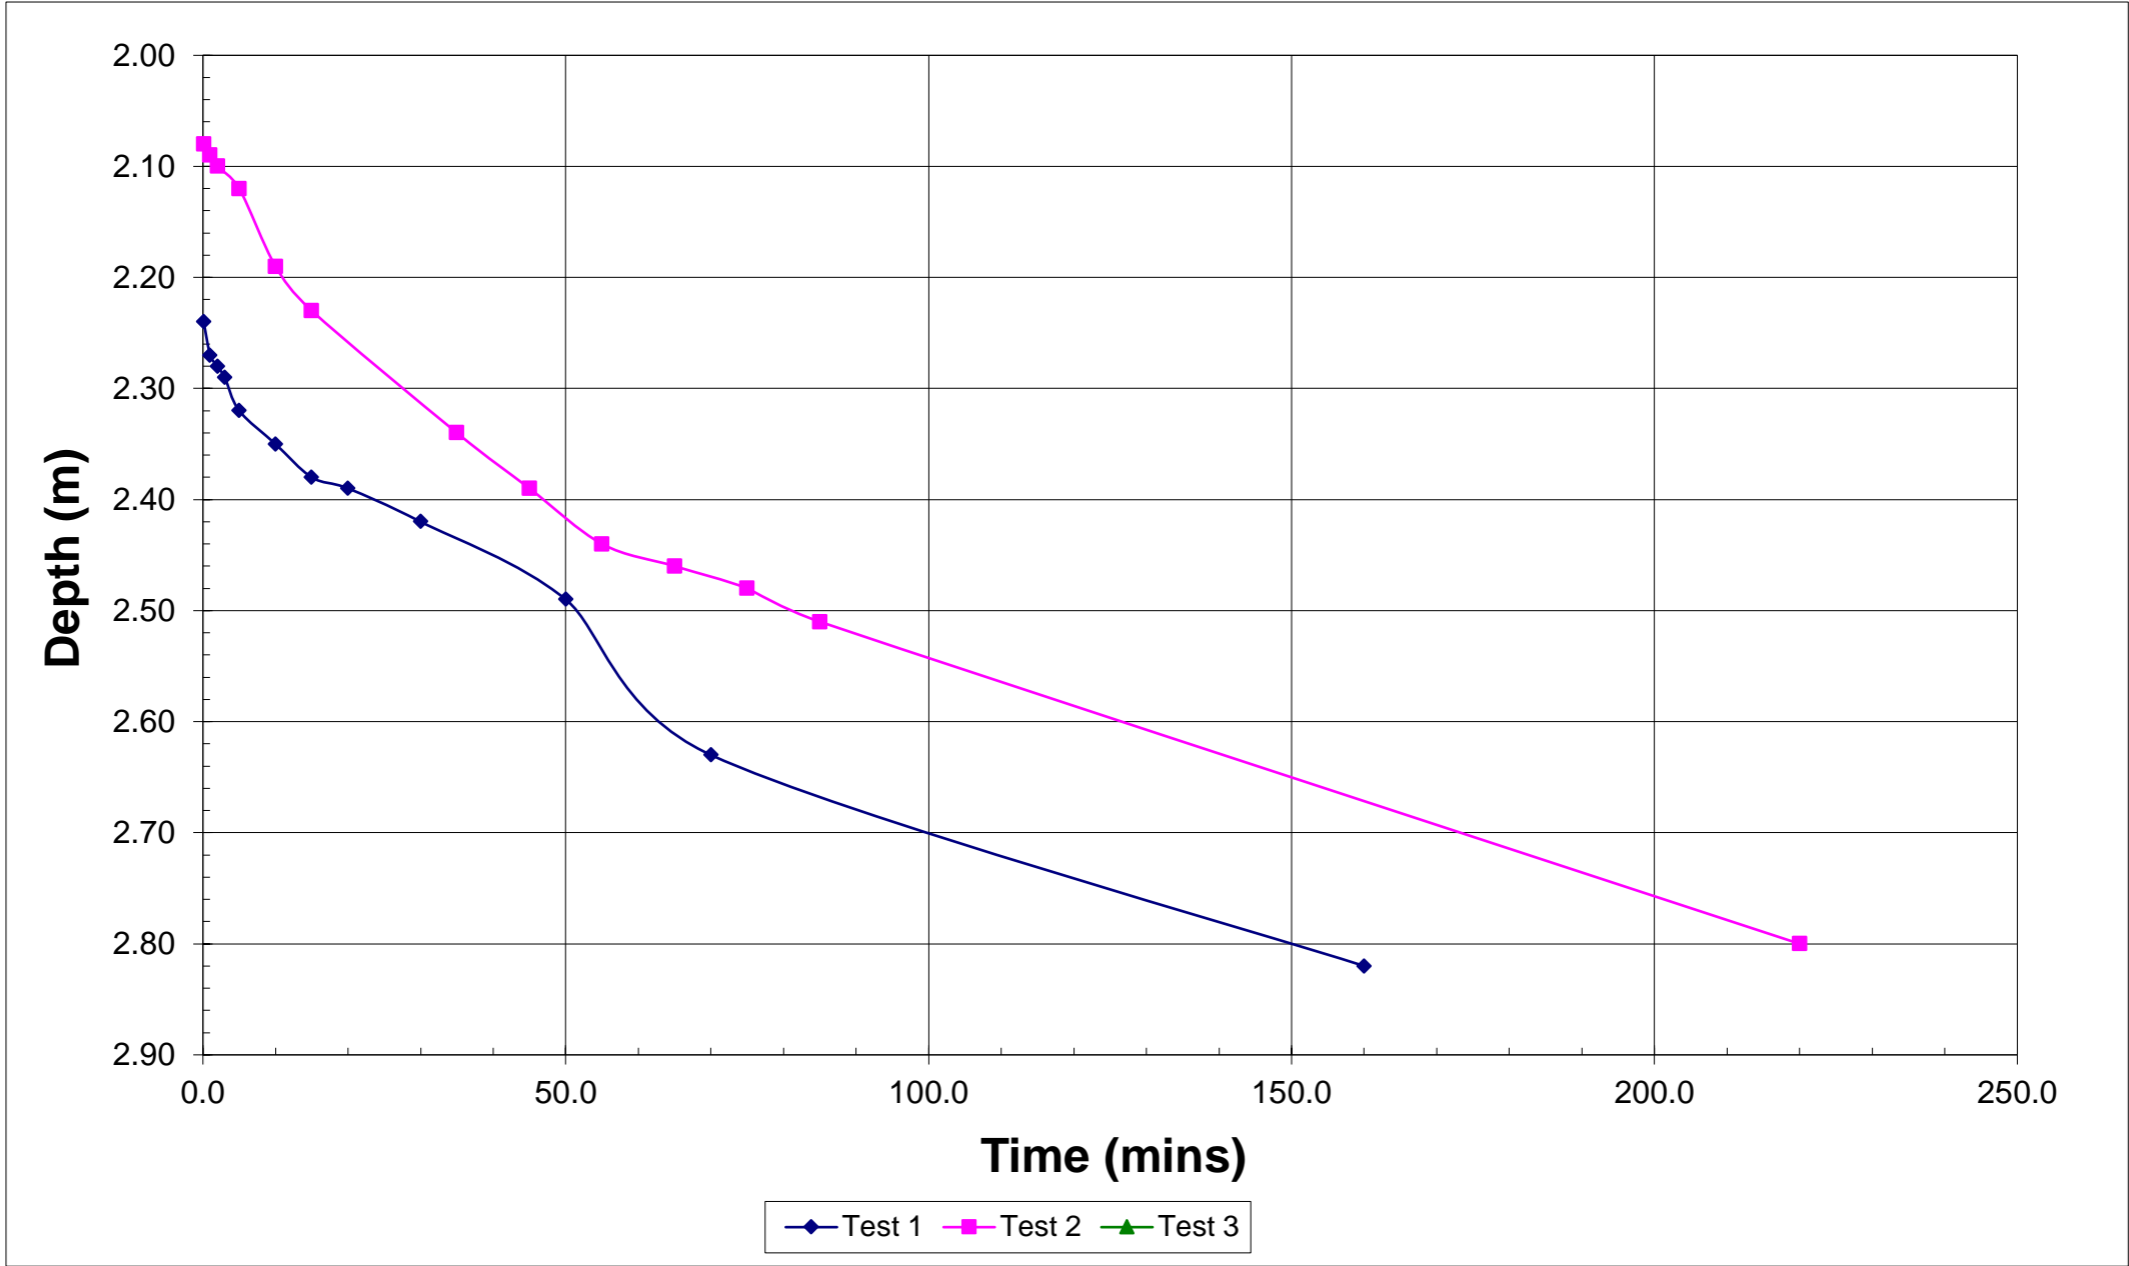
Max. depth (m)	3.00	3.00	3.00
Effective depth (m)	0.76	0.92	3.00
75% effective depth (m)	2.43	2.31	0.75
50% effective depth (m)	2.62	2.54	1.50
25% effective depth (m)	2.81	2.77	2.25
t75 (min)	34.00	30.00	
t50 (min)	68.00	100.00	
t25 (min)	155.00	210.00	
Vp 75-25	0.44	0.54	1.75
ap 50	3.0944	3.5008	8.784
tp 75-25	121.00	180.00	0.00

Soil infiltration rate (m/s)	2.0E-05	1.4E-05	#DIV/0!
Soil infiltration rate (mm/hr)	7.09E+01	5.10E+01	#DIV/0!

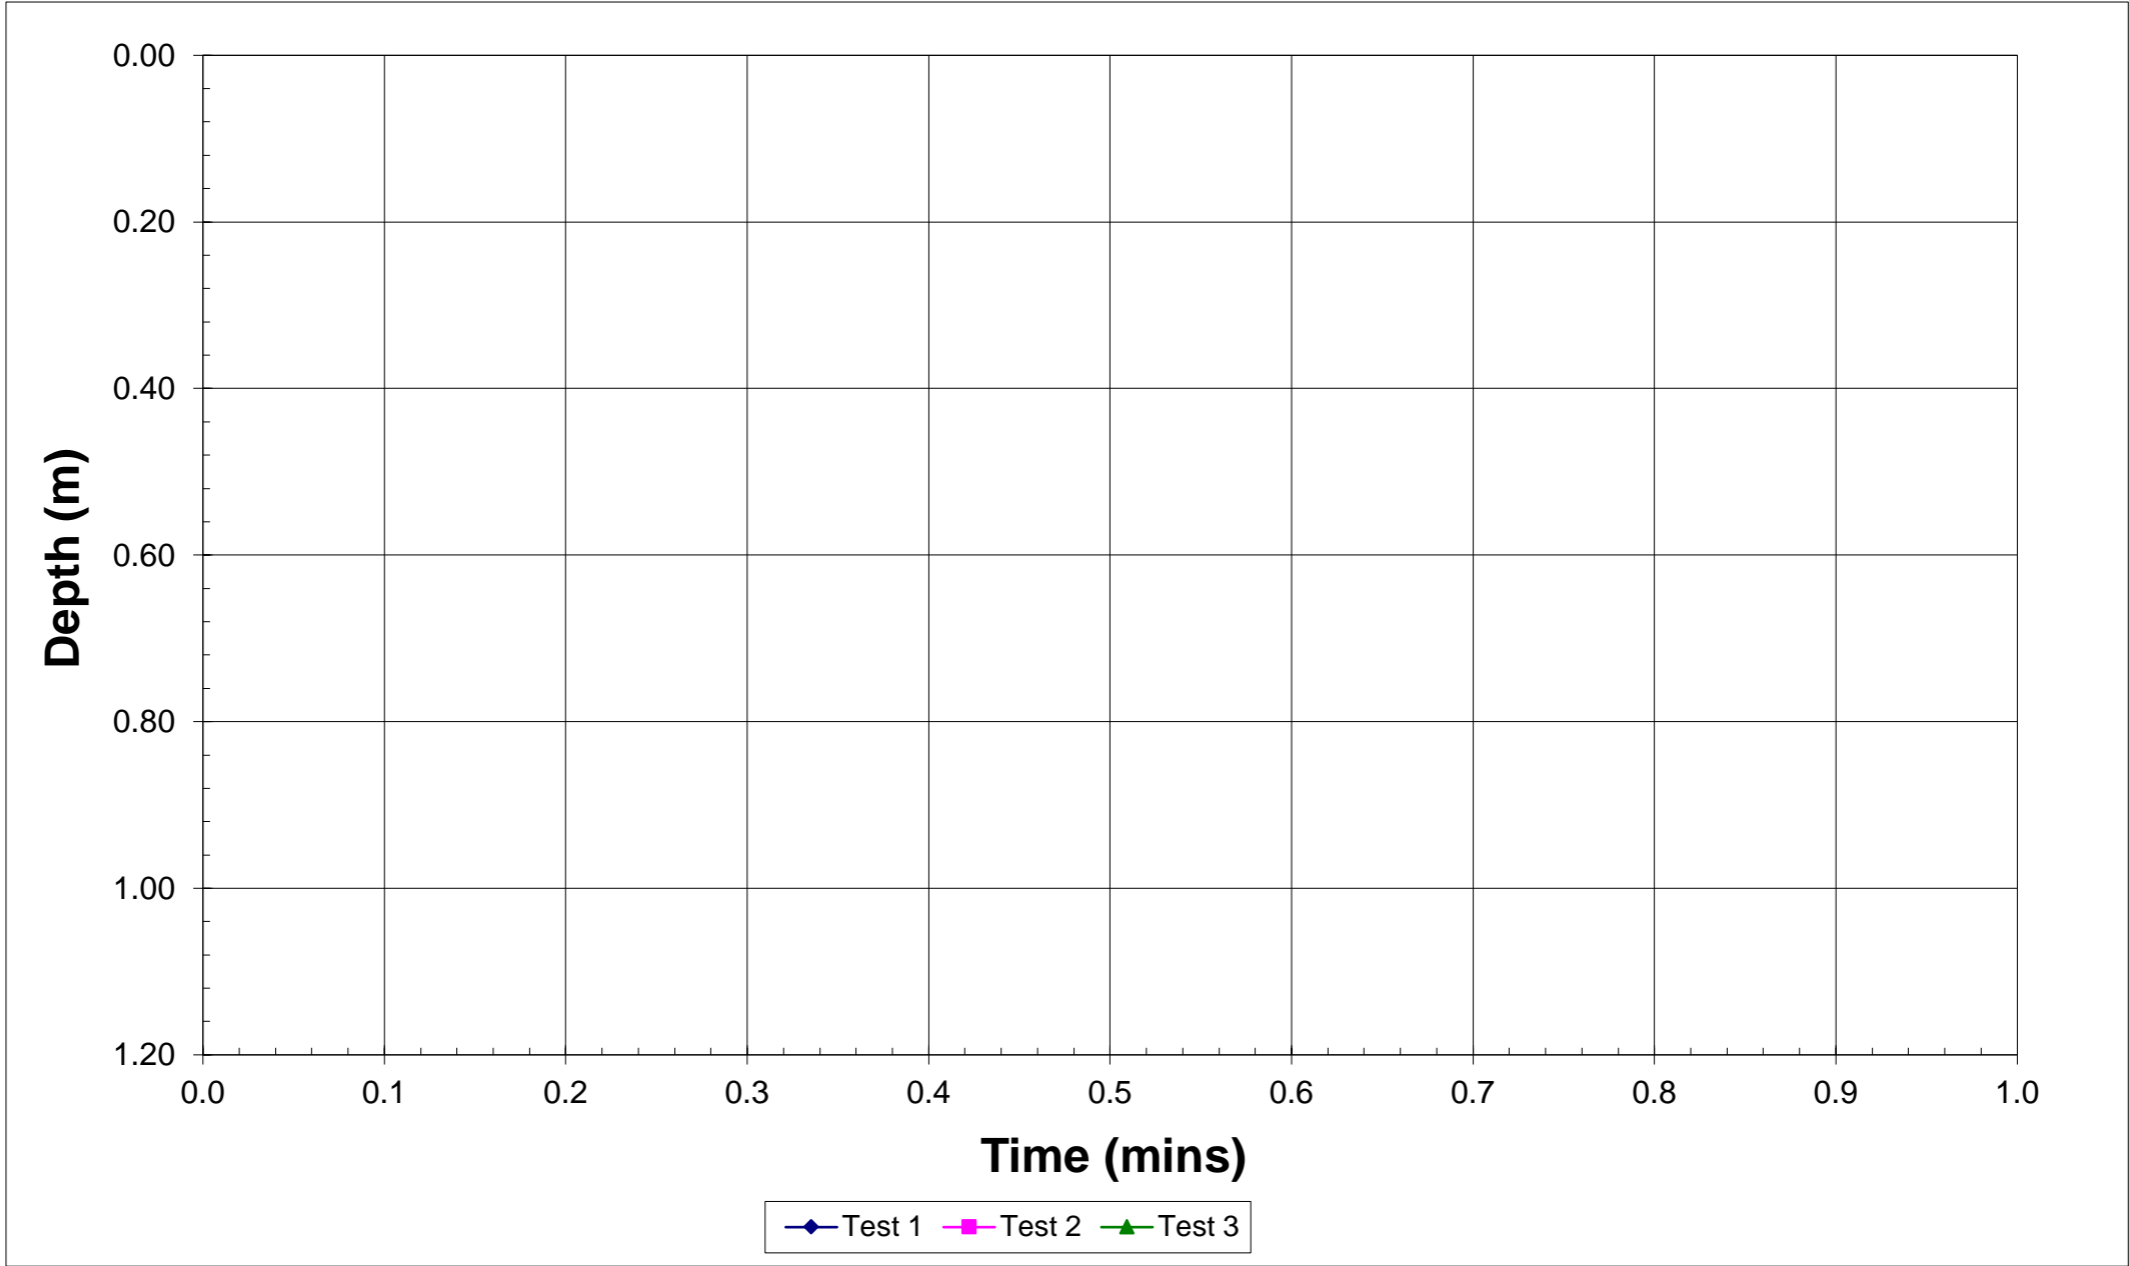
Water outflow was too fast for a head of water to build in the pit. c. 1800litres of water pumped into the pit for the test. Water drained out immediately. Multiple fillings were attempted, each having the same outcome.

Max. depth (m)	3.00	3.00	3.00
Effective depth (m)	3.00	3.00	3.00
75% effective depth (m)	0.75	0.75	0.75
50% effective depth (m)	1.50	1.50	1.50
25% effective depth (m)	2.25	2.25	2.25
t75 (min)			
t50 (min)			
t25 (min)			
Vp 75-25	1.76	1.76	1.76
ap 50	8.82	8.82	8.82
tp 75-25	0.00	0.00	0.00

Soil infiltration rate (m/s)	#DIV/0!	#DIV/0!	#DIV/0!
Soil infiltration rate (mm/hr)	#DIV/0!	#DIV/0!	#DIV/0!

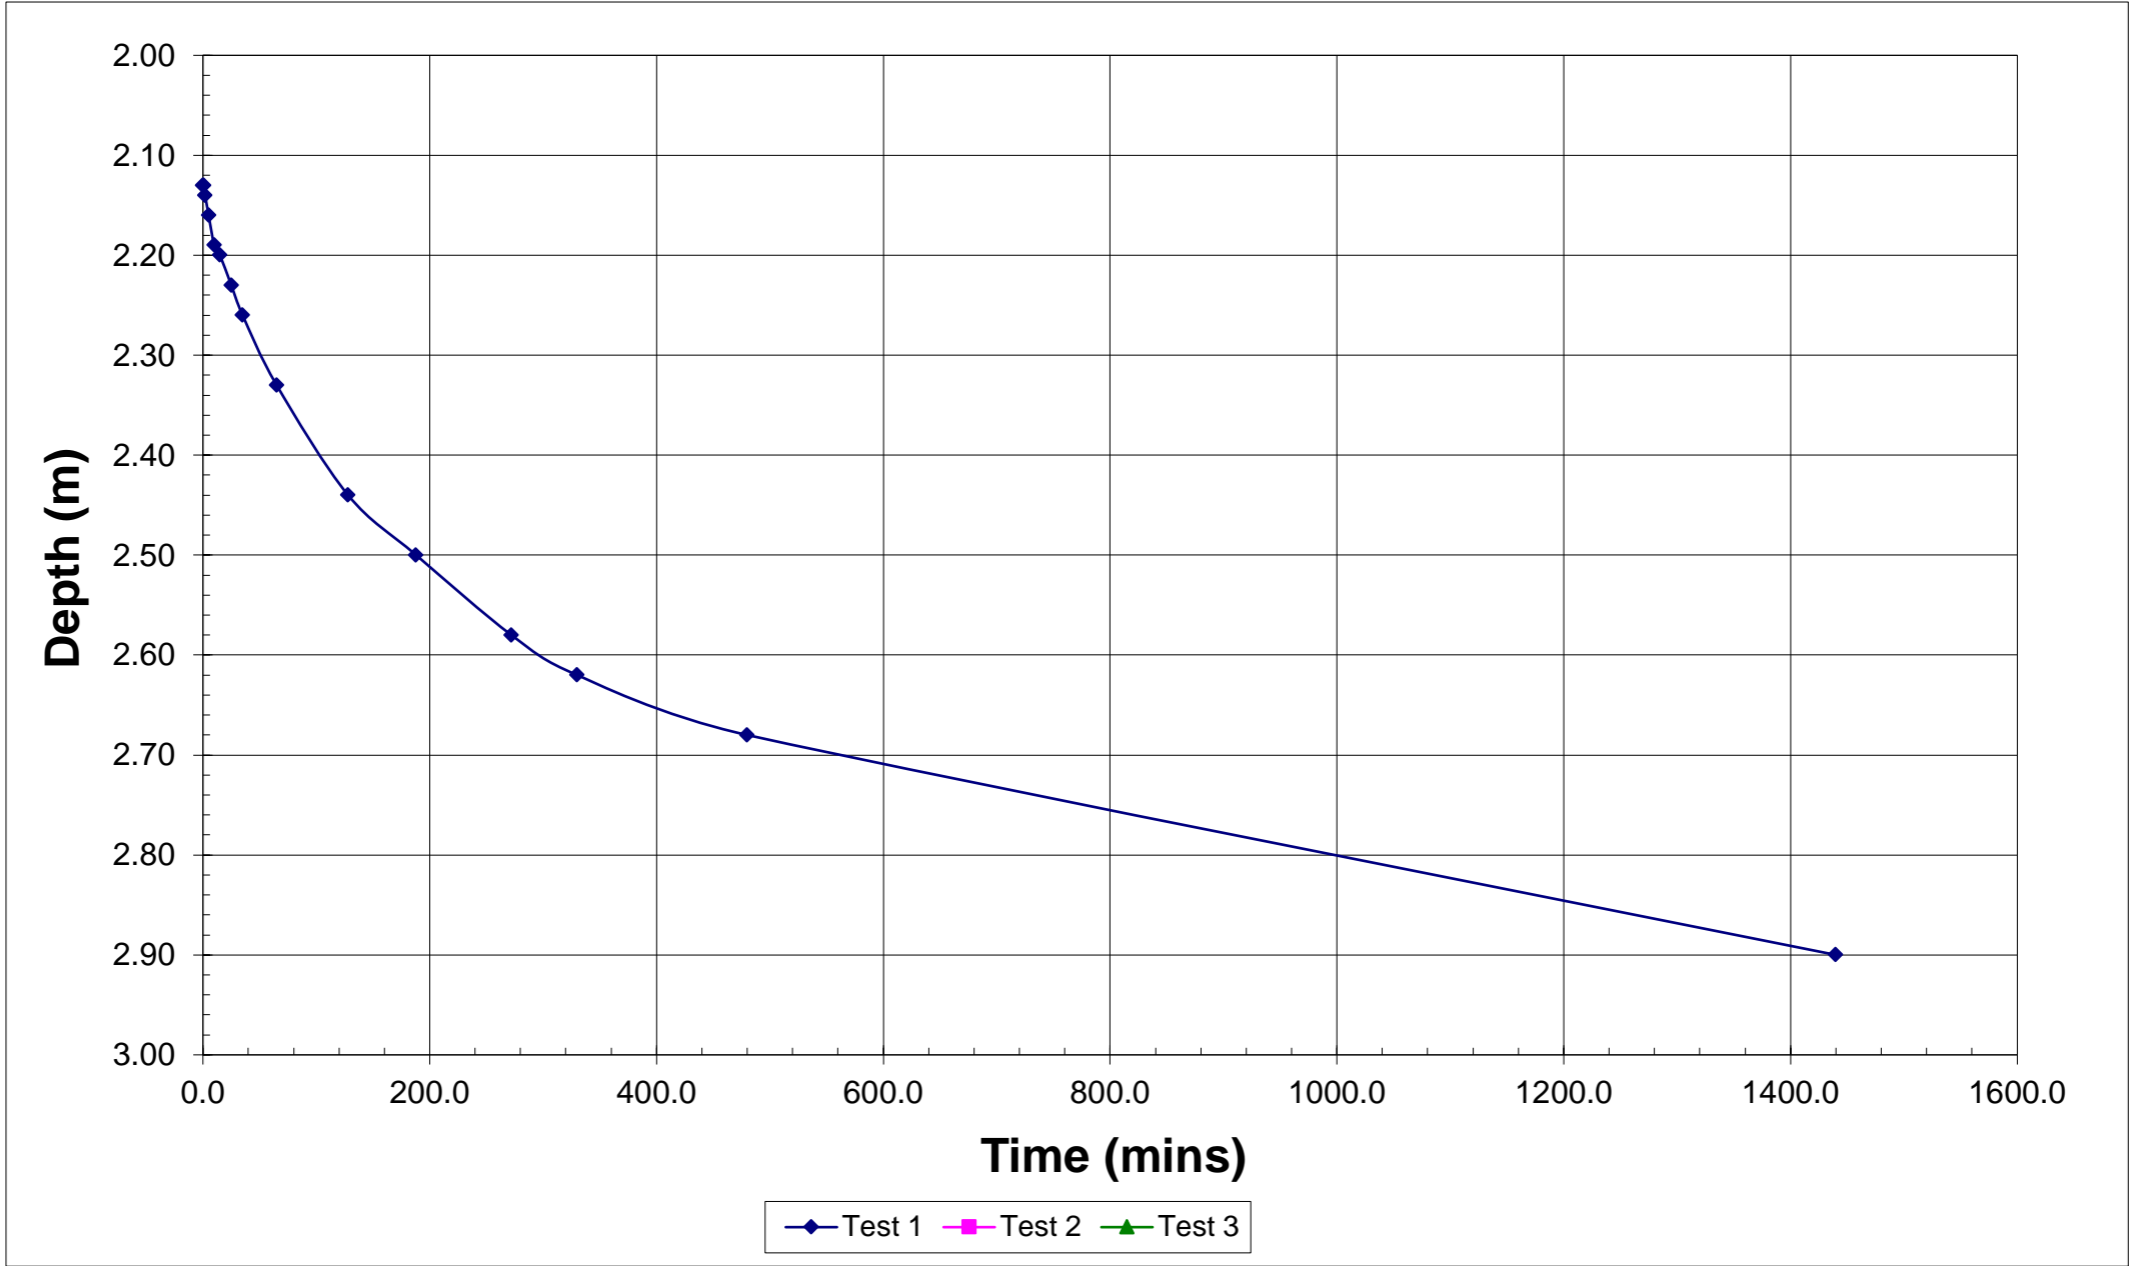
Max. depth (m)	3.10	3.10	3.10
Effective depth (m)	0.97	3.10	3.10
75% effective depth (m)	2.37	0.78	0.78
50% effective depth (m)	2.62	1.55	1.55
25% effective depth (m)	2.86	2.33	2.33
t75 (min)	85.00		
t50 (min)	330.00		
t25 (min)	1400.00		
Vp 75-25	0.49	1.58	1.58
ap 50	3.251	8.15	8.15
tp 75-25	1315.00	0.00	0.00

Soil infiltration rate (m/s)	1.9E-06	#DIV/0!	#DIV/0!
Soil infiltration rate (mm/hr)	6.94E+00	#DIV/0!	#DIV/0!

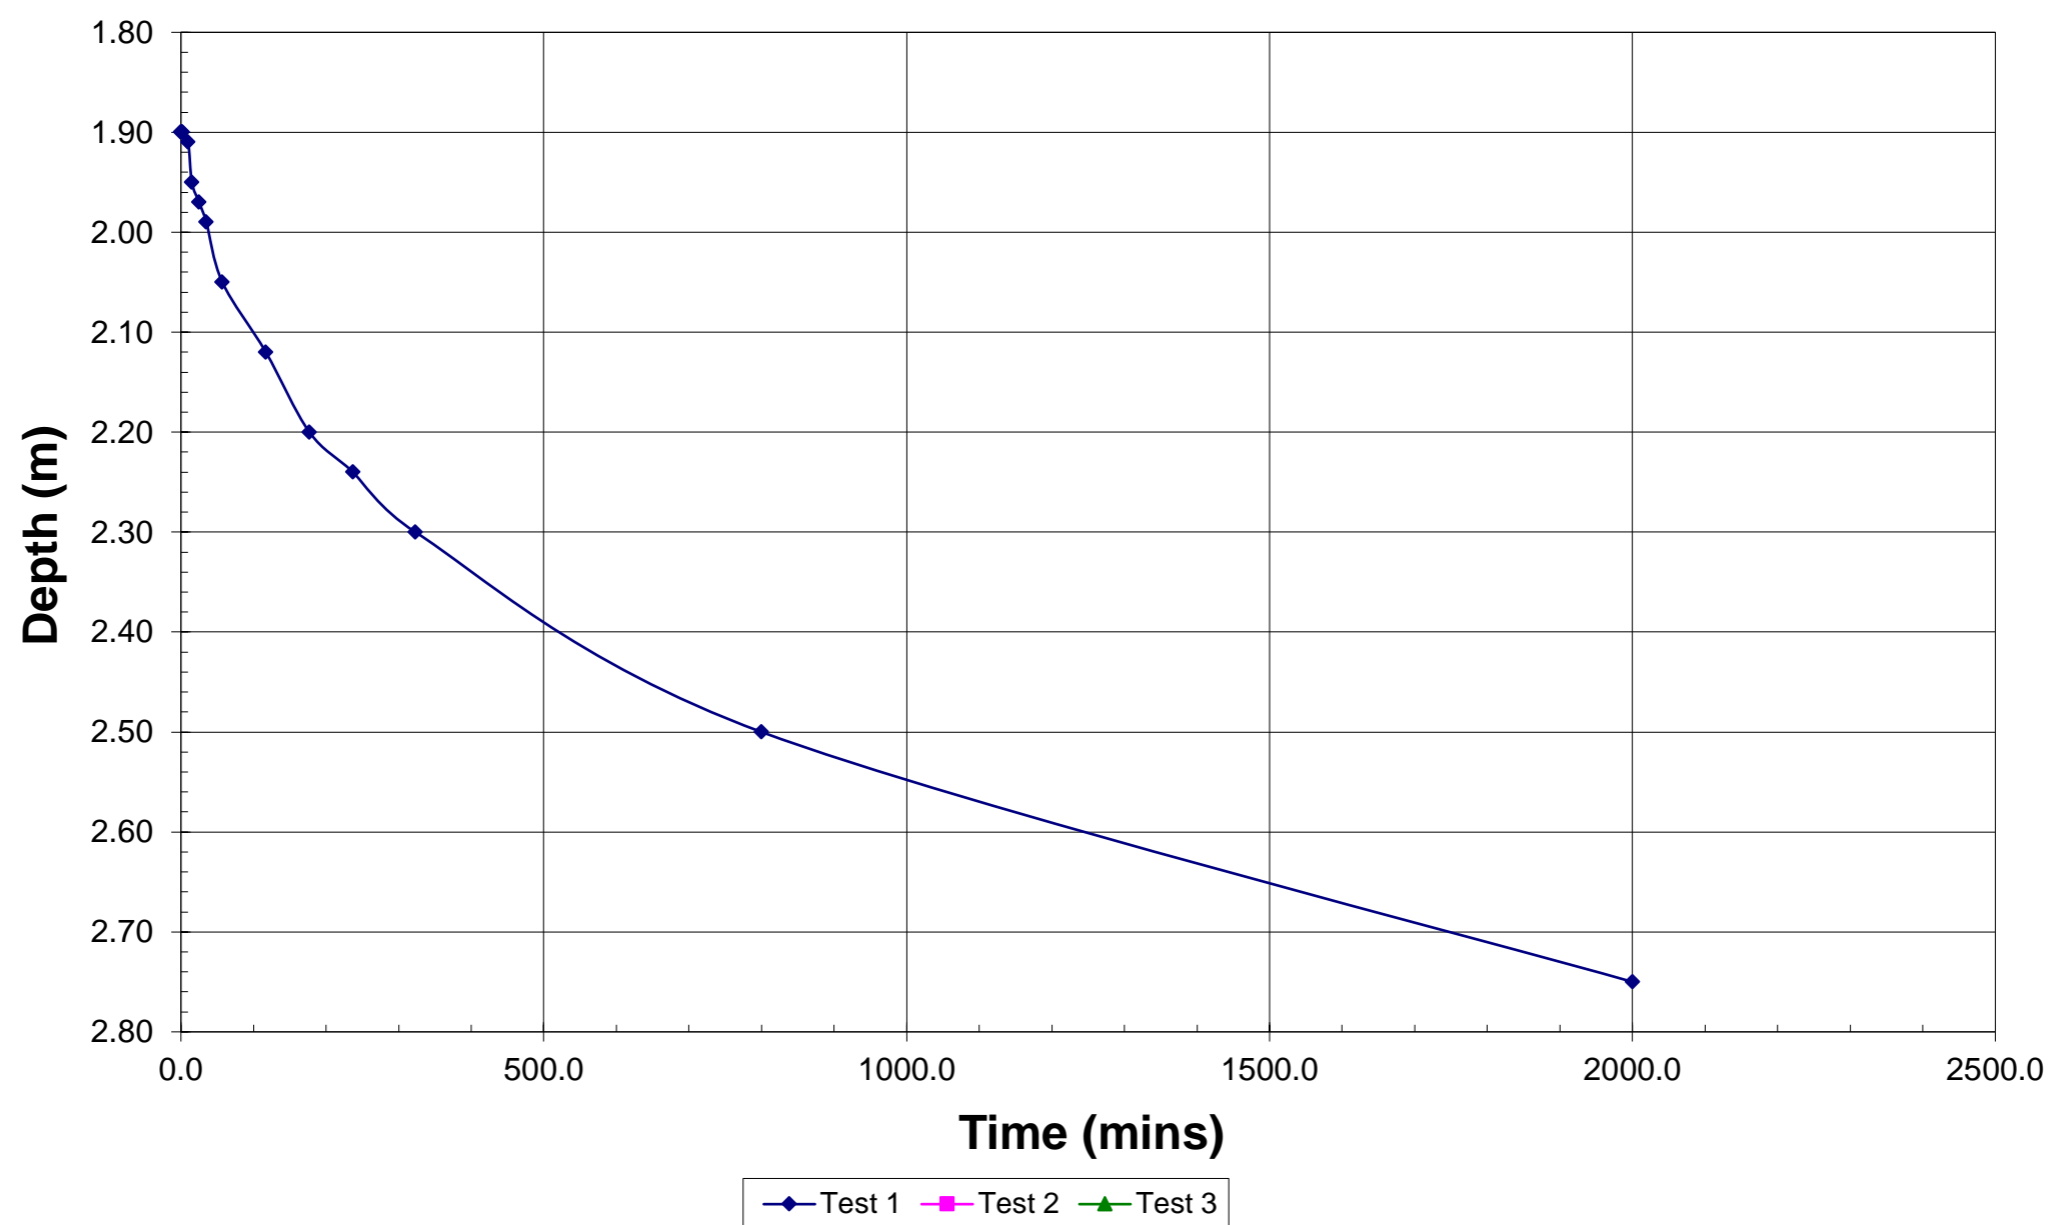
Max. depth (m)	3.00	3.00	3.00
Effective depth (m)	1.10	3.00	3.00
75% effective depth (m)	2.18	0.75	0.75
50% effective depth (m)	2.45	1.50	1.50
25% effective depth (m)	2.73	2.25	2.25
t75 (min)	160.00		
t50 (min)	650.00		
t25 (min)	1900.00		
Vp 75-25	0.58	1.58	1.58
ap 50	3.635	8.1	8.1
tp 75-25	1740.00	0.00	0.00

Soil infiltration rate (m/s)	1.5E-06	#DIV/0!	#DIV/0!
Soil infiltration rate (mm/hr)	5.48E+00	#DIV/0!	#DIV/0!
