Our ref: GE16226/GR02.2/171018

RE: Downend Road, Portchester

Further to the request received via Odyssey and your subsequent instruction, we write to present the findings of the supplementary permeability testing undertaken on this site. The site location is shown on Figure 1 enclosed. This letter includes a minor revision from letter ref. GE16226/GR02/170217 in that the enclosed Figures 2 and 3 reflect the revised site extent as indicated on TOR Drawings ref. 2495-01/PP-002 Aug 2017 and 2495-01/SK-013 Rev C Oct 2017. These drawings should be referred to for the definitive red line boundary and the proposed development layout.

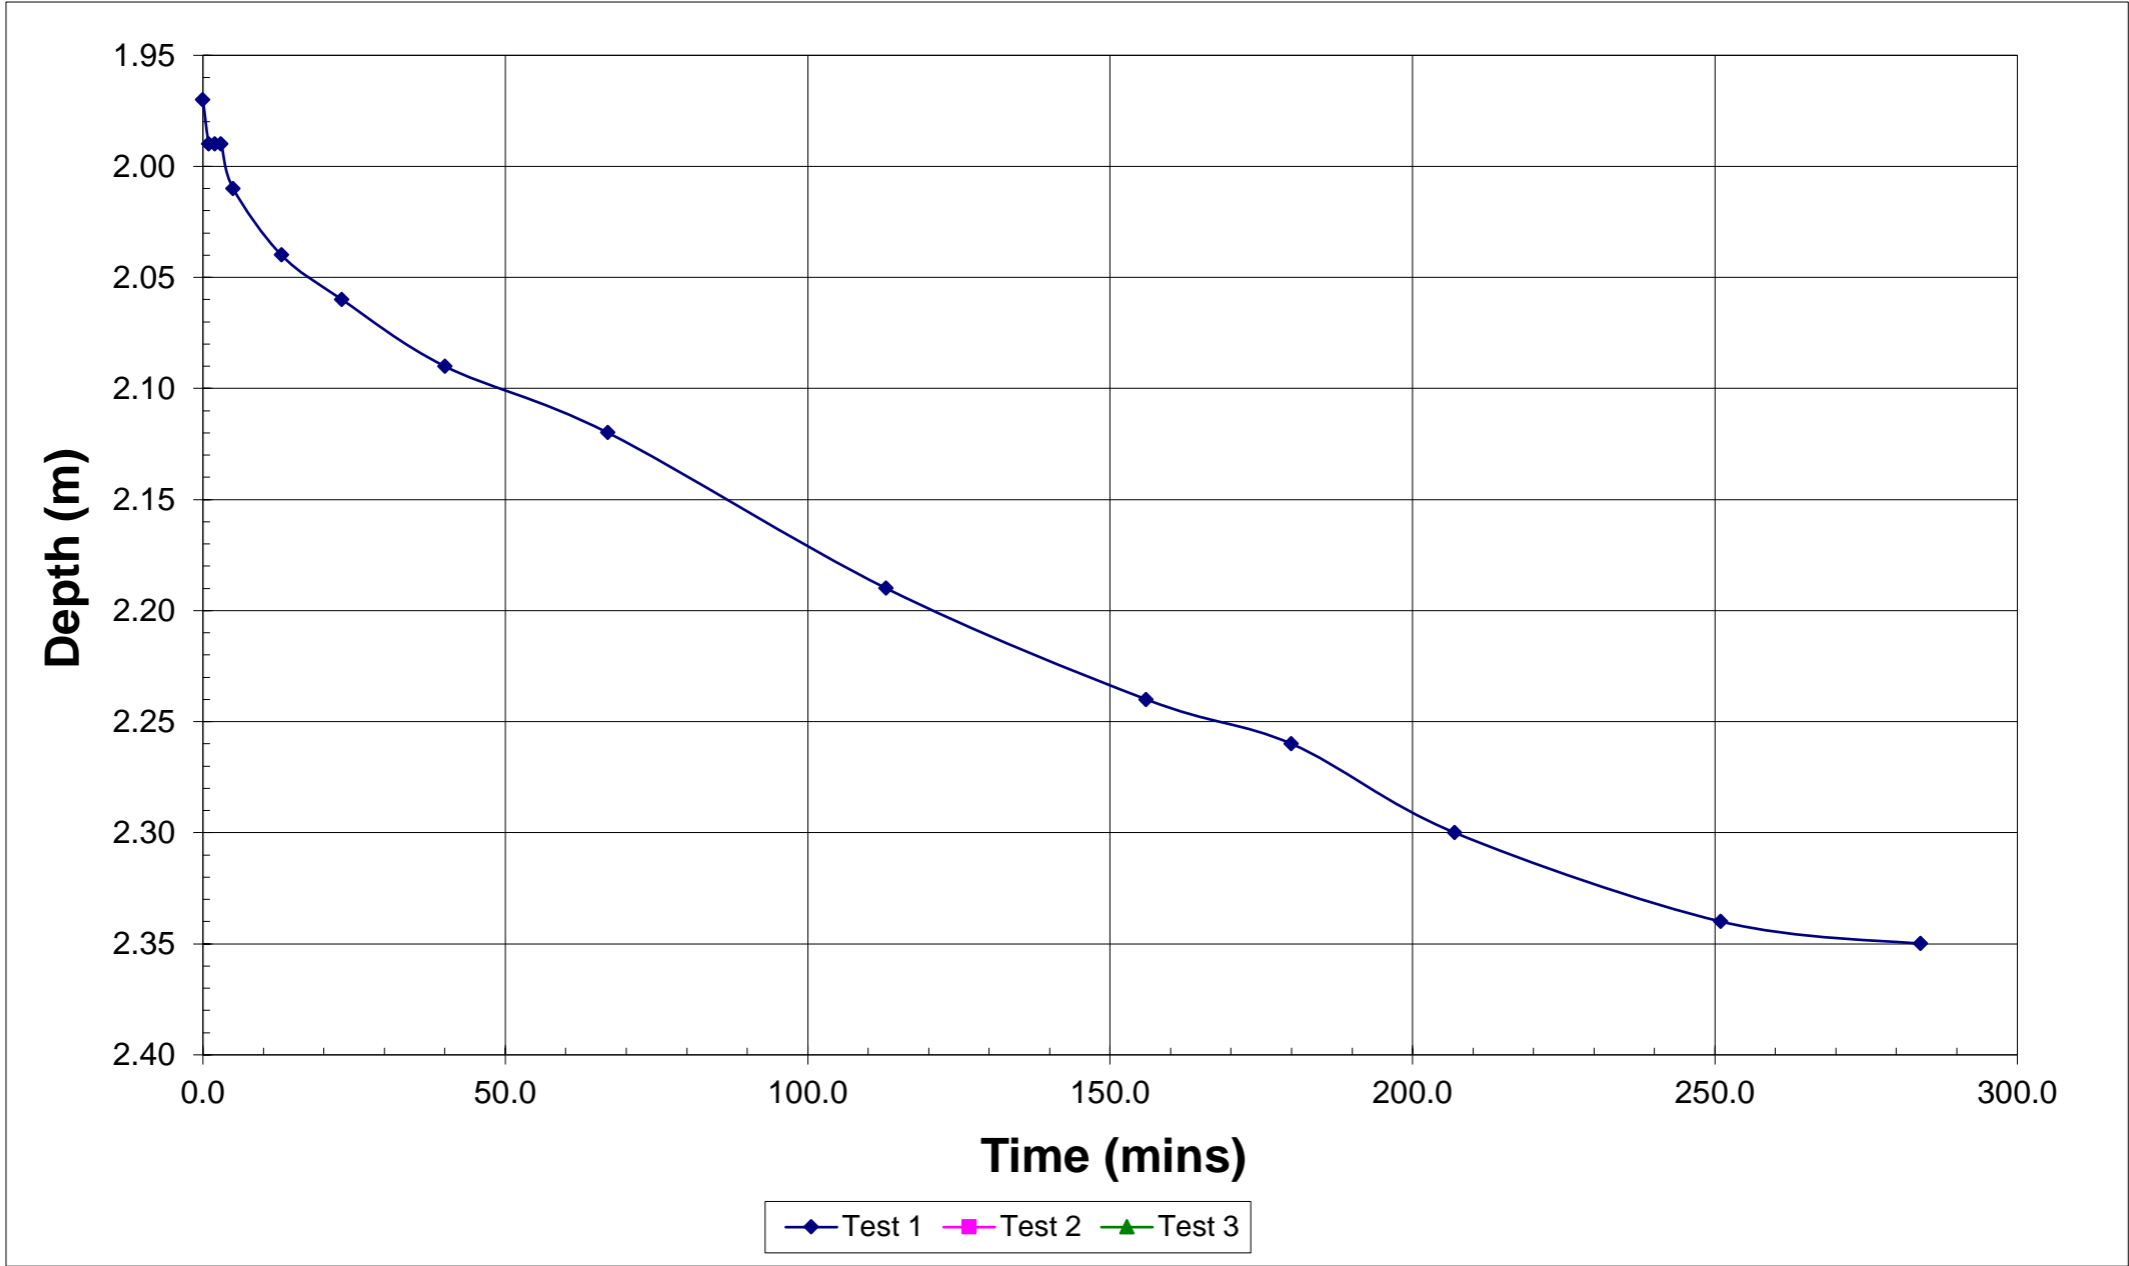
Max. depth (m)	2.35	2.35	2.35
Effective depth (m)	0.38	2.35	2.35
75% effective depth (m)	2.07	0.59	0.59
50% effective depth (m)	2.16	1.18	1.18
25% effective depth (m)	2.26	1.76	1.76
t75 (min)	30.00		
t50 (min)	90.00		
t25 (min)	180.00		
Vp 75-25	0.23	1.41	1.41
ap 50	2.188	7.31	7.31
tp 75-25	150.00	0.00	0.00

NOTE: Values are based on the measured final water depth and not a fully drained test. Thus results are indicative only of the test range and the permeability over an extended test range could be lower.

Soil infiltration rate (m/s)	1.2E-05	#DIV/0!	#DIV/0!
Soil infiltration rate (mm/hr)	4.17E+01	#DIV/0!	#DIV/0!

It should be noted that the fall in water level within each pit tested as part of the supplementary investigation was insufficient to achieve the 75% drained depth required to determine a soil infiltration rate. As such, the infiltration rates presented for each of these trial pits (TP501-503 and TP601-603) are estimates based on the actual fall in water level recorded during the test. It is possible that the permeability could be lower than this estimated value.

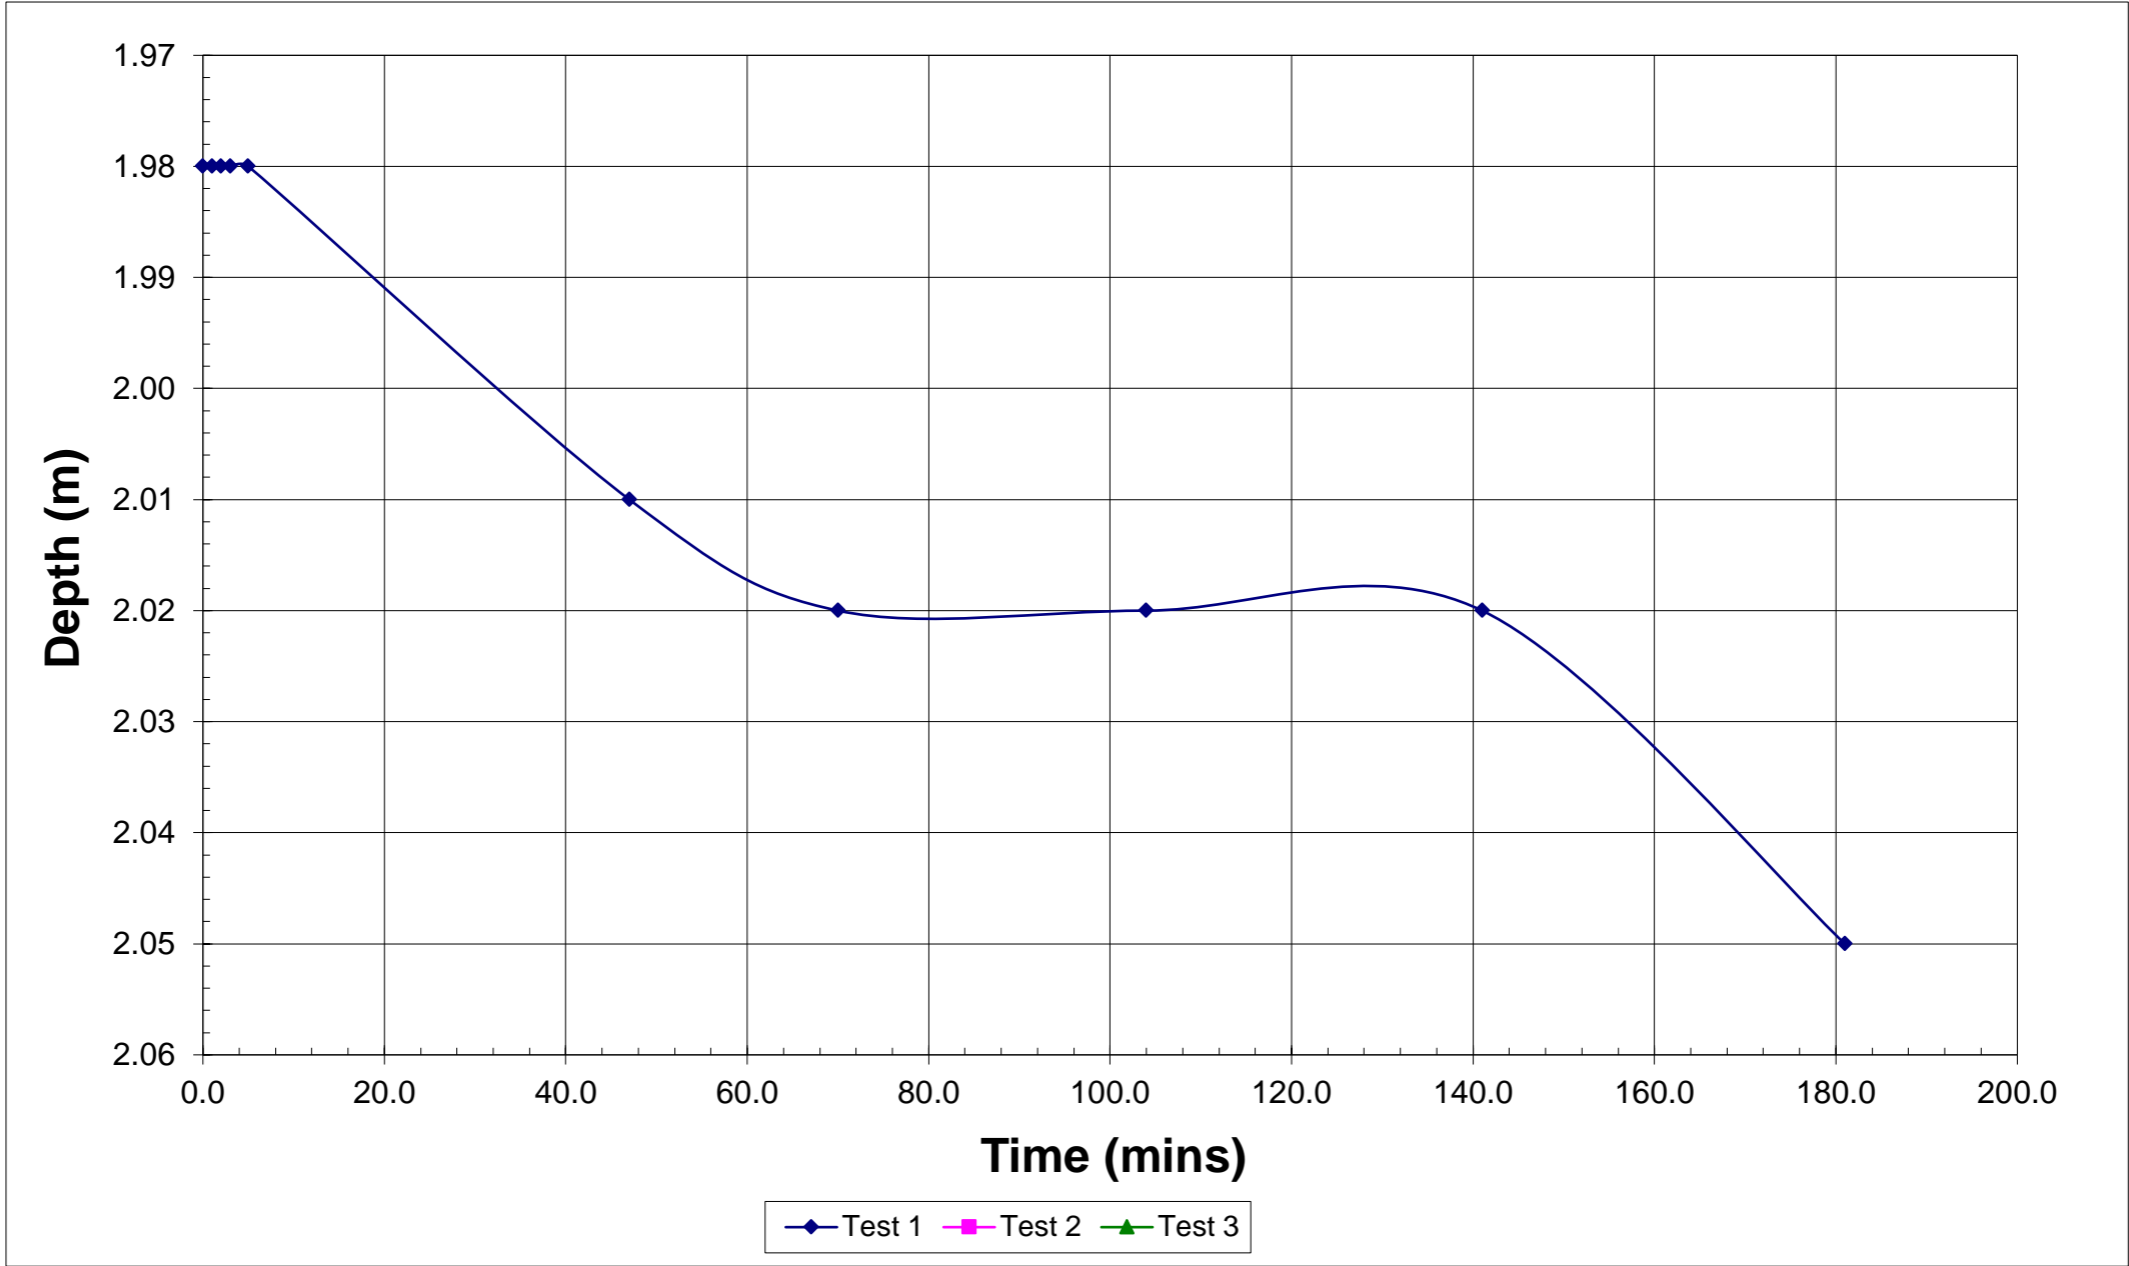
Pit reference	TP502	Base depth adjusted to maximum water depth during test
Pit depth (m)	2.05	
Pit width (m)	0.60	
Pit length (m)	2.15	
Depth to standing water (m)

Max. depth (m)	2.05	2.05	2.05
Effective depth (m)	0.07	2.05	2.05
75% effective depth (m)	2.00	0.51	0.51
50% effective depth (m)	2.02	1.03	1.03
25% effective depth (m)	2.03	1.54	1.54
t75 (min)	36.00		
t50 (min)	70.00		
t25 (min)	156.00		
Vp 75-25	0.05	1.32	1.32
ap 50	1.4825	6.9275	6.9275
tp 75-25	120.00	0.00	0.00

NOTE: Values are based on the measured final water depth and not a fully drained test. Thus results are indicative only of the test range and the permeability over an extended test range could be lower.

Soil infiltration rate (m/s)	4.2E-06	#DIV/0!	#DIV/0!
Soil infiltration rate (mm/hr)	1.52E+01	#DIV/0!	#DIV/0!

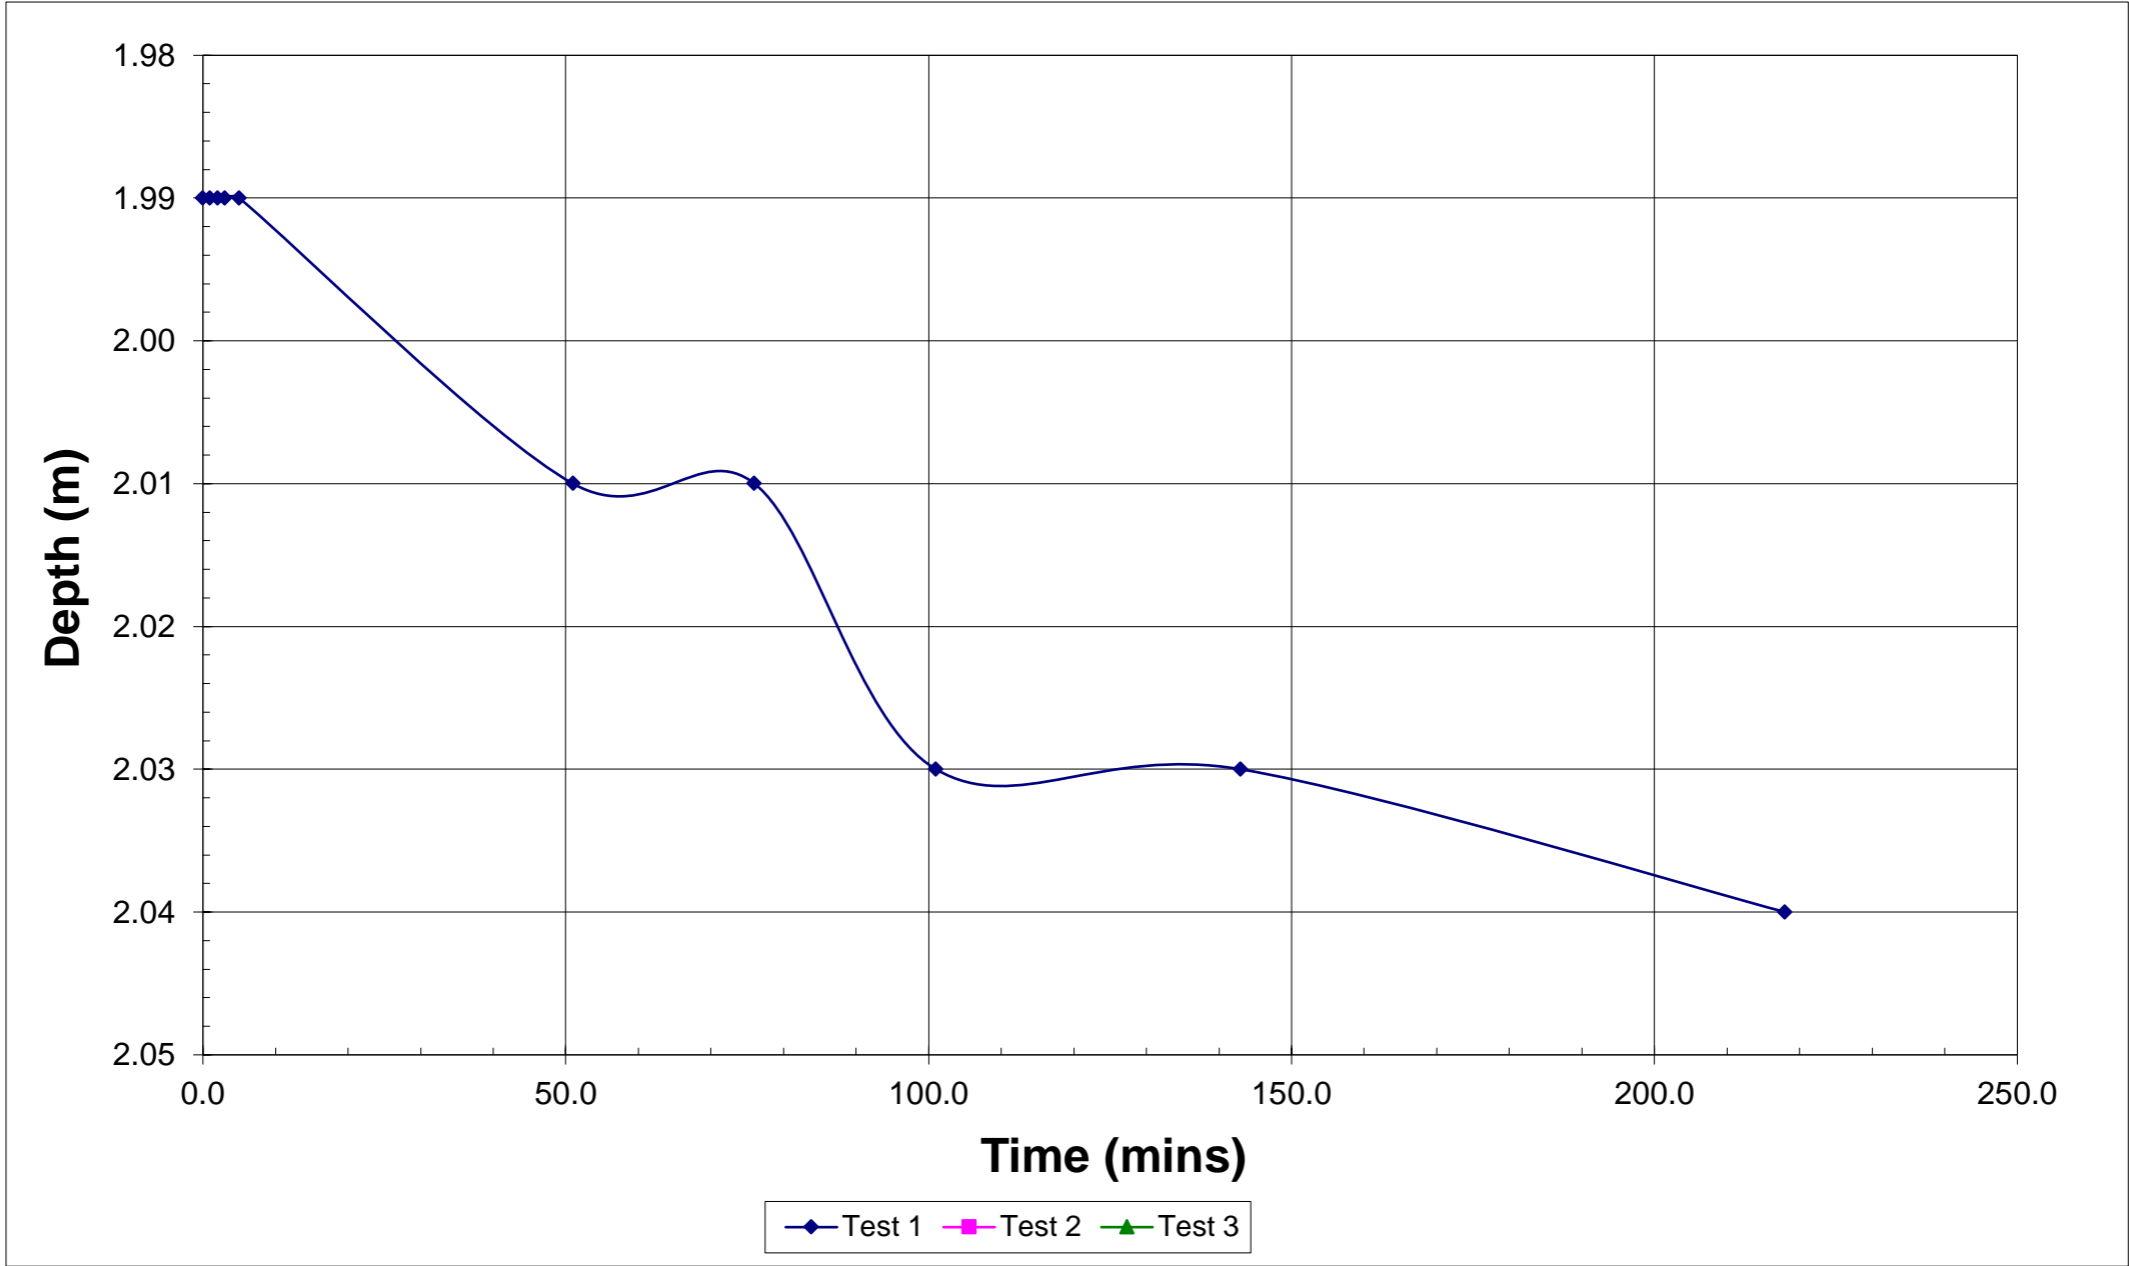
Max. depth (m)	2.04	2.04	2.04
Effective depth (m)	0.05	2.04	2.04
75% effective depth (m)	2.00	0.51	0.51
50% effective depth (m)	2.02	1.02	1.02
25% effective depth (m)	2.03	1.53	1.53
t75 (min)	27.00		
t50 (min)	85.00		
t25 (min)	100.00		
Vp 75-25	0.03	1.19	1.19
ap 50	1.2975	6.372	6.372
tp 75-25	73.00	0.00	0.00

NOTE: Values are based on the measured final water depth and not a fully drained test. Thus results are indicative only of the test range and the permeability over an extended test range could be lower.

Soil infiltration rate (m/s)	5.1E-06	#DIV/0!	#DIV/0!
Soil infiltration rate (mm/hr)	1.85E+01	#DIV/0!	#DIV/0!

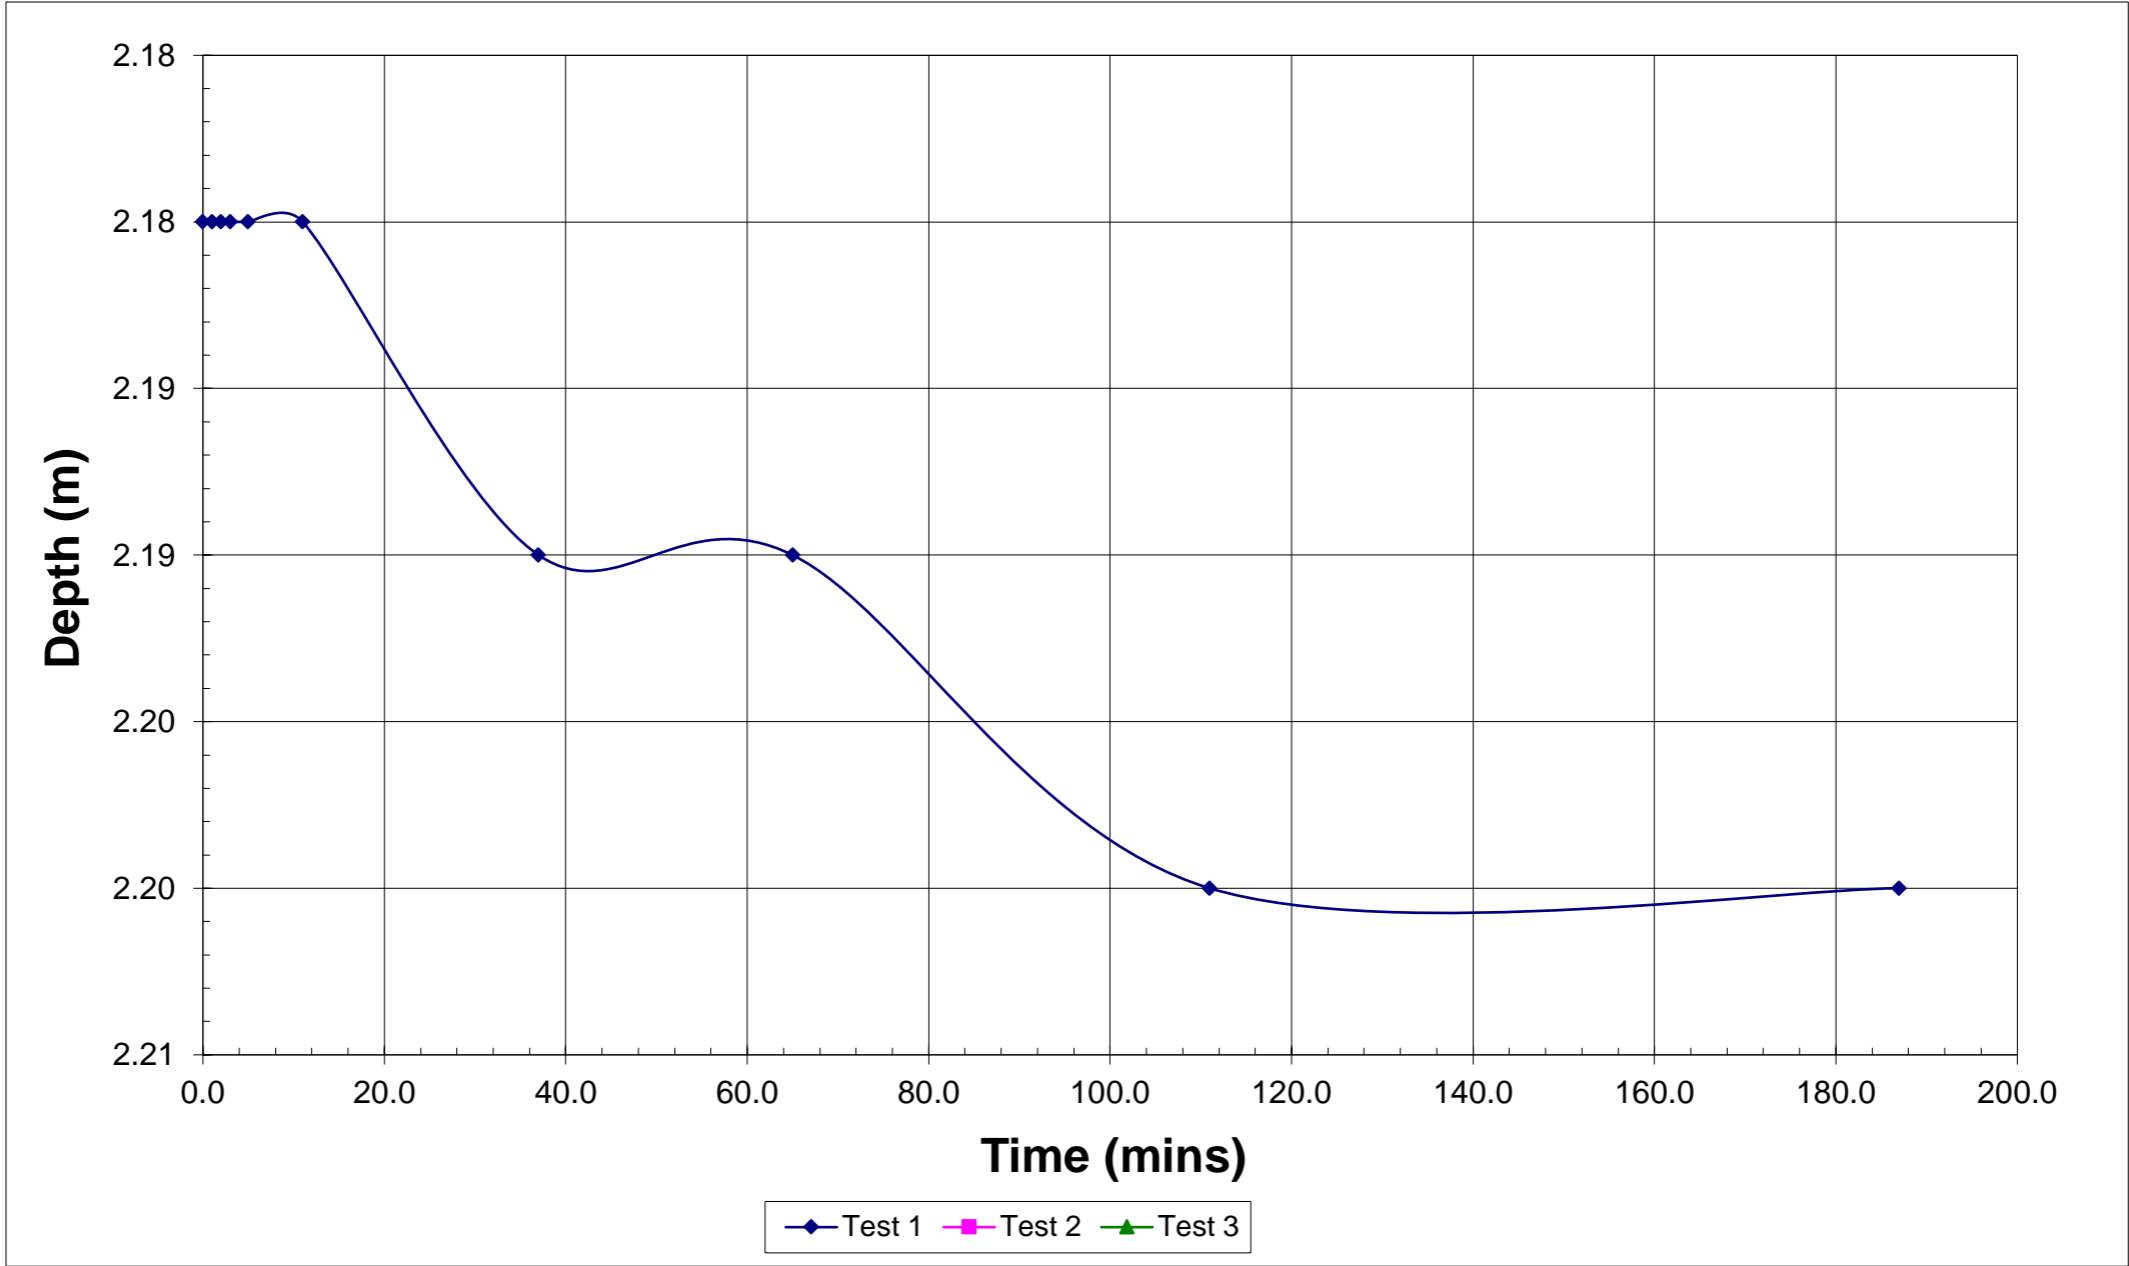
Pit reference	TP603	Base depth adjusted to maximum water depth during test
Pit depth (m)	2.20	
Pit width (m)	0.60	
Pit length (m)	2.05	
Depth to standing water (m)

Max. depth (m)	2.20	2.20	2.20
Effective depth (m)	0.02	2.20	2.20
75% effective depth (m)	2.19	0.55	0.55
50% effective depth (m)	2.19	1.10	1.10
25% effective depth (m)	2.20	1.65	1.65
t75 (min)	24.00		
t50 (min)	24.00		
t25 (min)	86.00		
Vp 75-25	0.01	1.35	1.35
ap 50	1.283	7.06	7.06
tp 75-25	62.00	0.00	0.00

NOTE: Values are based on the measured final water depth and not a fully drained test. Thus results are indicative only of the test range and the permeability over an extended test range could be lower.

Soil infiltration rate (m/s)	2.6E-06	#DIV/0!	#DIV/0!
Soil infiltration rate (mm/hr)	9.28E+00	#DIV/0!	#DIV/0!

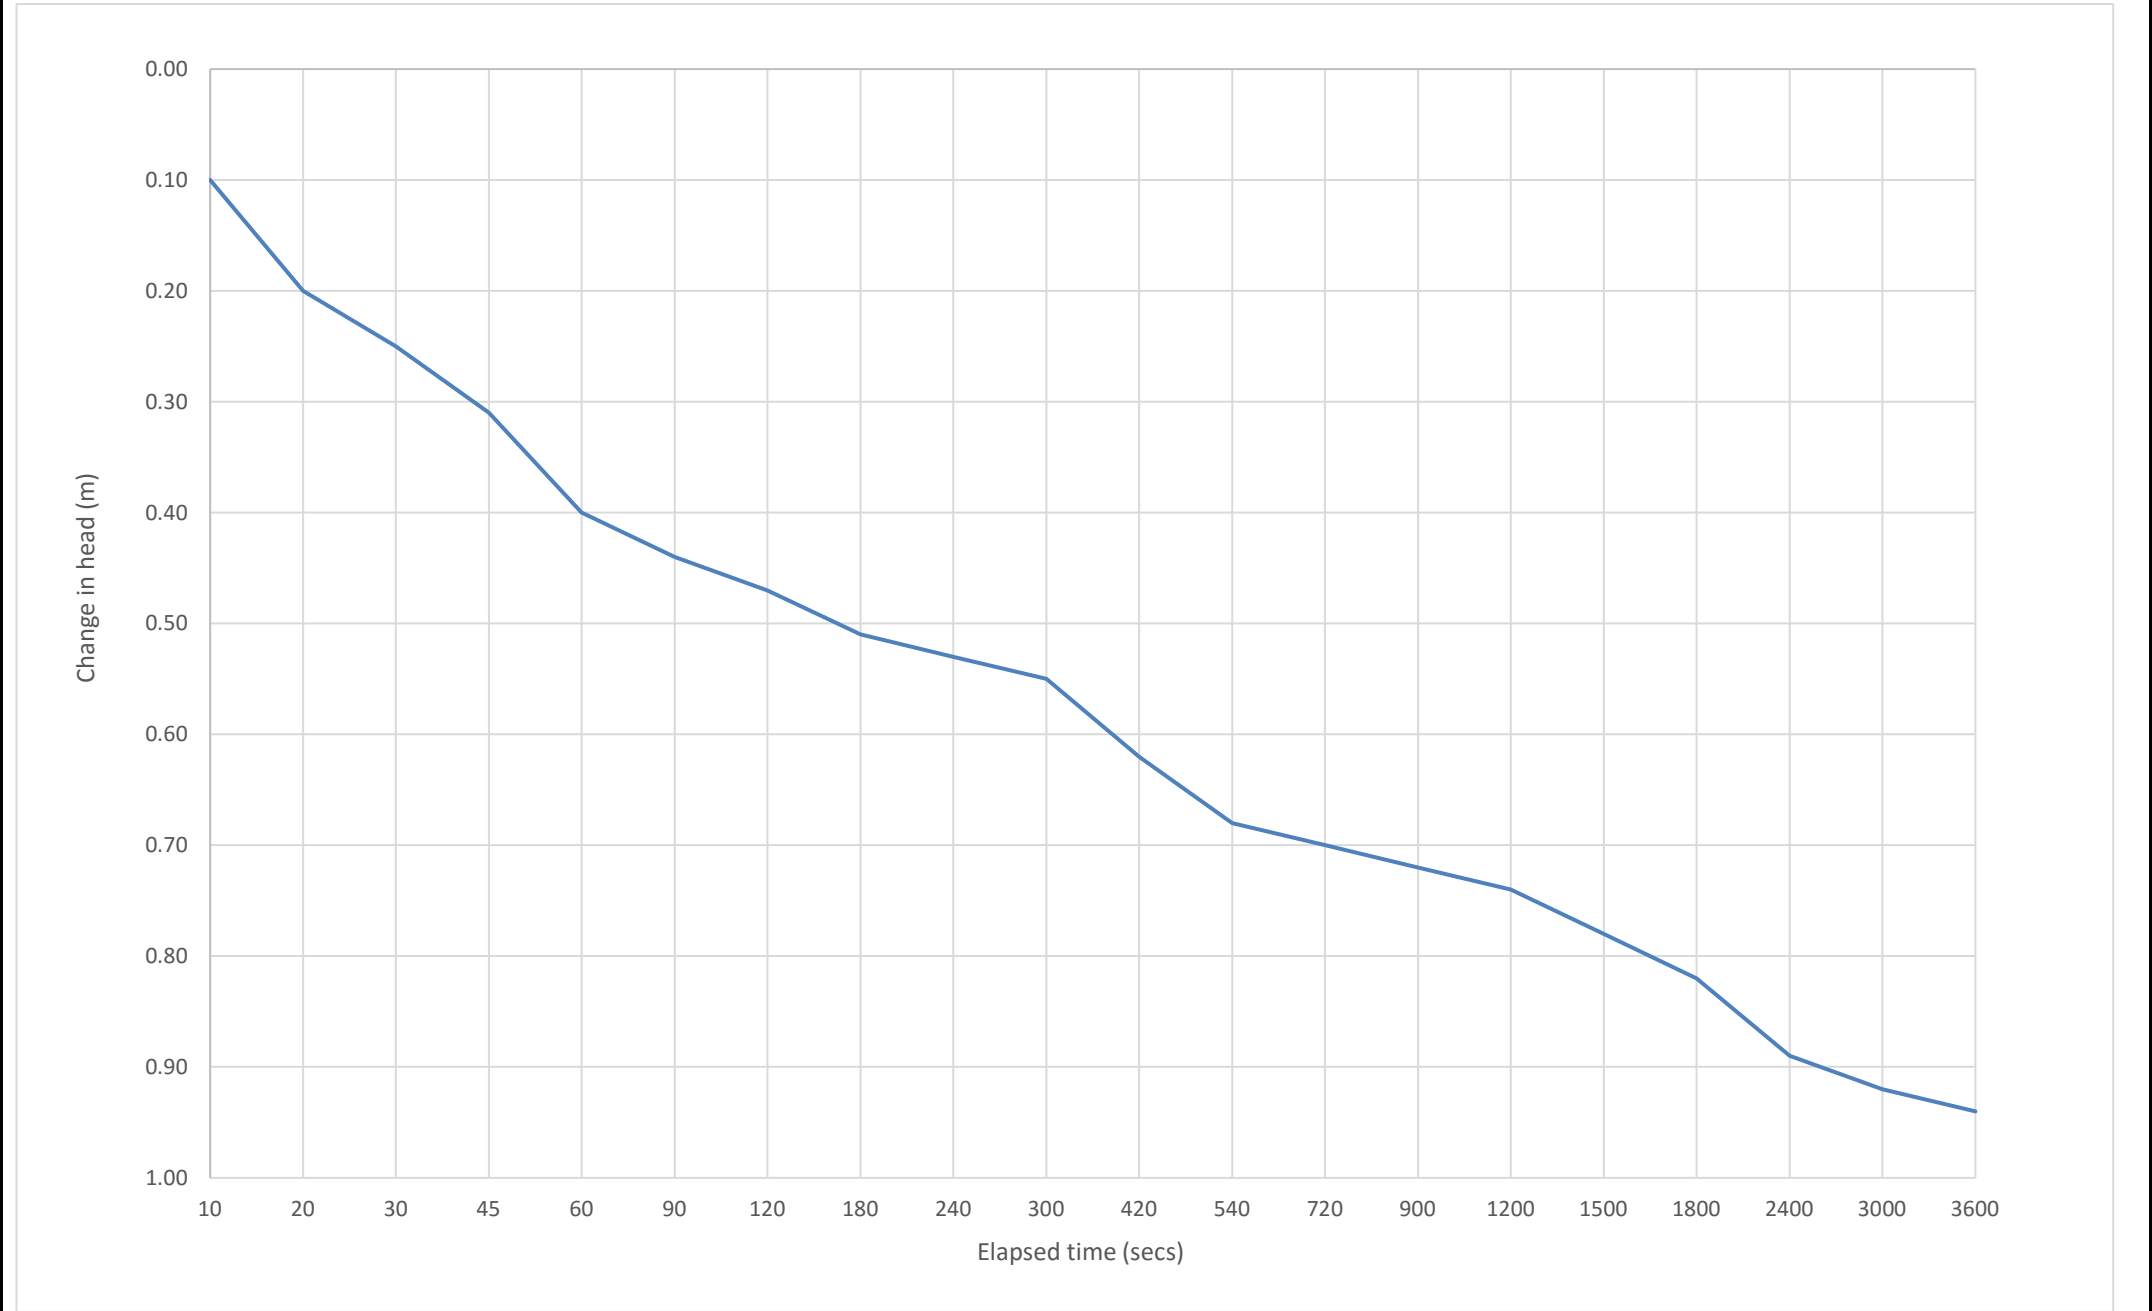
Casing height above ground level (m)	-	Depth of casing below ground level (m bgl)	1.5	Casing diameter (m)	0.15
--------------------------------------	---	--	-----	---------------------	------

Shape Factor F (from BS EN ISO 22282-1

L =	1.50
D =	0.15
L/D =	10.00
F=	3.15

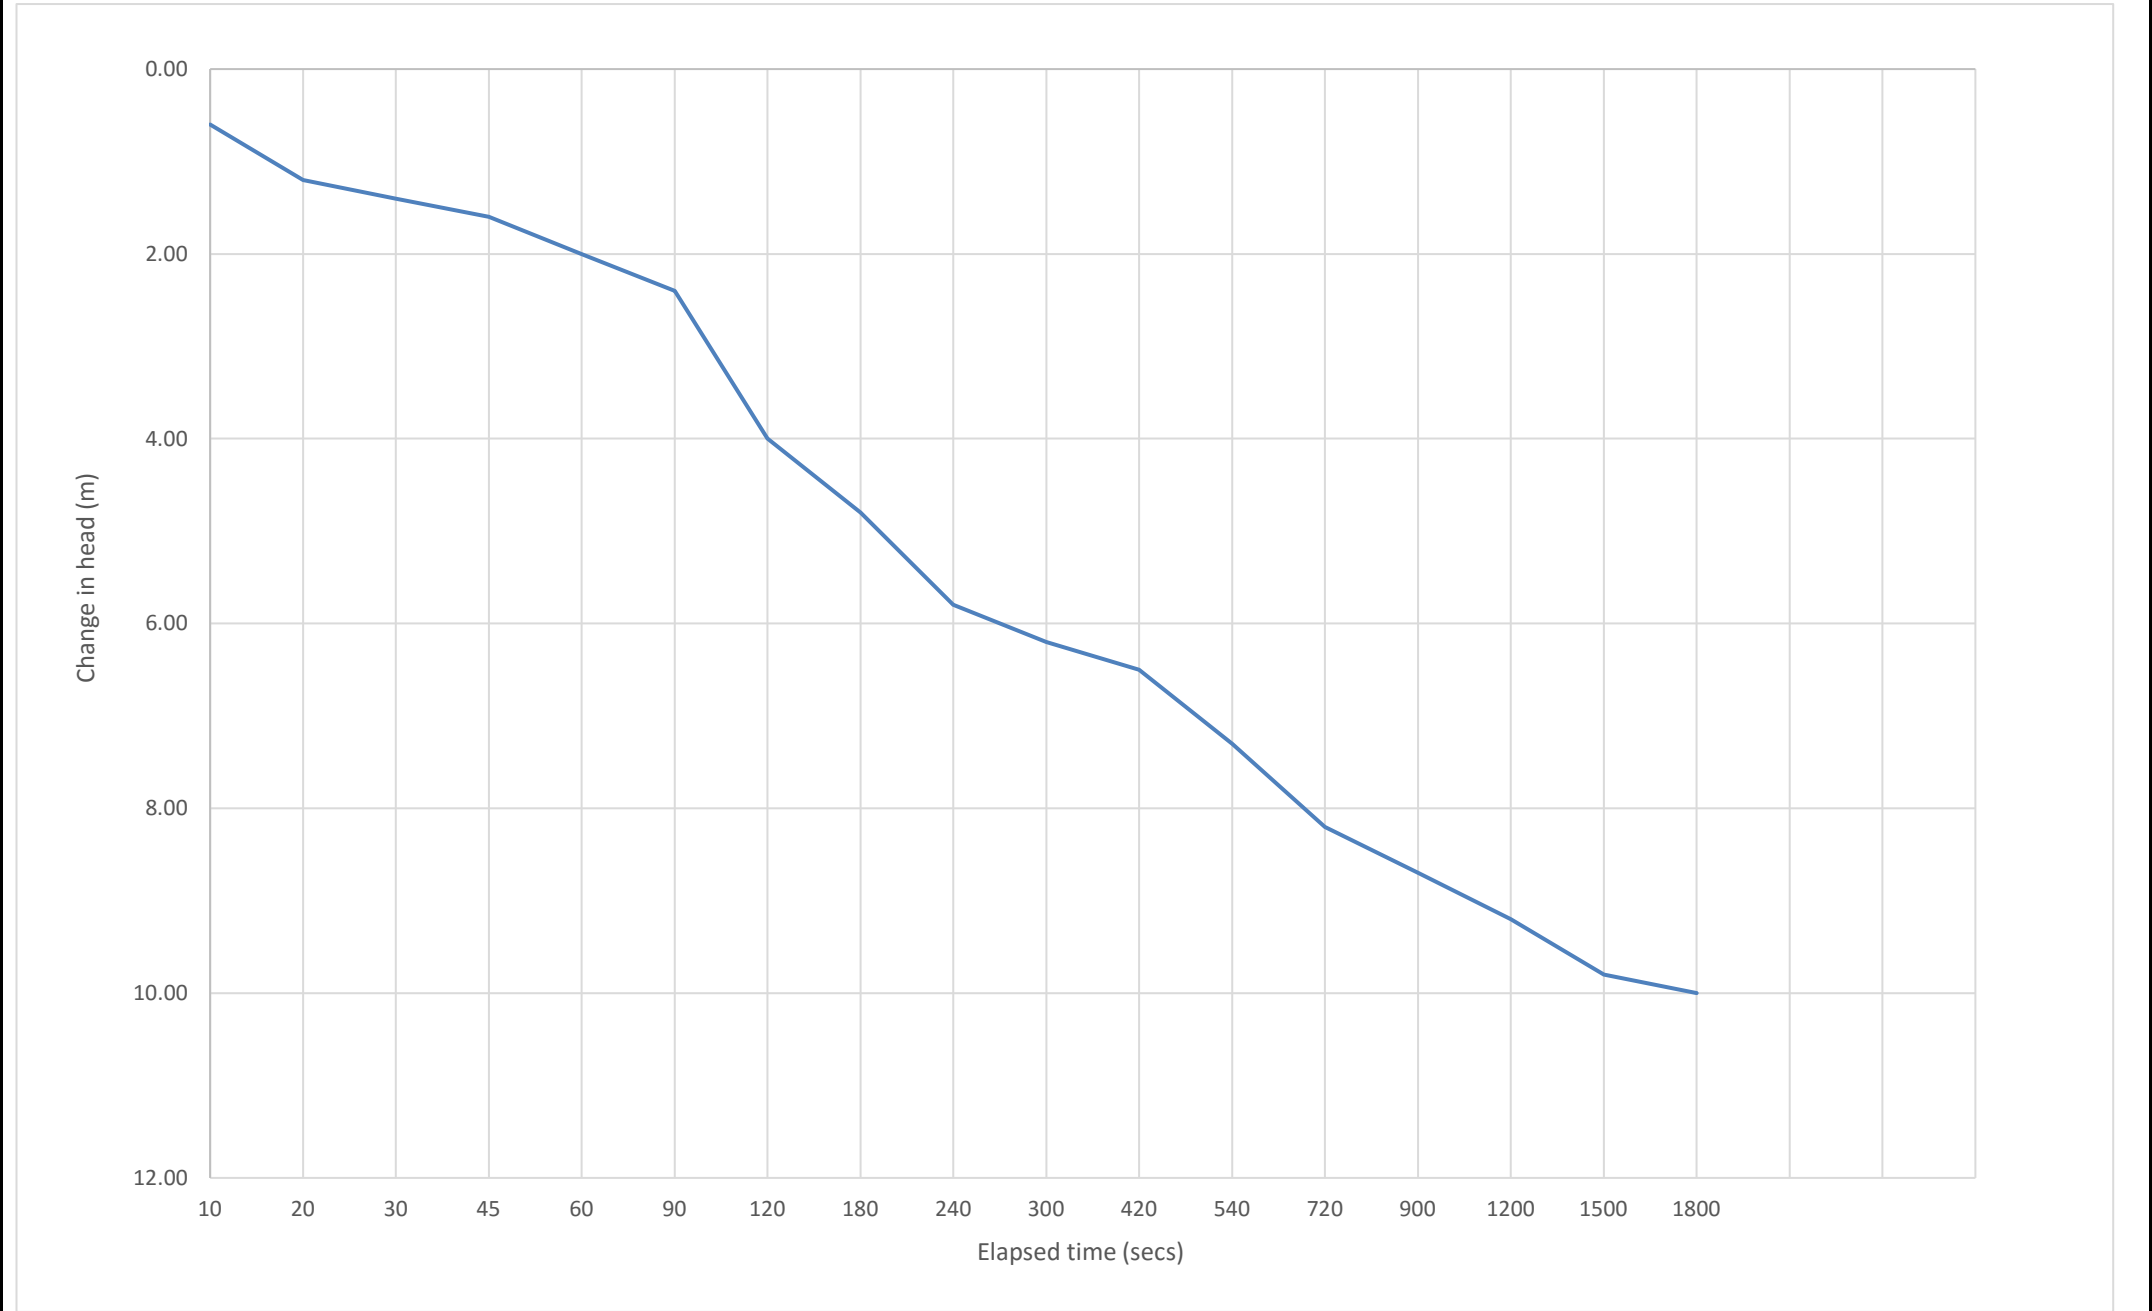
Casing height above ground level (m)	-	Depth of casing below ground level (m bgl)	3	Casing diameter (m)	0.15
--------------------------------------	---	--	---	---------------------	------

Shape Factor F (from BS EN ISO 22282-1

L =	7.00
D =	0.15
L/D =	46.67
F=	9.70

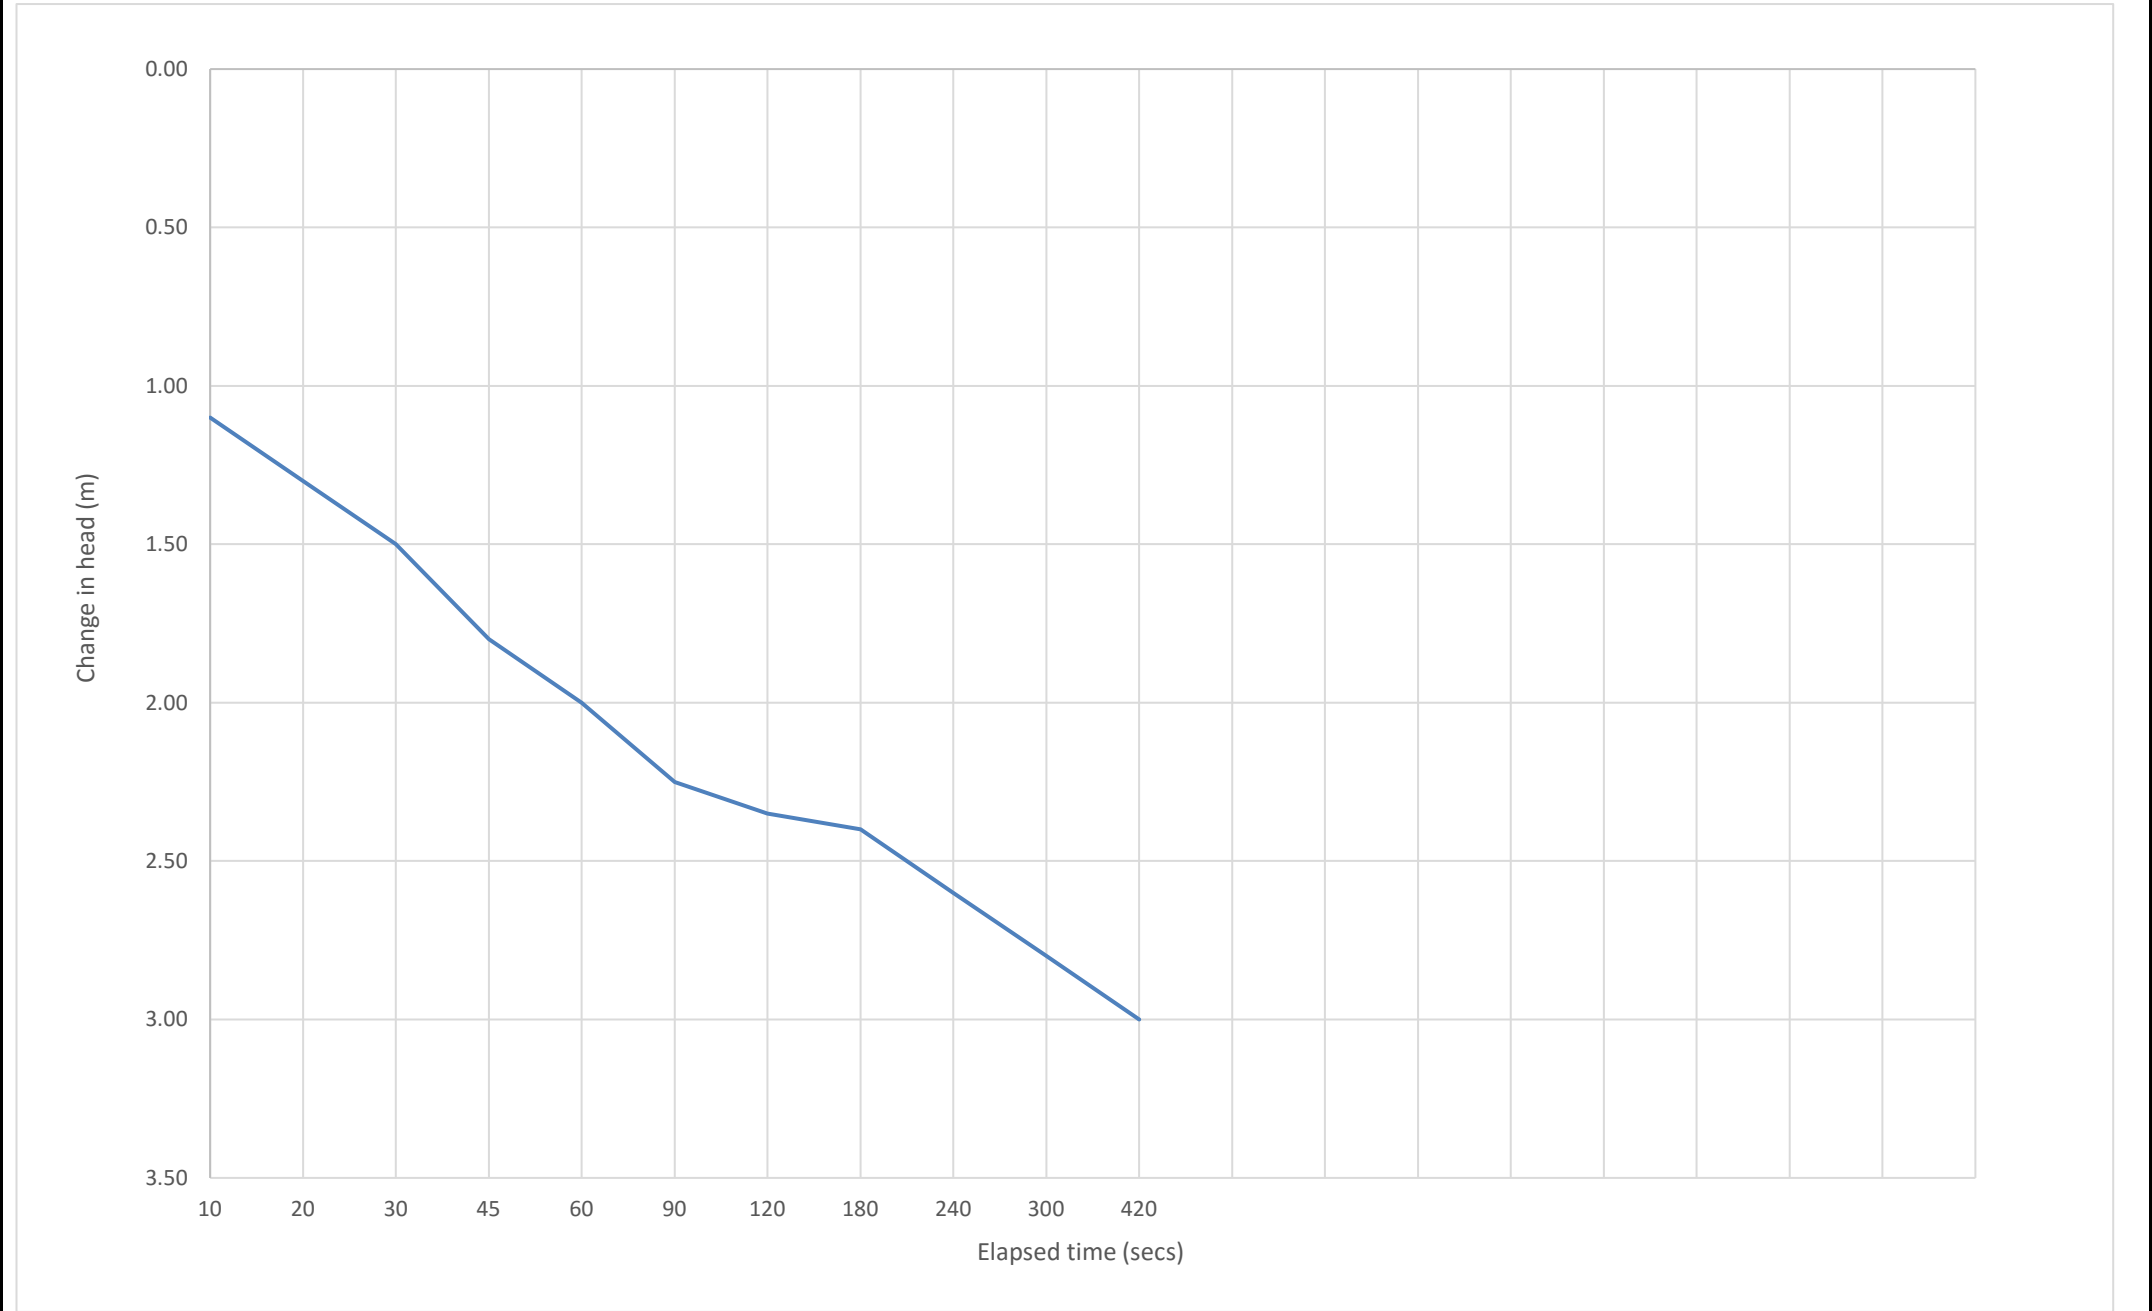
Casing height above ground level (m)	0.5	Depth of casing below ground level (m bgl)	2.5	Casing diameter (m)	0.15
--------------------------------------	-----	--	-----	---------------------	------

Shape Factor F (from BS EN ISO 22282-1

L =	0.50
D =	0.15
L/D =	3.33
F=	1.64
