Our ref: GE16226/GR02.2/171018

RE: Downend Road, Portchester

Further to the request received via Odyssey and your subsequent instruction, we write to present the findings of the supplementary permeability testing undertaken on this site. The site location is shown on Figure 1 enclosed. This letter includes a minor revision from letter ref. GE16226/GR02/170217 in that the enclosed Figures 2 and 3 reflect the revised site extent as indicated on TOR Drawings ref. 2495-01/PP-002 Aug 2017 and 2495-01/SK-013 Rev C Oct 2017. These drawings should be referred to for the definitive red line boundary and the proposed development layout.

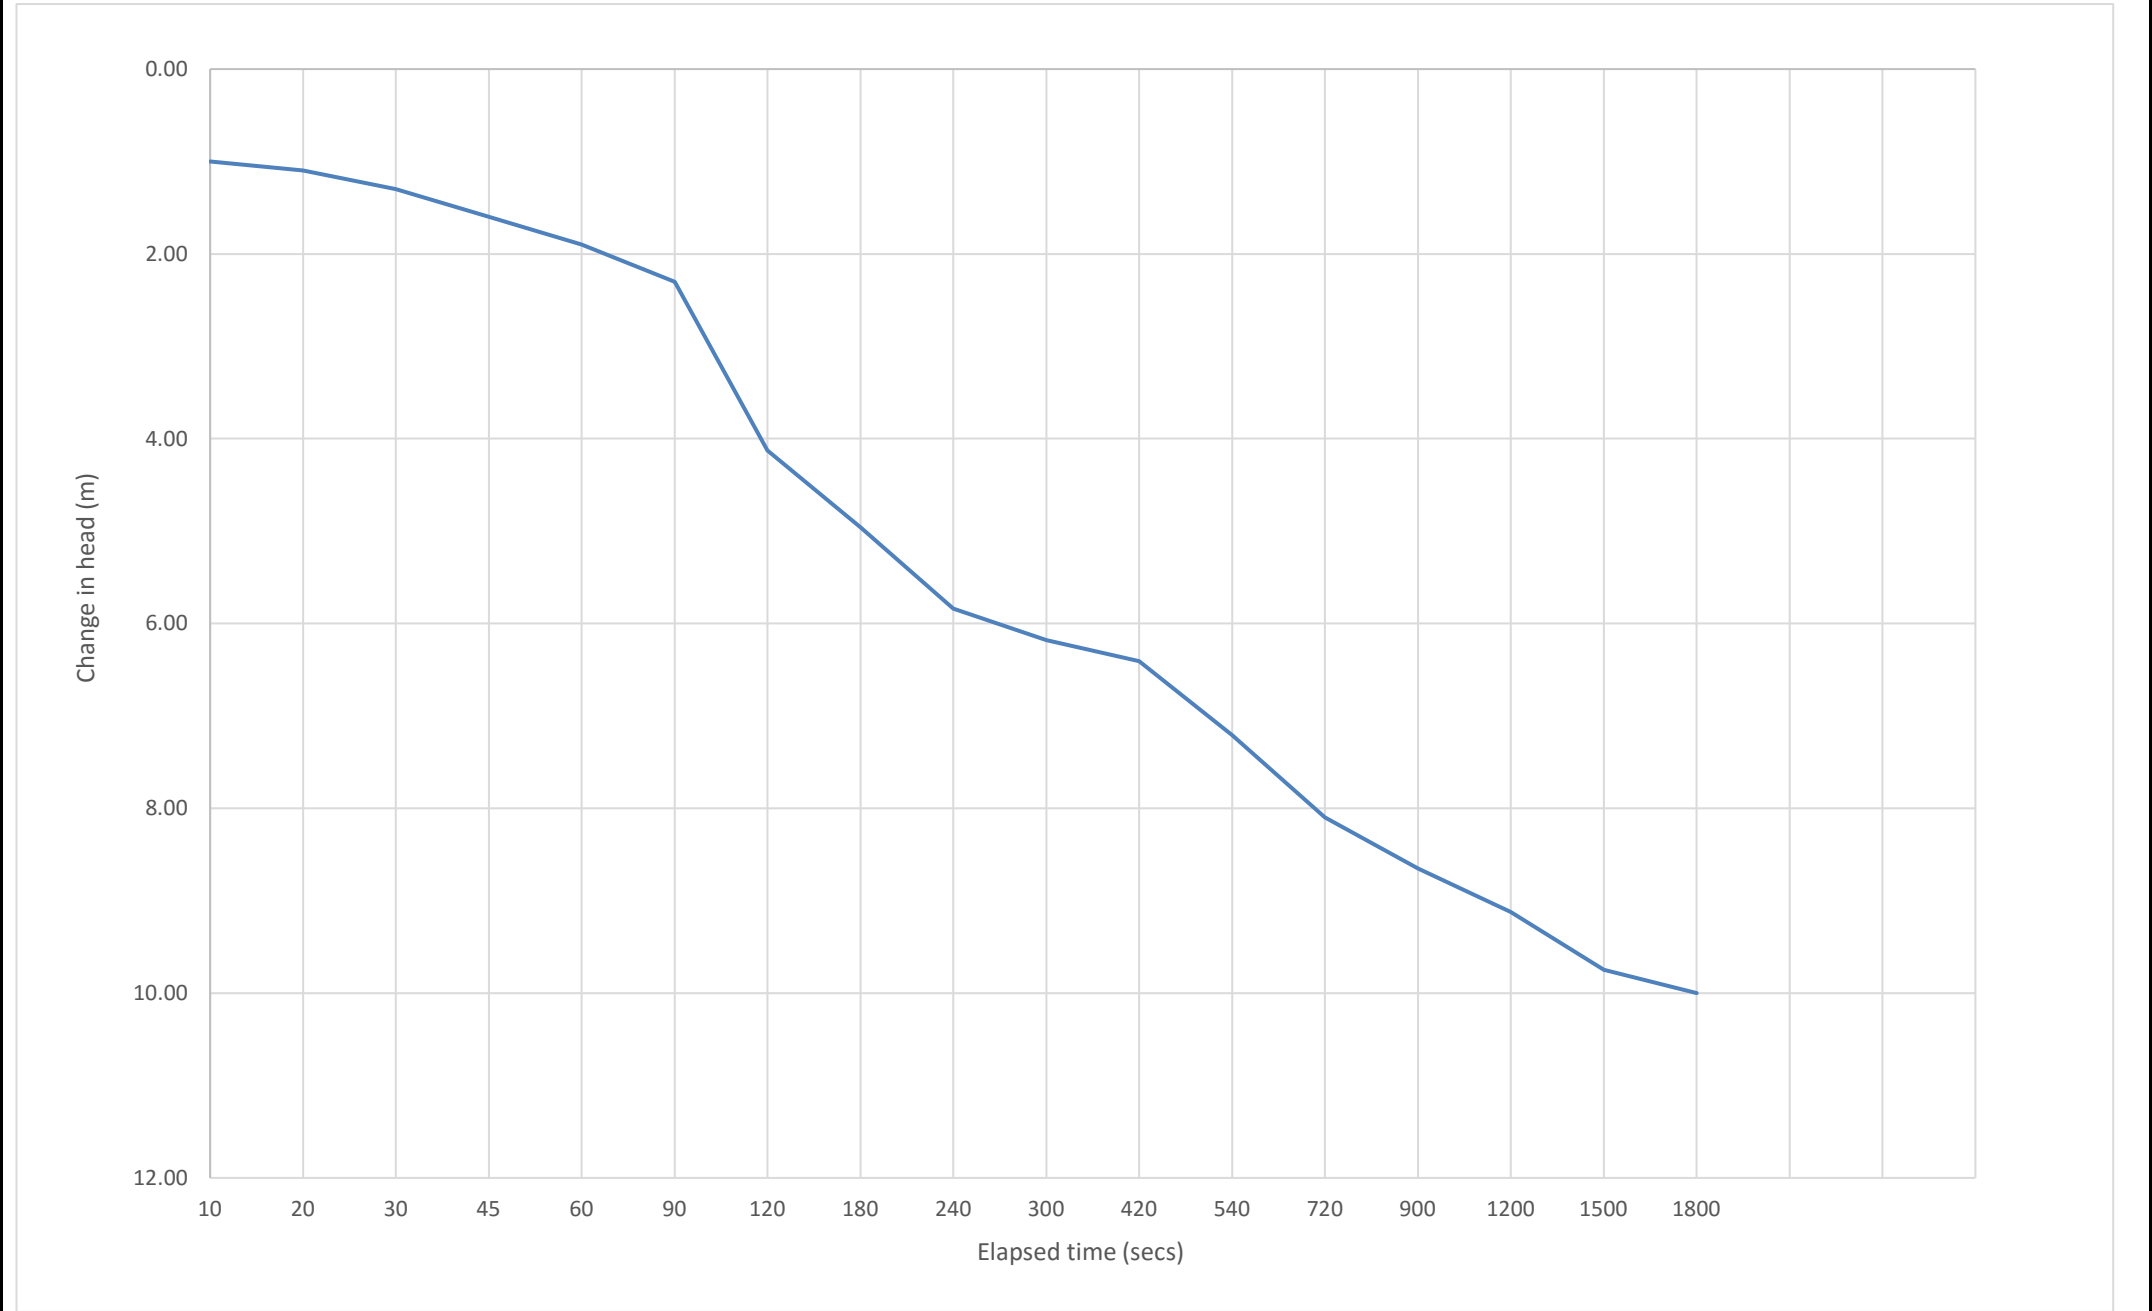
Casing height above ground level (m)		Depth of casing below ground level (m bgl)	4.5	Casing diameter (m)	0.15
--------------------------------------	--	--	-----	---------------------	------

Shape Factor F (from BS EN ISO 22282-1)

L =	5.50
D =	0.15
L/D =	36.67
F=	8.05
