Proposed Residential Development
Land South of Funtley Road, Funtley

Non-Motorised User (NMU) Audit

Reside Developments Ltd

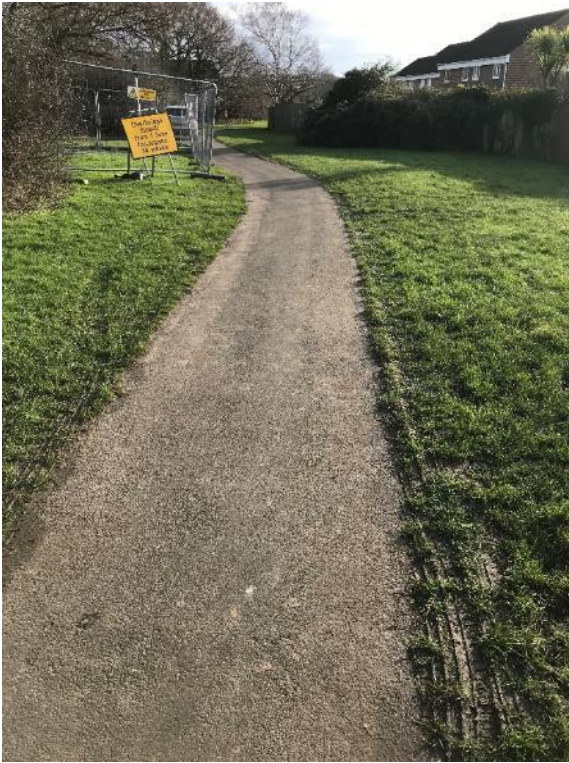
Photo 1

2.3 The first route utilises the footpath to the south of the M27 bridge in a westbound direction. The initial section of footpath south of the bridge (photo 1) is wide and benefits from lighting. It also has reasonable surveillance from adjacent properties. The footpath is comprised of a wide tarmac finish with lighting to a point where it meets a residential car park. The route is overlooked by residential properties with lighting. To the west of the car park, the footpath is unsurfaced (photo 2) with no lighting. It is however flat and wide.

3.4 The initial section of footway south of the bridge (photo 1) is wide and benefits from lighting. It also has reasonable surveillance from adjacent properties.

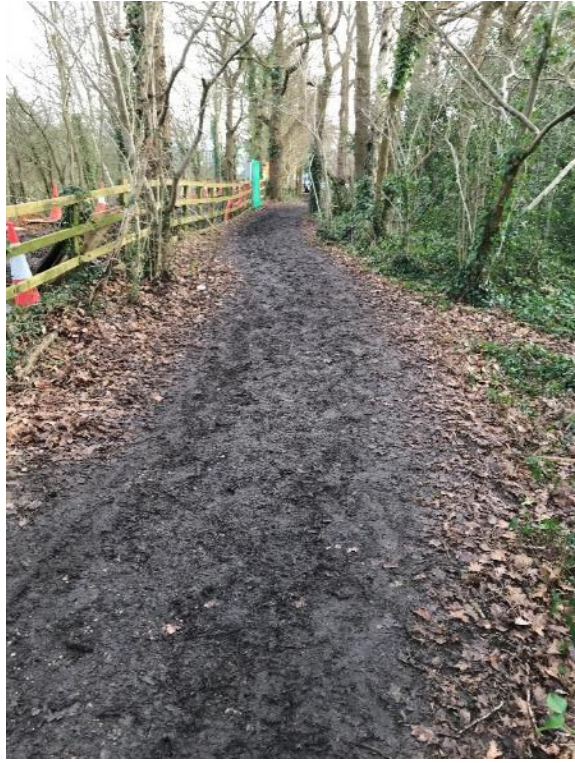
Photo 2

- 3.12 The final route involves a similar initial journey to route 1, although continues west towards the deviation line. The footpath is comprised of a wide tarmac finish with lighting to a point where it meets a residential car park. The route is overlooked by residential properties with lighting. To the west of the car park, the footpath is unsurfaced (photo 2) with no lighting. It is however flat and wide.

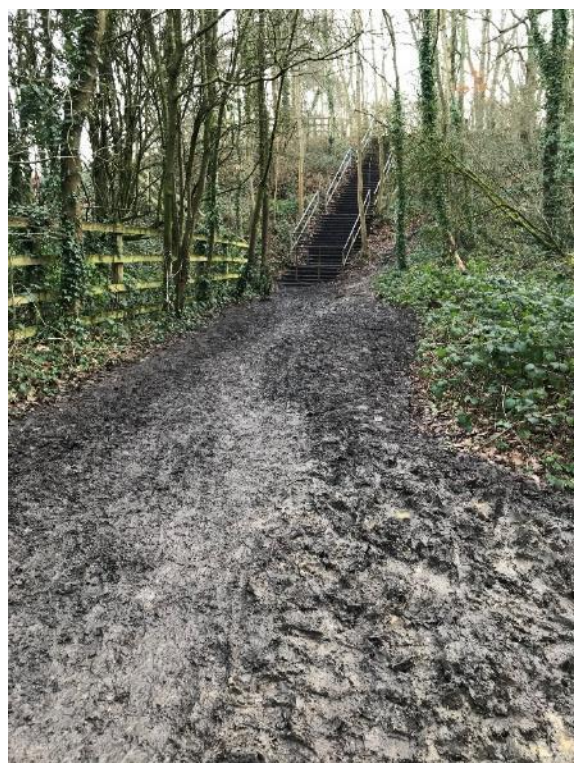
Photo 4

2.4 The footpath joins the Deviation Line by way of a staircase. There are no alternative routes to access the Deviation Line, and therefore the route is currently not suitable for cyclists. The surface of the footpath is poor where it meets the Deviation Line, and was observed during the audit as being very muddy. This makes navigating the route for able bodied people difficult (photo 4).

- 2.10 South of the underpass, the surface can become muddy and difficult to navigate (photo 4). This would make the route unattractive to some walkers during winter months.

- 3.9 South of the underpass, the surface can become muddy and difficult to navigate (photos 4 and 14). The route continues south along the deviation line, where the surface treatment is muddy throughout during winter months. This may make the route unattractive to some walkers during winter months.

- 5.6 In summary, the upgrading of footway surfacing broadly within the location between the two sets of steps is required to encourage walking trips throughout the year to the college. This would also aid general users of the Deviation Line, as well as those residents seeking access to Highland Road via the Deviation Line.
- 5.7 Additional measures to improve lighting and access for cyclists via the staircases would improve the attractiveness of the route to the college, as well as alternative access to amenities in Highlands Road.

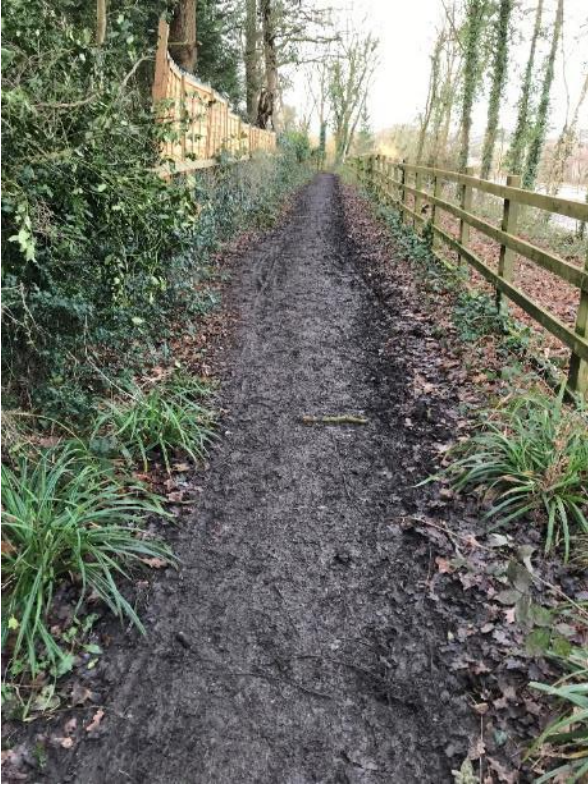
Photo 5

- 2.5 The route crosses the deviation line before making use of a second staircase. There is a secondary path enabling cyclists to avoid the staircase, although again during the audit the path was muddy and difficult to navigate. The footpath then continues westbound on a flat terrain (photo 5). The footpath varies in width, although is deemed suitable for the level of pedestrian or cycle flow it attracts. The route is not overlooked in places and has no lighting.

- 2.11 As with route 1, the route makes use of a staircase to the immediate south of the M27. There is a secondary path enabling cyclists to avoid the staircase, although again during the audit the path was muddy and difficult to navigate. The footpath then continues westbound on a flat terrain (photo 5). The footpath varies in width, although is deemed suitable for the level of pedestrian or cycle flow it attracts. The route is not overlooked in places and has no lighting.

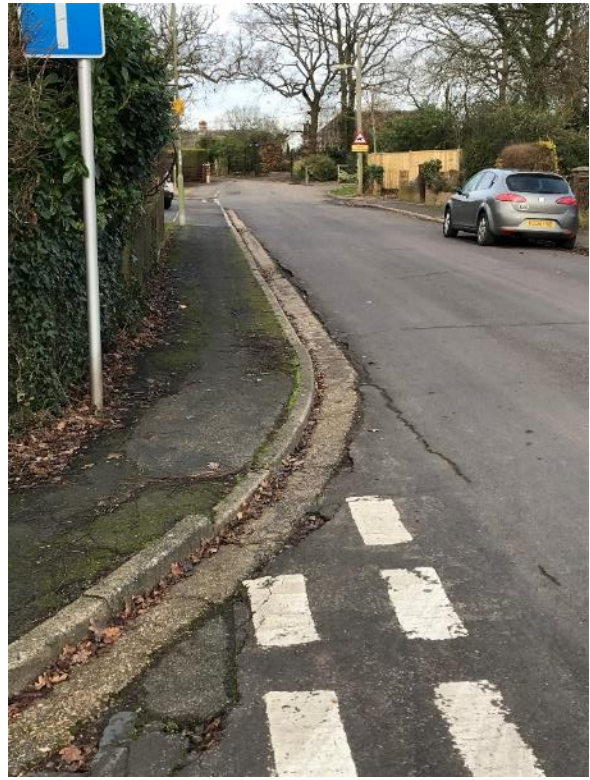
Photo 6

- 2.6 The footpath joins the residential cul-de-sac of Fareham Park Way, where the route heads south and then west along Wynton Road (photo 6). Footways are wide, with suitable crossing points when taking into context the quiet nature of surrounding residential roads. There are crossing points and a wide footway (photo 7) leading into the college grounds.

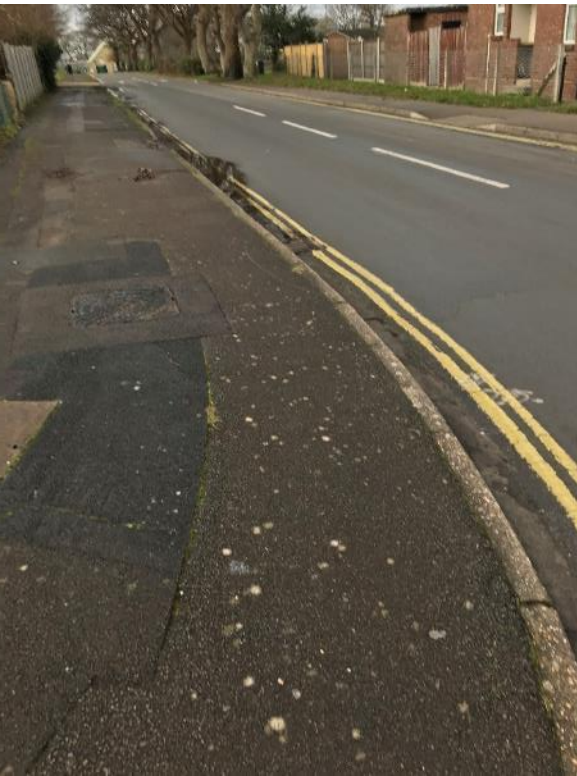
Photo 7

- 2.16 Footways continue alongside Highland Road, towards Fareham Park Road. Cyclists could continue to travel on-street along Highland Road and Fareham Park Road. The route heads north and then west along Wynton Road. Footways are wide, with suitable crossing points when taking into context the quiet nature of surrounding residential roads. There are crossing points and a wide footway (photo 7) leading into the college grounds.

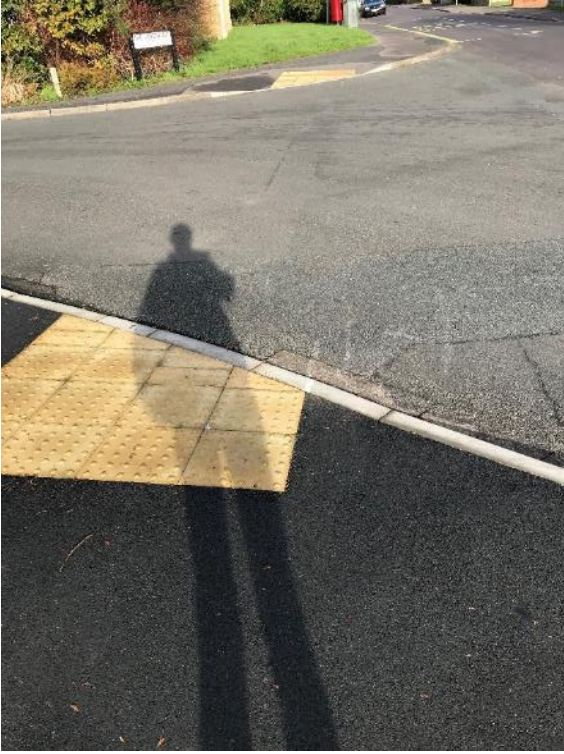
Photo 8

3.3 Route 1 is fairly direct, and primarily makes use of footways alongside quiet residential roads. Crossing points generally comprise of dropped kerbs with tactile paving (photo 8). Cycling on-street is feasible due to the low volume of traffic. There is a gradual gradient in the carriageway, however it is not sufficient to affect cyclists.

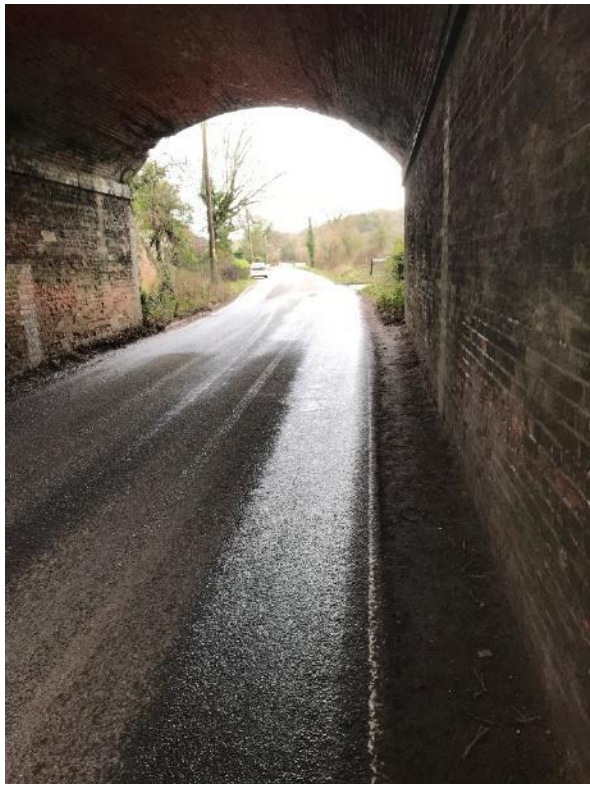
Photo 11

- 2.9 The deviation line benefits from a wide surface, although lacks any lighting. This reflects its nature as a rural route for walkers/cyclists during the daytime, and is unlikely to be used outside of daylight hours. There is an underpass beneath the M27 motorway (photo 11) which lacks any lighting or surveillance.

- 3.8 The deviation line benefits from a wide surface, although lacks any lighting. This reflects its nature as a rural route for walkers/cyclists during the daytime, and is unlikely to be used outside of daylight hours. There is an underpass beneath the M27 motorway (photo 11) which lacks any lighting or surveillance.

- 5.4 Whilst the route lacks lighting in most places, the introduction of lighting could be to the detriment of the rural nature of the route which would typically only be used during daylight hours. However it is suggested that some low level lighting is explored in the vicinity of the crossing point south of the M27 since this route is most likely to be used by pedestrians accessing the college.

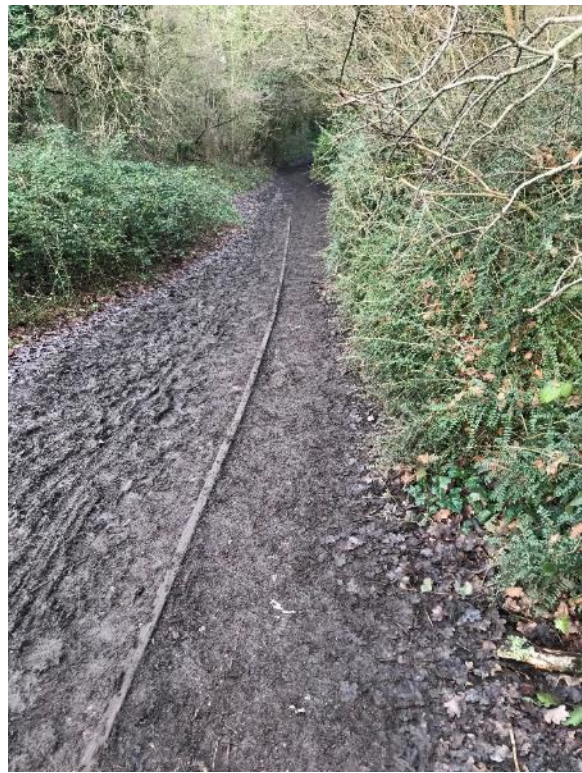
Photo 15

- 3.10 Whilst the route is wide in most places, there are short narrow sections (photo 15). The route then joins Highland Road as per route 1.
- 3.11 The route generated a score of 4, with surface treatment and lighting scoring low in places. Surveillance also scores low in places.

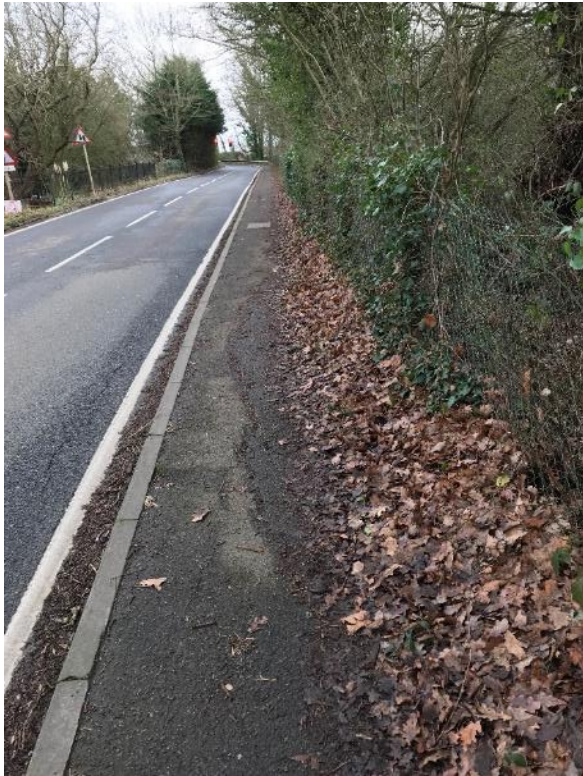
Photo 18

- 4.3 This route leads residents to the limited amenities within Funtley, namely the public house and social club. The route utilises a continuous footway on the southern side of Funtley Road in its entirety. The footway does not meet with guidance on footway widths in the vicinity of the site (photo 18), however when considering its limited use and services it connects to, it is considered suitable for its context. There is a gradient in the carriageway due to the railway bridge, although it is considered suitable for all users including cyclists.

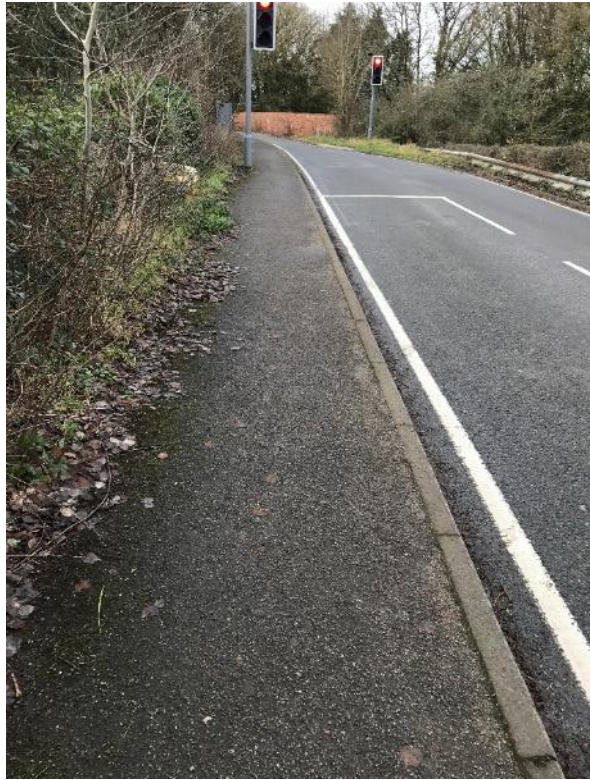
Photo 19

- 4.4 There is localised narrowing on the railway bridge due to street furniture, with the footway widening to the east of the railway bridge (photo 19). From this point there is a generous footway with good surveillance (photo 20).

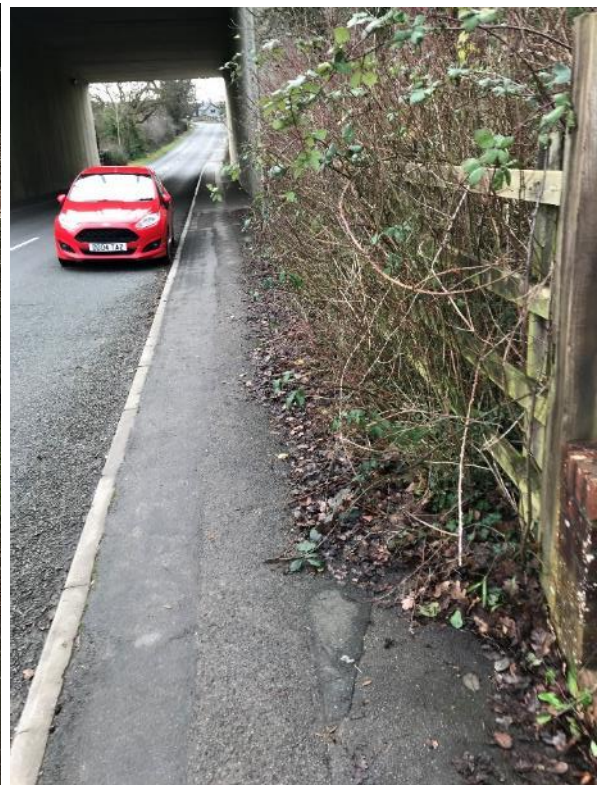
Photo 21

- 4.7 Route 2 is an extension of route 1, leading to Fareham Business Centre. The footway on the southern side of Funtley Road continues eastbound, although it does narrow in close proximity to the Business Centre (photo 21). There is also a reasonable gradient as the carriageway passes under the M27 bridge. However this route is only likely to attract limited trips for the working population to the business centre, and the route is considered suitable for able bodied pedestrians and cyclists.
- 4.8 The route has a rating of 4, scoring low/average on gradient and width in places.
