# Land south of Funtley Road, Funtley

Phase 1 Desk Study

Reference: 16687/DS

January 2018

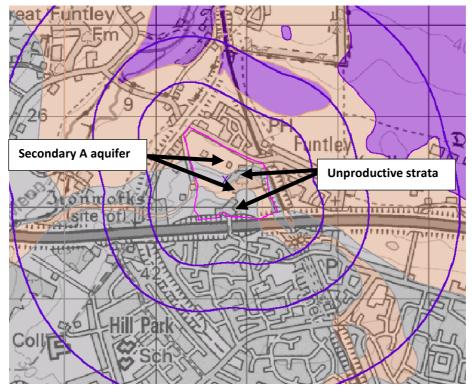
Figure 3.1. On-site bedrock aquifers

**Notes:** <sup>1</sup>Secondary A are permeable layers capable of supporting water supplies at a local rather than strategic scale, and in some cases forming an important source of base flow to rivers. <sup>2 3</sup> Unproductive strata are rock layers or drift deposits with low permeability that have negligible significance for water supply or river base flow. <sup>4</sup> Soils of high leaching potential with little ability to attenuate diffuse source pollutants and in which non-adsorbed diffuse source pollutants and liquid discharges have the potential to move rapidly to underlying strata or groundwater. (H1): soils that readily transmit liquid discharges because they are either shallow, or susceptible to rapid flow. <sup>5</sup> Soils in which pollutants are unlikely to penetrate the soil layer because either water movement is largely horizontal, or they have a significant ability to attenuate diffuse source pollutants. <sup>6</sup> See Figure 3.1

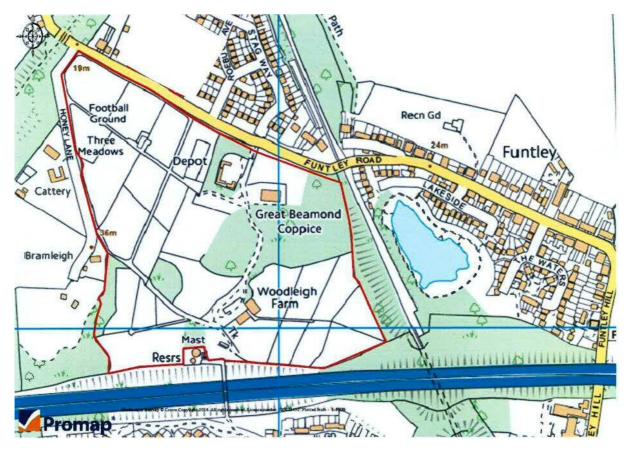
Figure I – Site Location Map

The site was located at Land south of Funtley Road, Funtley, Fareham, Hampshire PO15 6DL and had an O.S Land Ranger Grid Reference of SU 560 082.

The site location map is presented in Figure 1 and the full Site Walkover is discussed in Section 2.1 of this report.

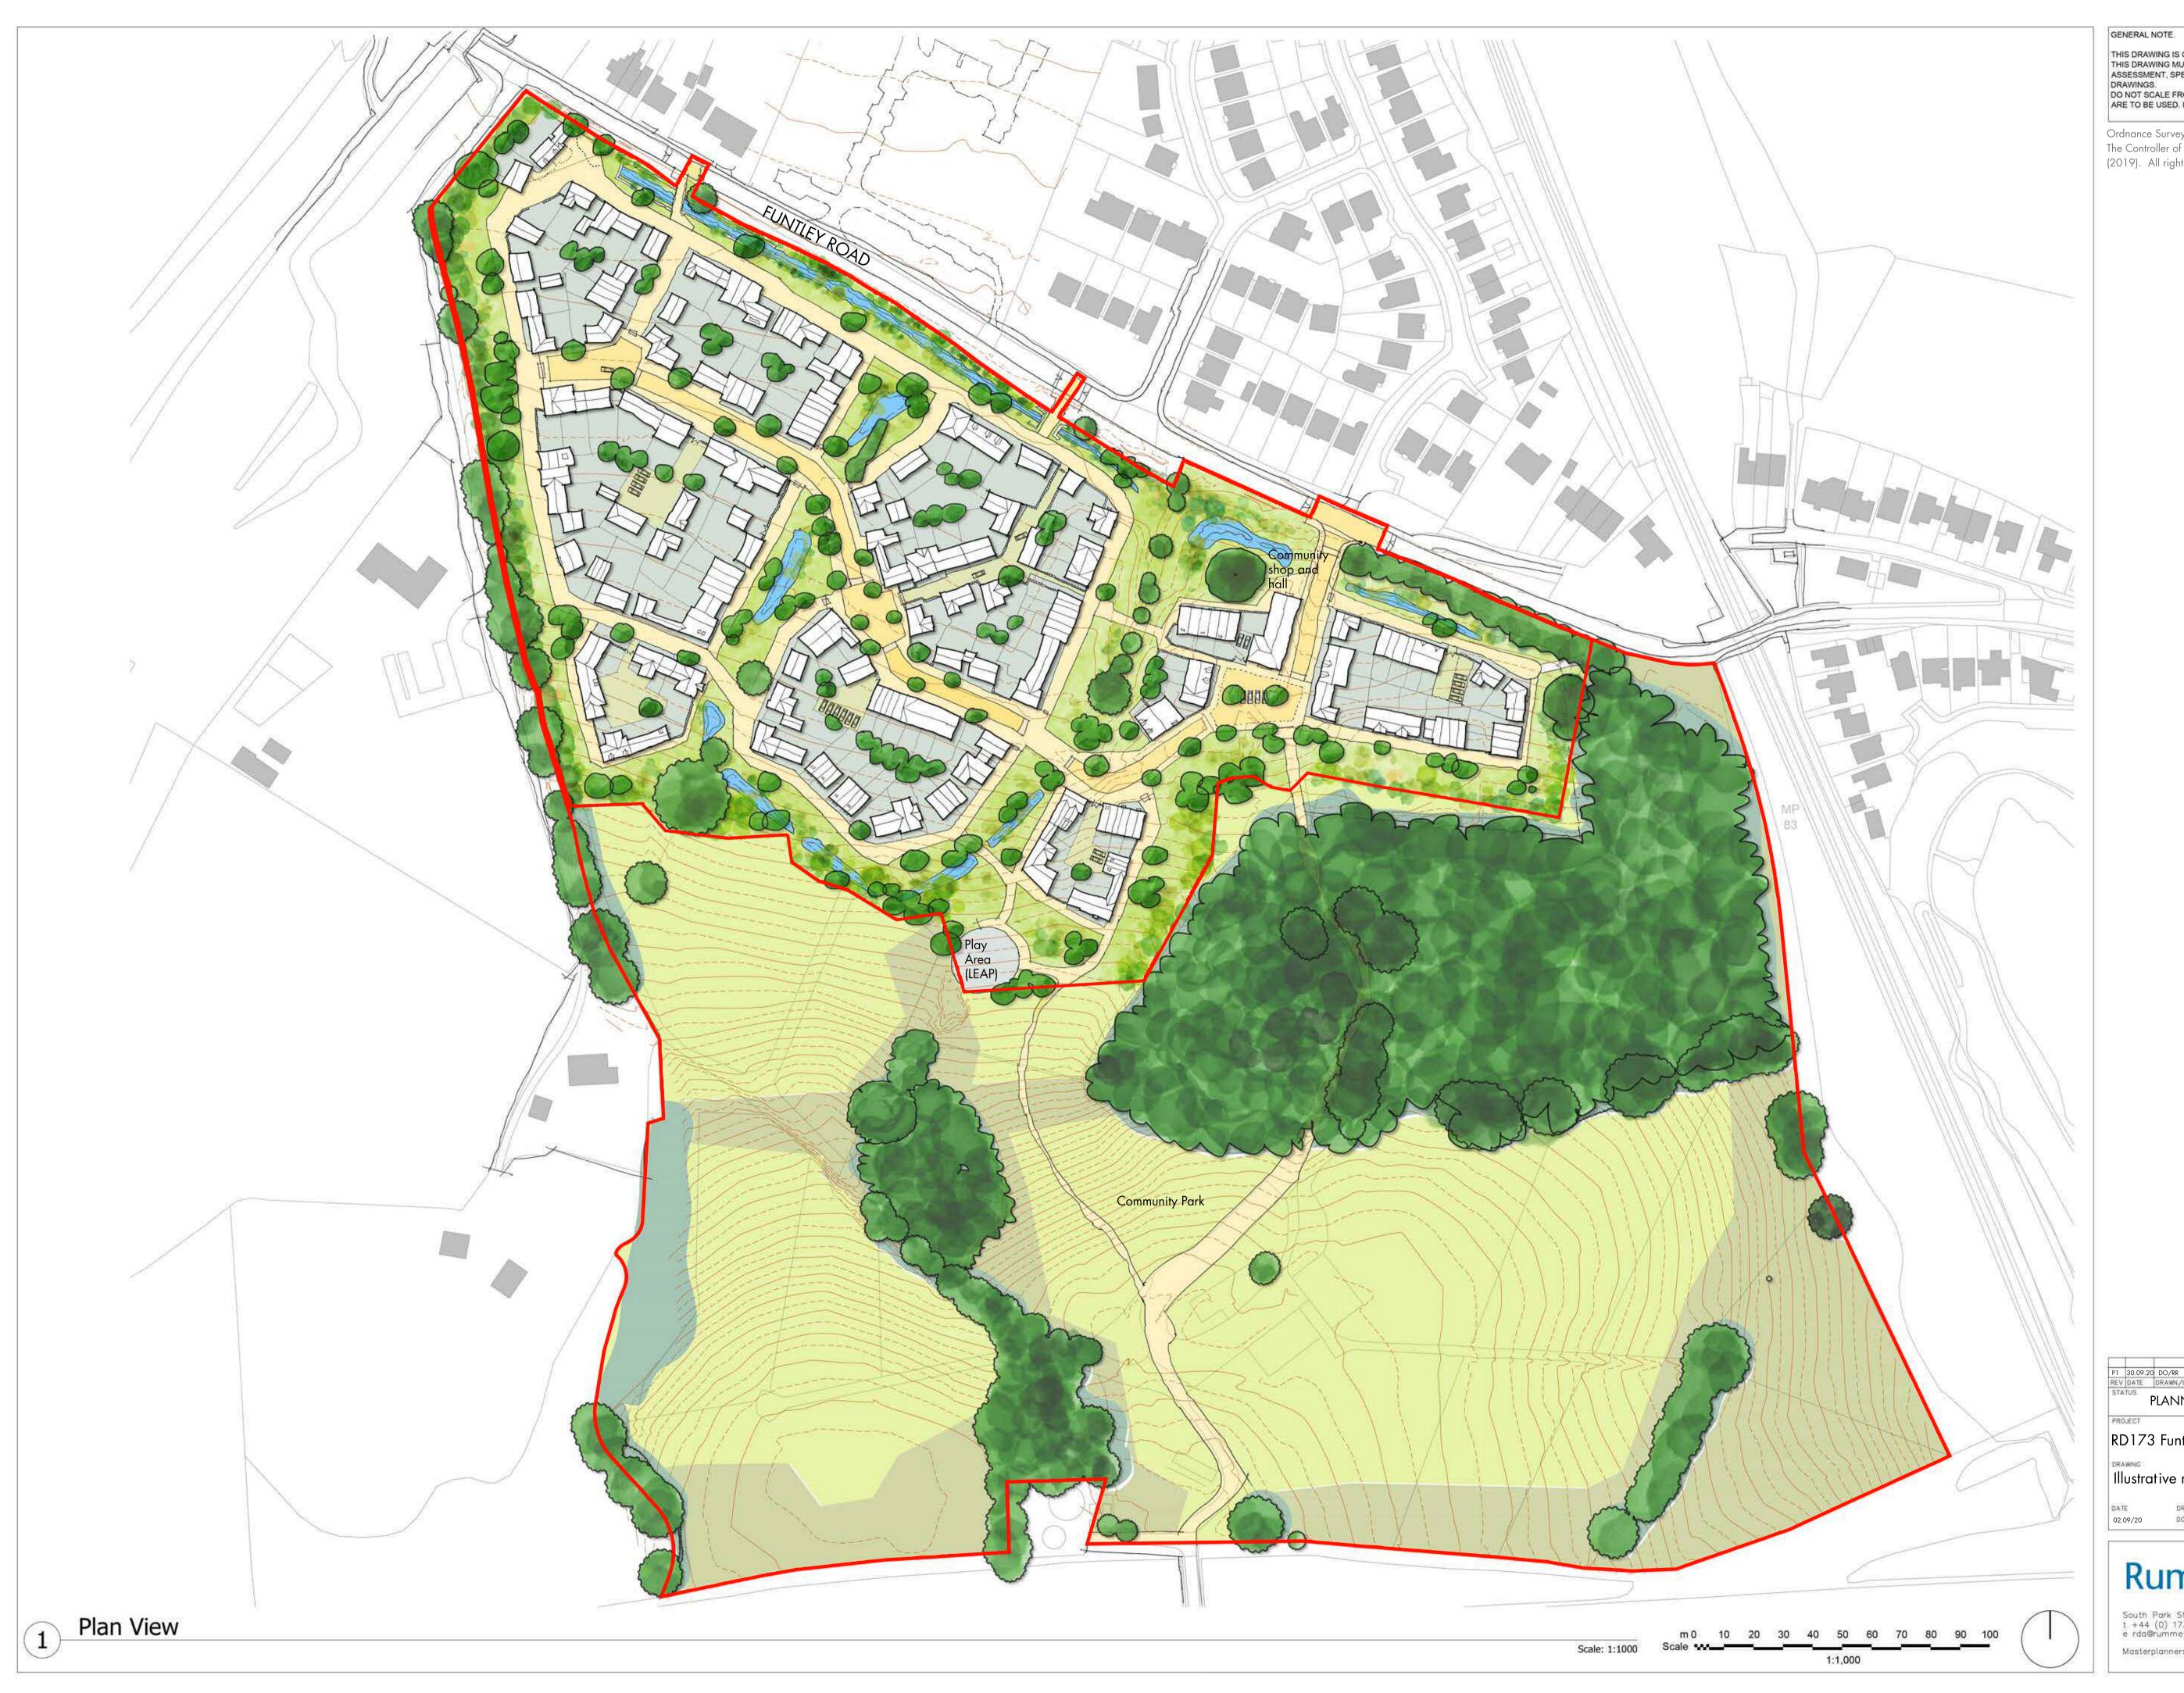
# **Appendix A Proposed Development Plans**

The proposed development will be to provide up to 125 one, two, three and four-bedroom dwellings including 6 Self/Custom build plots, Community Building or Local Shop (Use Class E & F.2) with associated infrastructure, new community park, landscaping and access.

In compiling this report reliance was placed on the masterplan (document reference: RD1731-F3-L100 Rev P1, dated September 2020) prepared by Rummey Design.

The proposed development plans have been provided in Appendix A.
