FILE	CLIENT
PROPOSED ROUNDABOUT TO NEWGATE LANE EAST VEHICLE SWEEP PATH ANALYSIS - LARGE REFUSE VEHICLE	MILLER HOMES AND BARGATE HOMES

Walking, Cycling and Horse-Riding Assessment Report

Proposed Roundabout and footway link Newgate Lane East Fareham

PROJECT TITLE
Land east of Newgate Lane East, Fareham

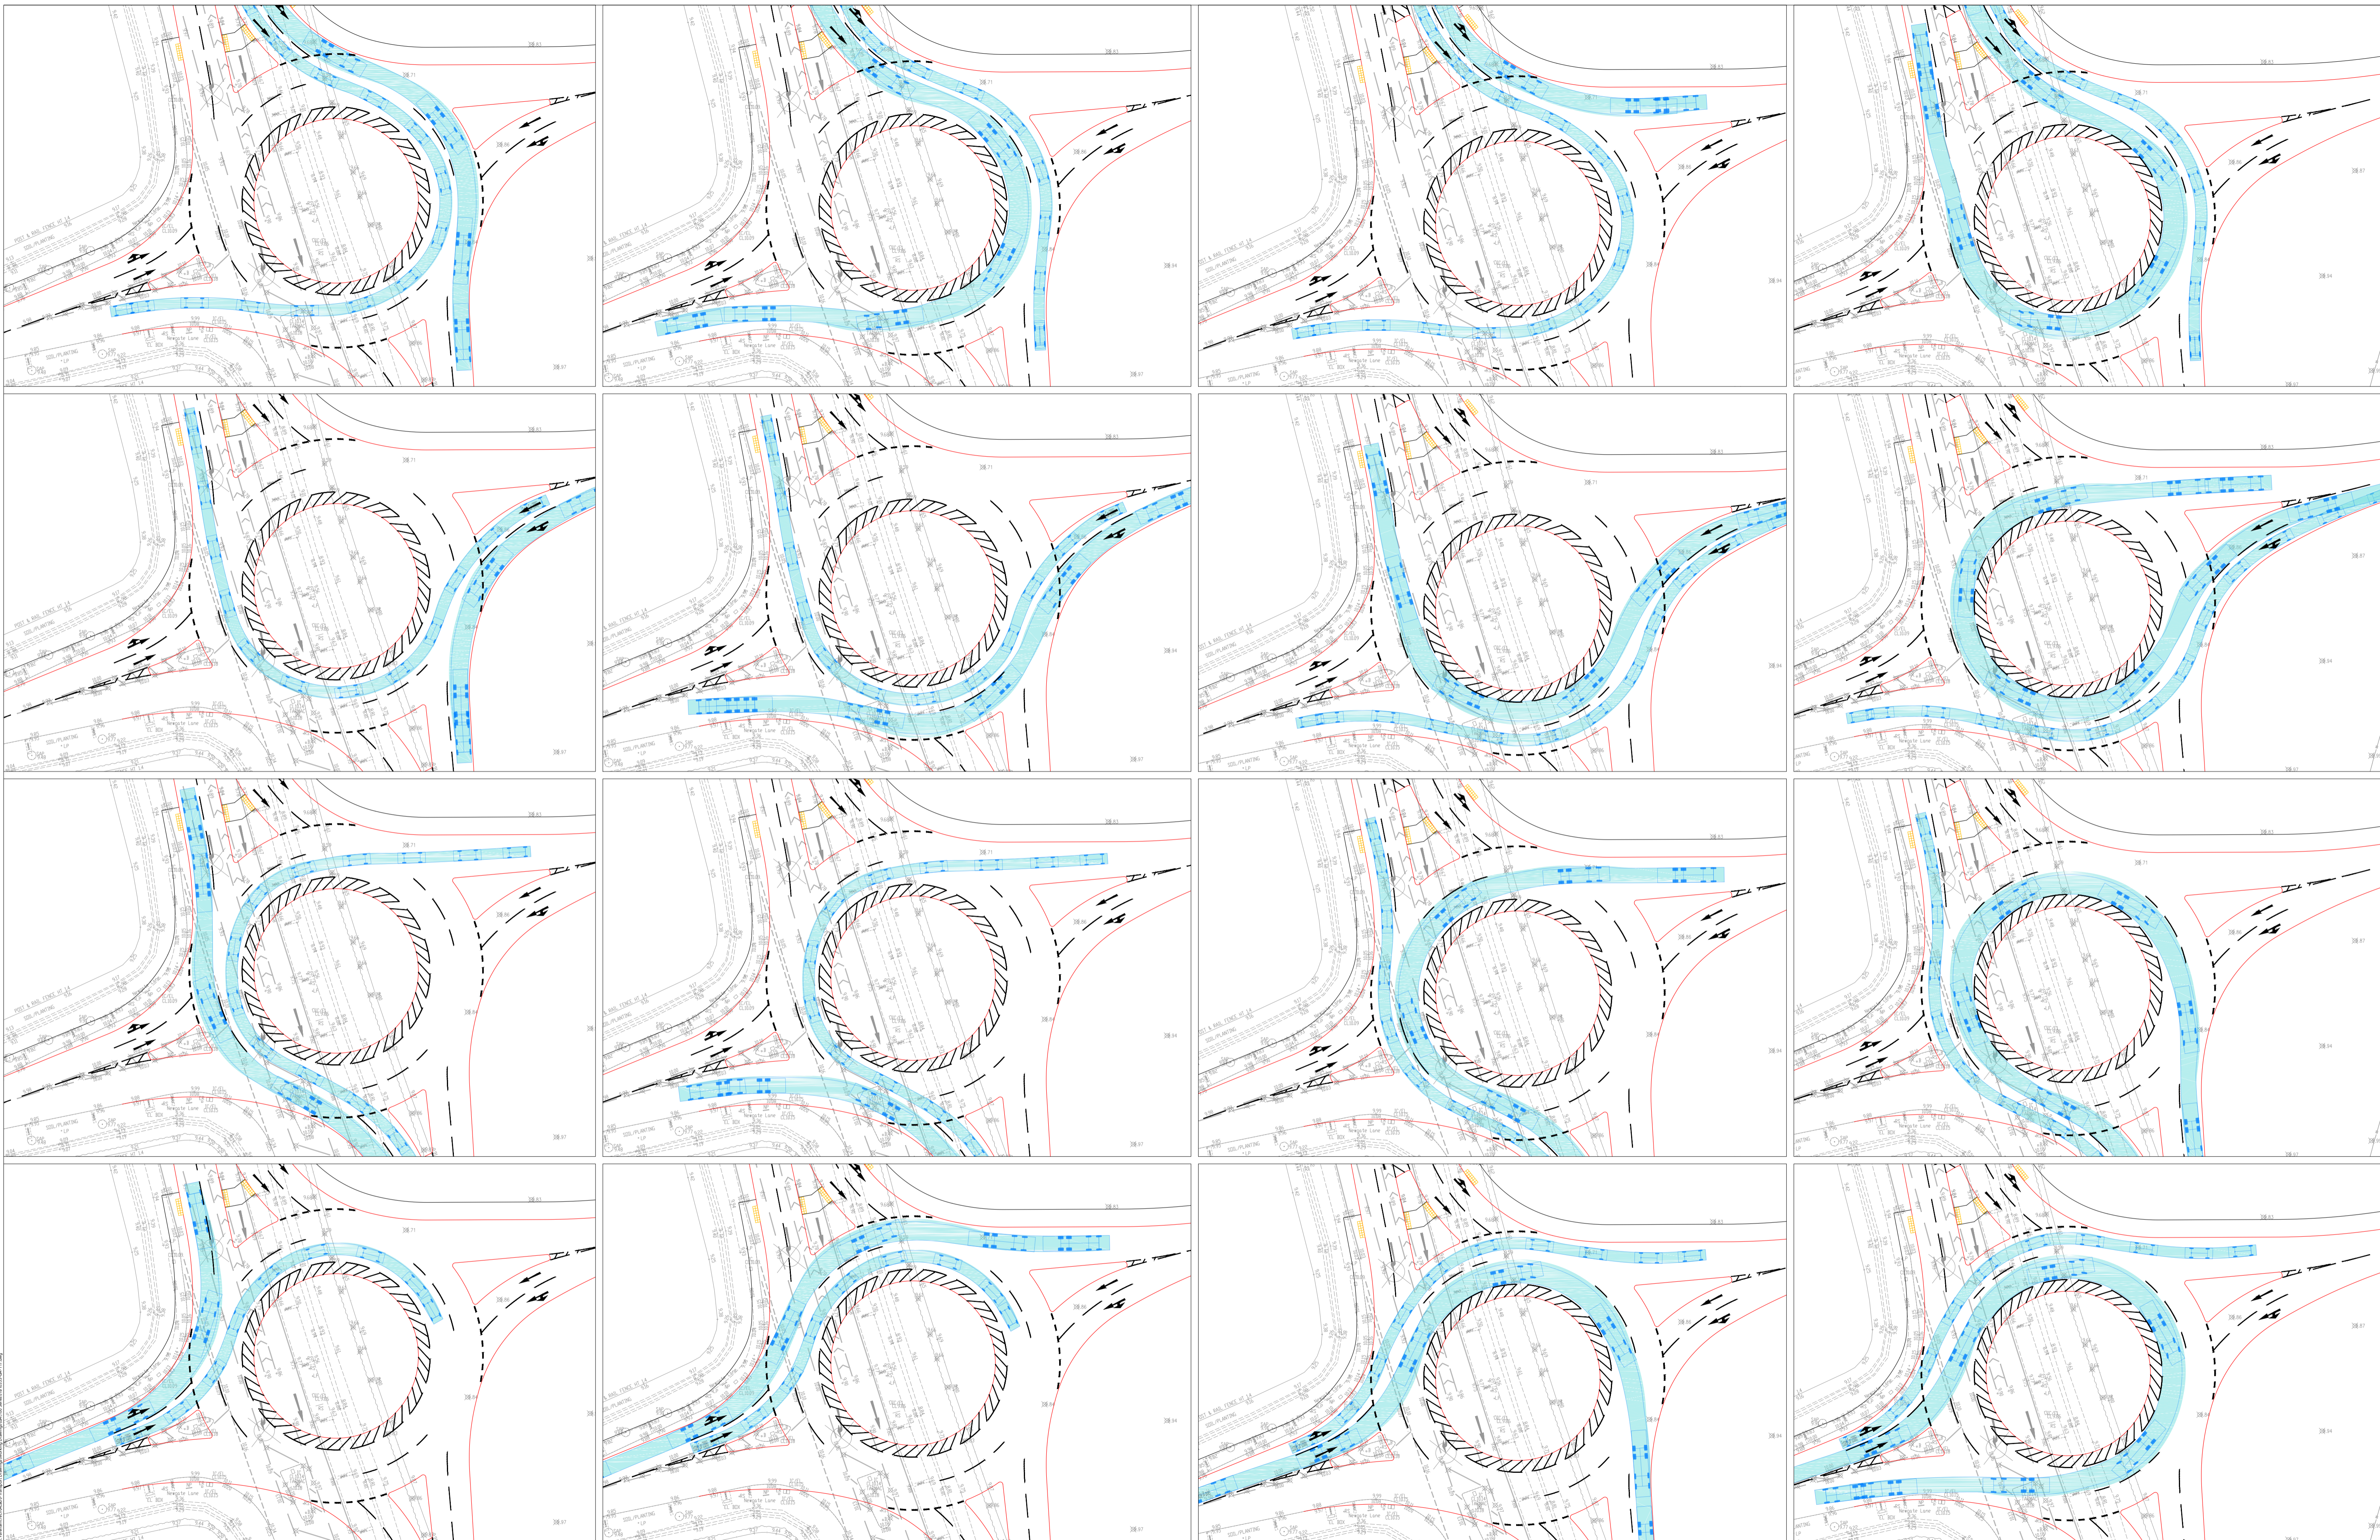
DRAWN	CHECKED	APPROVED
MC	MC	TW
PROJECT No: ITB10353	SCALE @ A1: 1:500	DATE: 25.10.21
DRAWING No: ITB10353-GA-117	REV:

NOTE: VEHICLE TRACK SPEEDS MINIMUM OF 15mph

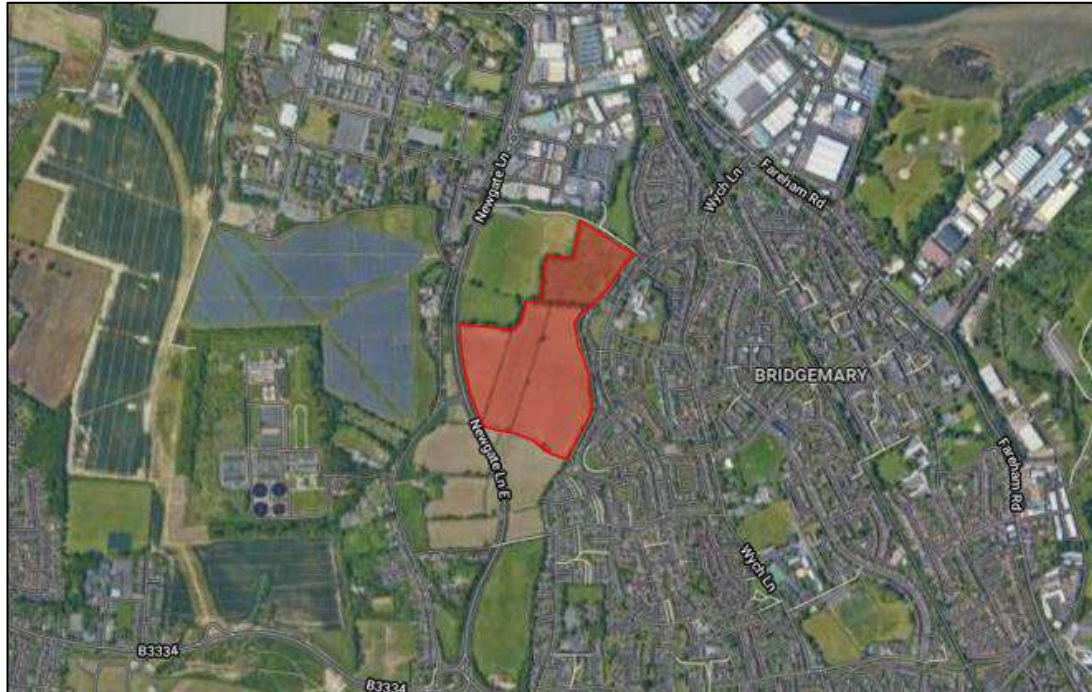
Image 1.1: Site Boundary

*An existing three-arm ghost island priority junction between the B3385 Newgate Lane East and Newgate Lane is proposed to be upgraded into a four-arm roundabout junction to serve a proposed development of up to 420 residential dwellings. The site boundary is presented below in **Image 1.1**.*

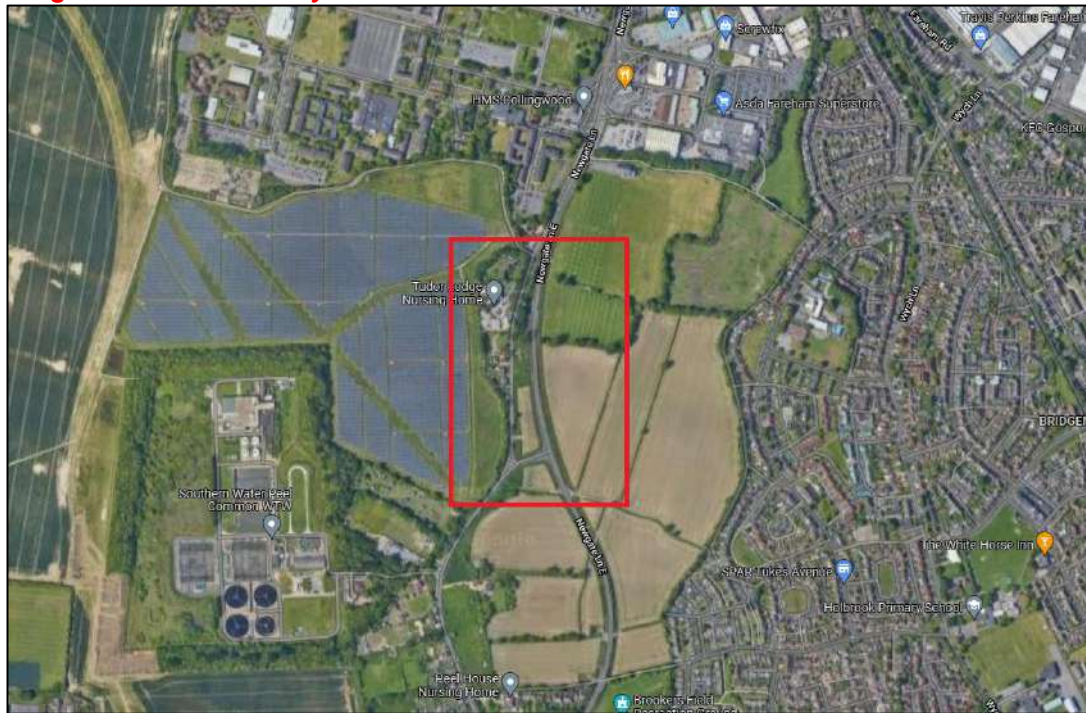
Image 1.3: WCHAR Study Area

A plan showing the WCHAR study area is provided as **Image 1.3**.

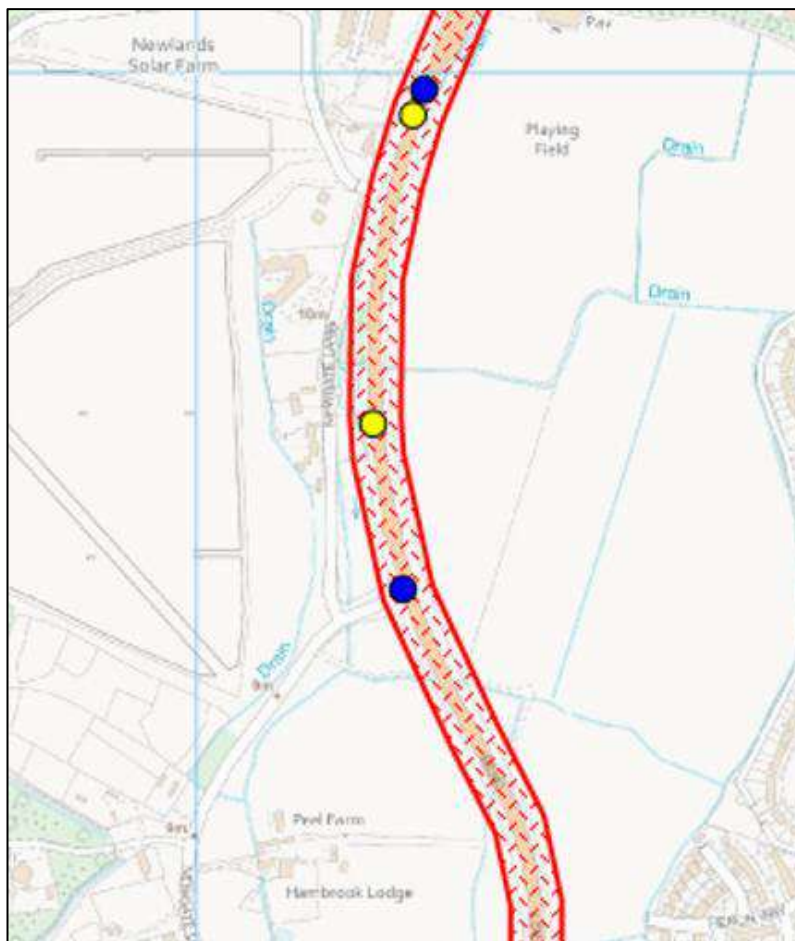
Image 2.1: PIA Plan

Two serious injury accidents and two slight injury accidents were recorded in the latest five-year period within the study area. No fatal accidents were recorded.

There was one serious injury accident recorded at the junction between the B3385 Newgate Lane East and Old Newgate Lane. The collision occurred when a car travelling east along Old Newgate Lane turned right onto the B3385 and collided with a motorcycle travelling north along the B3385 Newgate Lane. Driver error was considered to be the factor leading to the accident.

One of the slight injury accidents occurred when a car travelling north on the B3385 Newgate Lane East braked heavily as a deer ran across the road and a following car failed to break in time and collided with the rear of the first car. Another slight injury accident occurred when a motorcycle travelling south filtering passed traffic, misjudged car travelling in slow moving traffic in front and collided with rear of the car.

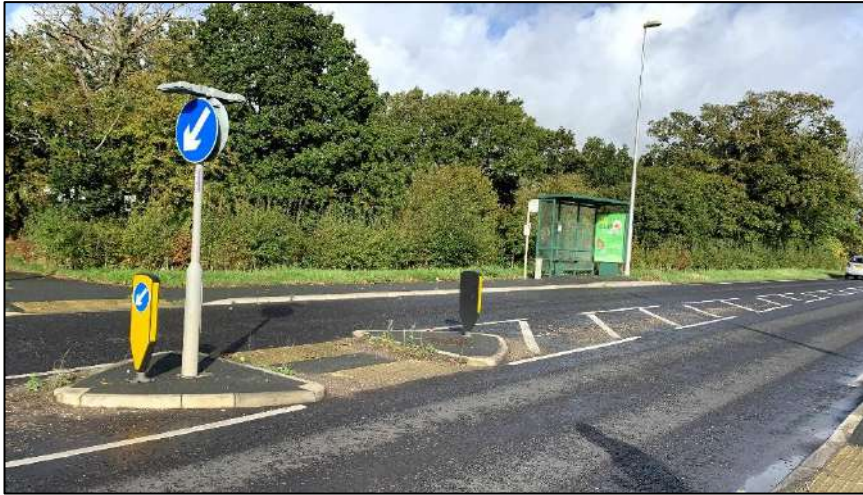
Image 2.2: Northbound Bus Stop on the B3385 Newgate Lane East

There are currently no existing footways from the site leading to these bus stops. However, as part of the development proposals, pedestrian links to these from the site will be provided. This will ensure the bus services are within easy reach of future residents of the site. The bus stops are served by "Route 21" operated by First Portsmouth, Fareham & Gosport. These run between Fareham and Hill Head providing a two-hourly service between 08:58 and 17:00 Mondays to Friday and between 08:21 to 17:39 on Saturdays.

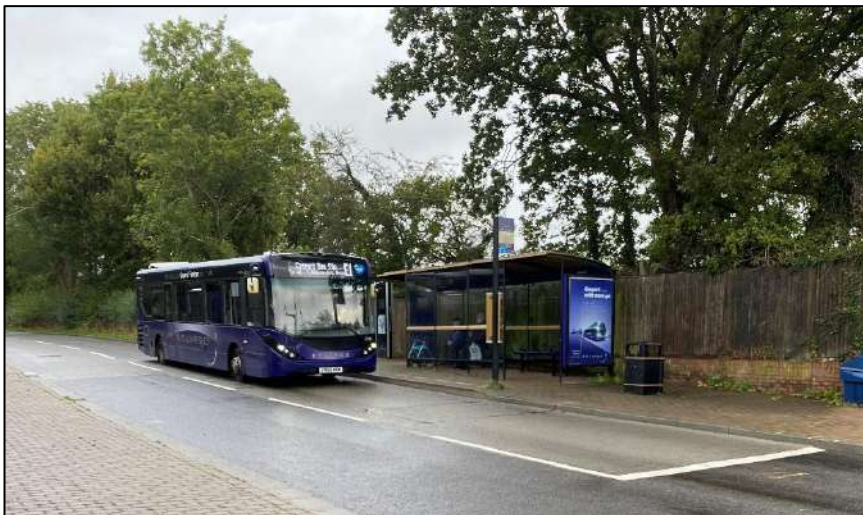
Image 2.3: Henry Cort Way BRT

Furthermore, the bus stops on Henry Cort Way which can be accessed within 450m (5-min walk) from the site via Tukes Avenue provides access to frequent Eclipse bus network services E1 and E2 (BRT) linking key towns and destinations in southeast Hampshire. These operate every 10-15 minutes Mondays to Fridays, every 12-15 minutes on Saturdays and every 25 minutes on Sundays. Bus stops in both directions are provided with sheltered seating and RTI displays.

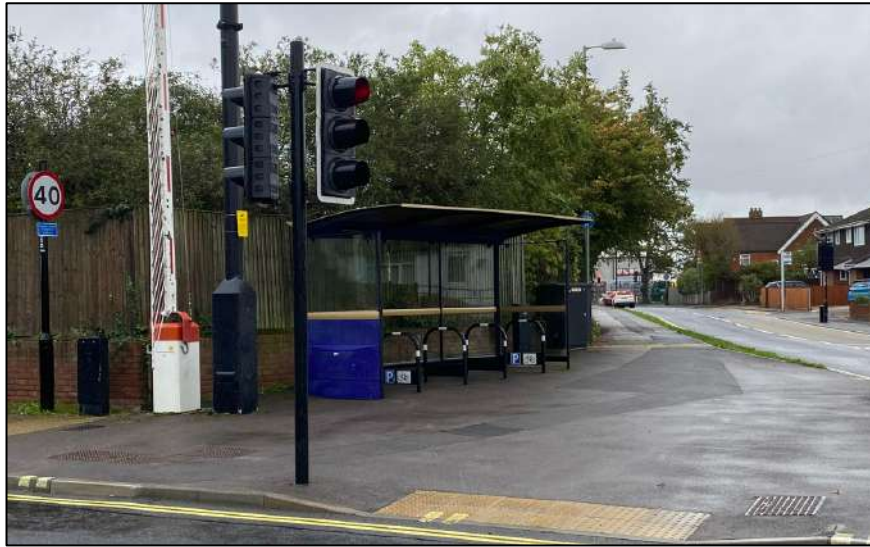
Image 2.4: Cycle Parking

Sheltered cycle parking facility is also available adjacent to the bus stops.

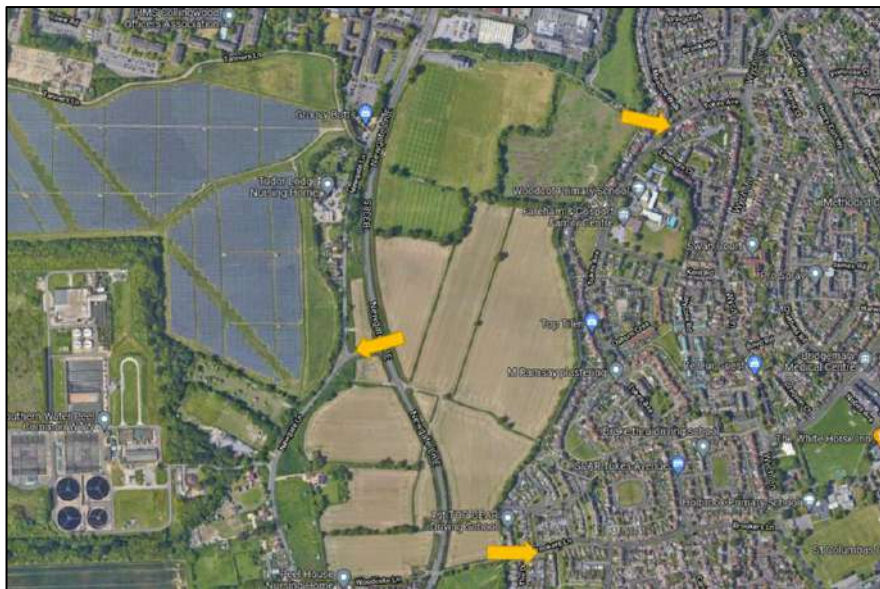
Image 2.5: Pedestrian / Cyclist Access

*The proposed development will have several pedestrian / cyclist access points. These are discussed below and the location of these is illustrated in **Image 2.5**.*

- **B3385 Newgate Lane East**

The proposed main access to the site will be provided on the B3385 Newgate Lane. The proposals will include new footway/cycleway which will connect to the existing footway and on road cycleway on the old Newgate Lane.

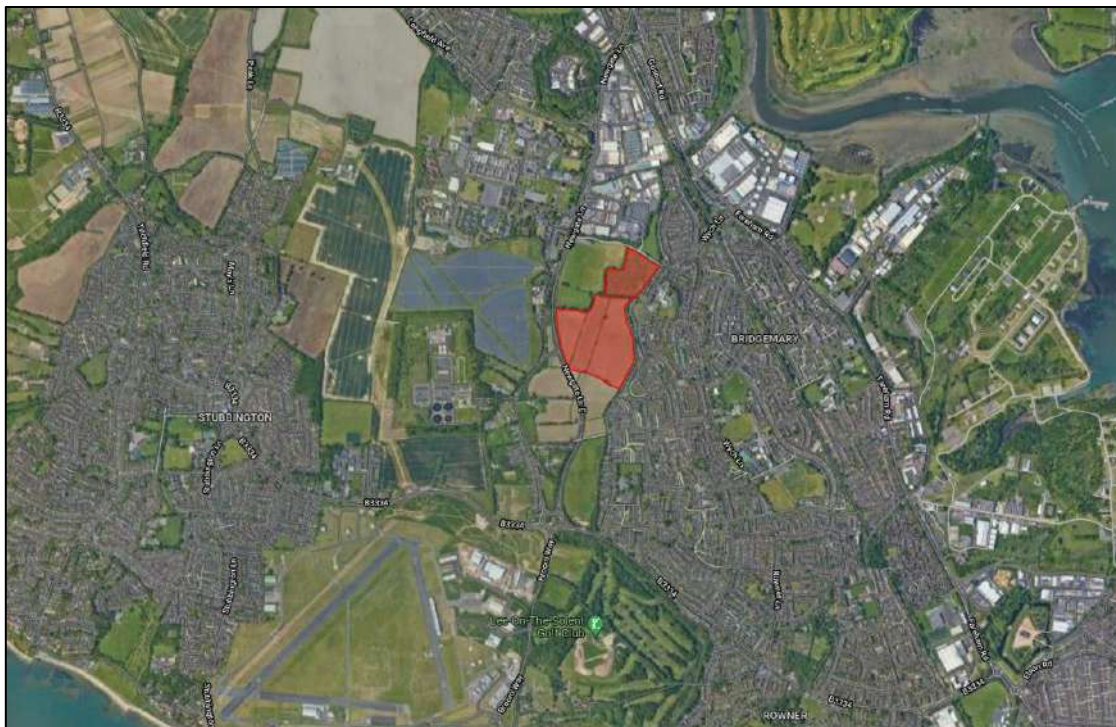
Image 1.1: Site Location

- 1.2.1 i-Transport LLP has been appointed by Miller Homes and Bargate Homes to provide highways and transport advice in relation to the proposed residential development of up to 425 dwellings on land to the east of Newgate Lane, Fareham.
- 1.2.2 The site is located to the south of Fareham and immediately to the west of Bridgemary ward boundary. An extract of the site location plan is shown in **Image 1.1**. As shown, the B3385 Newgate Lane East forms the western boundary of the site whilst the existing residential area of Bridgemary forms the eastern boundary of the site. Sports pitches are present to the northwest of the site and Brookes Lane development site is located to the south.

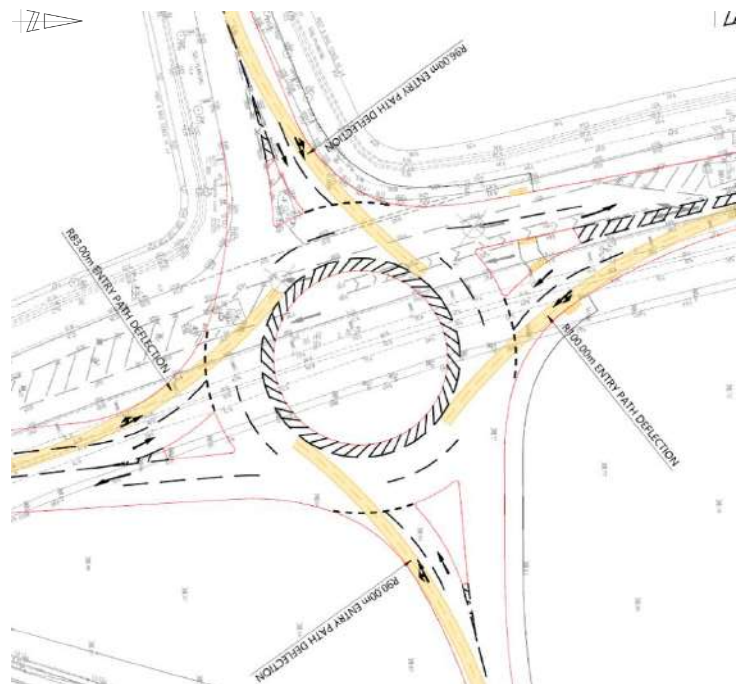
RECOMMENDATION:	
It is recommended that an adequate amount of deflection is provided on each approach.	
Location Plan:

<p>DESIGN ORGANISATION RESPONSE provided by i-Transport on the 2nd December 2021 following formal issue of this Stage 1 Road Safety Audit on the 22nd November 2021</p>	
<p>Agreed - The overrun area has been revised to provide a kerbed overrun area. This will provide a 25mm upstand and 150mm wide kerb. 1 in 12 return gradient to the central island with white lines and blacktop. The revised scheme is shown on Drawing ITB10353-GA-102 Rev A</p>	
<p>AUDITOR'S VIEW OF DESIGN ORGANISATION RESPONSE dated 6th December 2021</p>	
<p>Confirmation that the overrun area is to be formed with a 25mm upstand should ensure that the level of deflection is clear to approaching drivers at all times and addresses the road safety concern raised at this stage.</p>	
A.2	GENERAL
A.2.1	PROBLEM
Location:	Newgate Lane East
Summary:	No details of the proposed drainage have been provided at this stage
Acc Type:	Sideswipes and loss of control type collisions

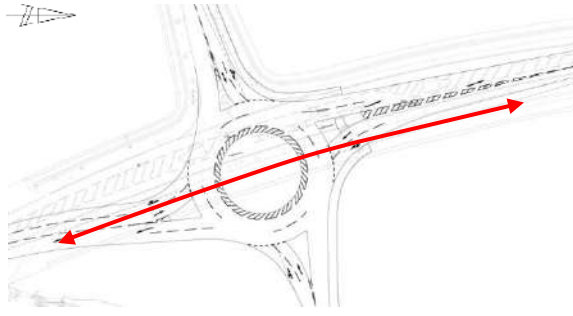
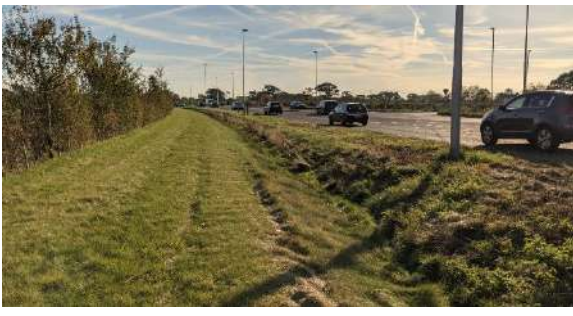
<p>Newgate Lane East is a relief road and benefits from a drainage ditch beyond a grass verge either side. Surface water that falls on the carriageway is understood to flow through a number of existing channels that are cut into the adjacent verge. The proposals that are subject to this Stage 1 Road Safety Audit include the provision of a four-arm roundabout and the realignment of the Newgate Lane East approaches. The proposed highway is to be provided where the existing ditches are present. Whilst levels have been provided on the topographical survey and along the centreline of the proposed carriageway, no details associated with the proposed contours or drainage have been provided at this stage. It can be assumed that the existing ditch is to be removed and that surface water will fall along the carriageway in accordance with the levels, however, an insufficient surface water drainage network could lead to ponding being observed which could result in loss of control type collisions especially during frosts.</p>

<p>RECOMMENDATION:</p>	
<p>It is recommended that an adequate surface water drainage network is provided</p>	
<p>Location Plan:</p>

<p>DESIGN ORGANISATION RESPONSE provided by i-Transport on the 2nd December 2021 following formal issue of this Stage 1 Road Safety Audit on the 22nd November 2021</p>	
<p>Agreed – diversion and culverting of the existing highway drain subject to OWC consent and to be discussed and agreed with HCC at detailed design stage to ensure adequate water drainage network is provided. Drawing ITB10353-GA-102 Rev A illustrates the likely ditch diversion and culverting that is expected to be required.</p>	
<p>AUDITOR'S VIEW OF DESIGN ORGANISATION RESPONSE dated 6th December 2021</p>	
<p>Confirmation that the ditch is to be diverted and culverted, addresses the road safety concern raised at this stage provided sufficient clearance is provided between the carriageway and diverted ditch.</p>	
A.2.2	PROBLEM
Location:	Newgate Lane East
Summary:	Vehicles may accelerate and overtake on approach to the roundabout

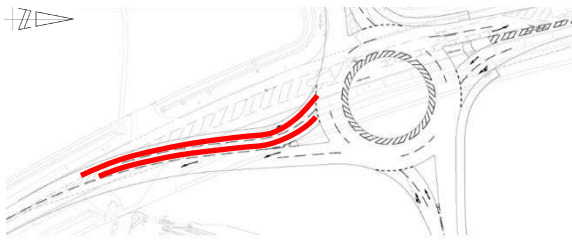
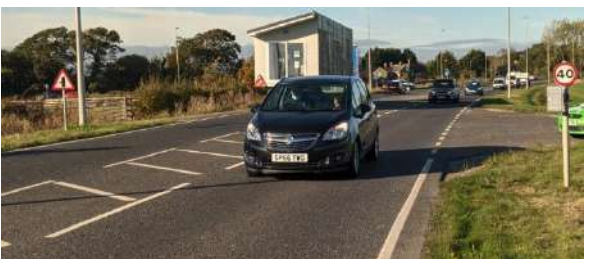
Acc Type:	Junction overshoot, heavy braking and loss of control type collisions
<p>Newgate lane East is a wide single carriageway two-way road that is subject to a 40mph speed limit and observes a traffic flow of circa 2400 during the morning and afternoon peak hours. The proposals that are subject to this Stage 1 Road Safety Audit include the provision of a four-arm roundabout along Newgate Lane East at the existing Newgate Lane priority junction. The scheme drawings provided with the Audit Brief illustrate that the carriageway width of the northbound Newgate Lane East approach to the roundabout increases to two 3.5 metre lanes from a point 70 metres from the give-way line. Whilst the information included within the Audit Brief identifies that the layout allows for two HGV's to enter the proposed roundabout side by side, no swept path of the approach is included. It is noted that the traffic flow data within the Junctions 10 data also provided with the Audit Brief, shows that the HGV content of southern arm of Newgate Lane East makes up just 2% of vehicles and therefore the likelihood of two large vehicles travelling through the junction side by side is negligible. The Audit Team have concerns that the wide two-lane approach will lead to high speed approaches and be utilised for overtaking manoeuvres leading to heavy braking and loss of control or overshoot type collisions.</p>

<p>RECOMMENDATION:</p>	
<p>It is recommended that the width and length of the two-lane approach is reduced</p>	
<p>Location Plan:</p>

<p>DESIGN ORGANISATION RESPONSE provided by i-Transport on the 2nd December 2021 following formal issue of this Stage 1 Road Safety Audit on the 22nd November 2021</p>	
<p>Agreed - The design has been amended to reduce the width and the length of the two lane approach on the southern side of the roundabout, which is reflected on Drawing ITB10353-GA-102 Rev A, with revised geometries shown on Drawing ITB10353-GA-105 Rev A. Drawing ITB10353-GA-119 has been produced to demonstrate how two 16.5m articulated vehicles can travel side-by-side on the approach to the junction.</p>	
<p>AUDITOR'S VIEW OF DESIGN ORGANISATION RESPONSE dated 6th December 2021</p>	
<p>Confirmation that the northbound approach has been adjusted, addresses the road safety concern raised at this stage.</p>	
A.2.3	PROBLEM
Location:	Newgate Lane East
Summary:	Splitter islands may not be clearly visible
Acc Type:	Loss of control and head-on type collisions

A.2.2 - Vehicles may accelerate and overtake on approach to the roundabout	It is recommended that the width and length of the two-lane approach is reduced	Agreed - The design has been amended to reduce the width and the length of the two lane approach on the southern side of the roundabout, which is reflected on Drawing ITB10353-GA-102 Rev A, with revised geometries shown on Drawing ITB10353-GA-105 Rev A. Drawing ITB10353-GA-119 has been produced to demonstrate how two 16.5m articulated vehicles can travel side-by-side on the approach to the junction.		
A.2.3 - Splitter islands may not be clearly visible	It is recommended that the keep left bollards are provided facing approaching traffic.	Agreed – keep left bollards to be provided facing approaching traffic. Exact details to be discussed and agreed with HCC at detailed design stage.		
A.3.1 - Proposals will restrict access to existing field entrances	It is recommended that dropped kerbs are provided to allow access to the field and the adjacent area of hard standing is adequate to accommodate the expected vehicles.	Agreed - The existing field access point on the western side of Newgate Lane East dropped kerb have been shown on revised Drawing ITB10353-GA-102 Rev A. On the eastern side, the existing field access is to be removed as part of the proposed development and therefore no provision has been made (the field benefits from a separate access some 50m south). This is reflected in the latest design drawing ITB10353-GA-102 Rev A.

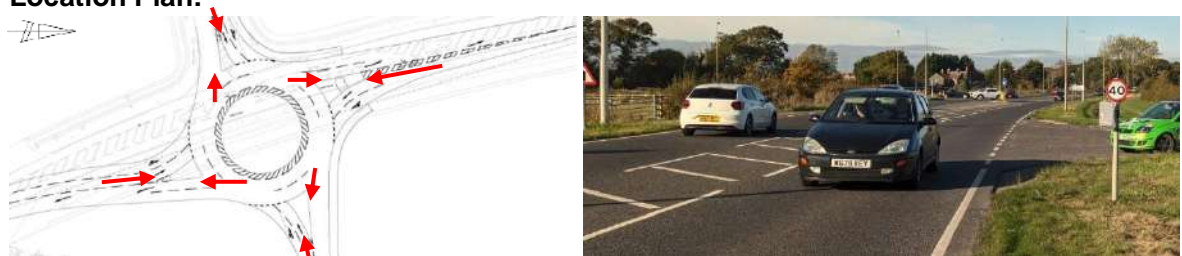
<p>The proposals that are subject to this Stage 1 Road Safety Audit include the provision of a four-arm roundabout along Newgate Lane East that accommodates two-lane approaches as well as two-lane exits that merge on Newgate Lane East and single lane exits on Newgate Lane as well as the proposed development access. The scheme drawings provided with the Audit Brief illustrate splitter islands on each arm of the proposed roundabout segregating traffic entering from traffic exiting, however, the islands may not be clearly visible to approaching drivers leading to kerb strikes and loss of control type collisions. Furthermore, foreign drivers may attempt to pass on the wrong side of the islands into the path of opposing traffic leading to head-on collisions.</p>	
<p>RECOMMENDATION:</p>	
<p>It is recommended that the keep left bollards are provided facing approaching traffic.</p>	
<p>Location Plan:</p>

<p>DESIGN ORGANISATION RESPONSE provided by i-Transport on the 2nd December 2021 following formal issue of this Stage 1 Road Safety Audit on the 22nd November 2021</p>	
<p>Agreed – keep left bollards to be provided facing approaching traffic. Exact details to be discussed and agreed with HCC at detailed design stage.</p>	
<p>AUDITOR'S VIEW OF DESIGN ORGANISATION RESPONSE dated 6th December 2021</p>	
<p>Confirmation that keep left bollards are to be provided, addresses the road safety concern raised at this stage.</p>

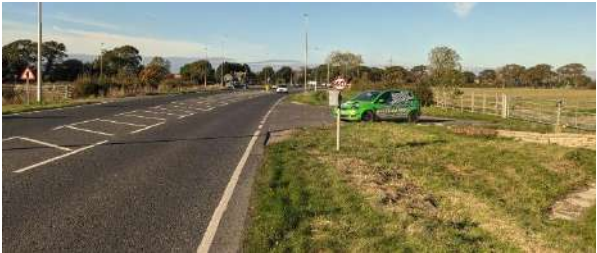
A.3	JUNCTIONS
A.3.1	PROBLEM
Location:	Newgate Lane East
Summary:	Proposals will restrict access to existing field entrances
Acc Type:	Rear end impact collisions
<p>Newgate Lane East is a two-way single carriageway road that is bounded by grass verges and allows access to a number of gated field entrances. The proposals that are subject to this Stage 1 Road Safety Audit include the provision of a roundabout and realignment of Newgate Lane East. The scheme drawings provided with the Audit Brief illustrate that the proposals have an impact on two field entrances with the area of hardstanding adjacent to the eastern access, reduced and the area adjacent to the western access increased. No kerbing details have been provided at this stage, however, the provision of full height kerbs will restrict access to the entrances which could lead to a loss of control type collision or a vehicle stopping to mount the full height kerbs and rear impact collisions. Furthermore, the Audit Team have concerns that the hard standing adjacent to the field access to the east, will be inadequate to accommodate a tractor and trailer whilst the gates are being opened or closed which could lead to part of the vehicle encroaching the carriageway and front / rear end collisions.</p>

RECOMMENDATION:	
It is recommended that dropped kerbs are provided to allow access to the field and the adjacent area of hard standing is adequate to accommodate the expected vehicles.	
Location Plan:

<p>DESIGN ORGANISATION RESPONSE provided by i-Transport on the 2nd December 2021 following formal issue of this Stage 1 Road Safety Audit on the 22nd November 2021</p>	
<p>Agreed - The existing field access point on the western side of Newgate Lane East dropped kerb have been shown on revised Drawing ITB10353-GA-102 Rev A. On the eastern side, the existing field access is to be removed as part of the proposed development and therefore no provision has been made (the field benefits from a separate access some 50m south). This is reflected in the latest design drawing ITB10353-GA-102 Rev A.</p>	
<p>AUDITOR'S VIEW OF DESIGN ORGANISATION RESPONSE dated 6th December 2021</p>	
<p>Confirmation that the field accesses are to removed / retained where appropriate, addresses the road safety concern raised at this stage.</p>

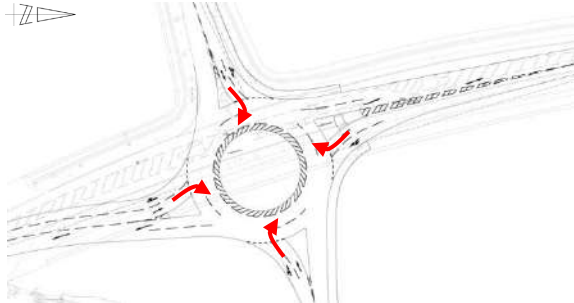
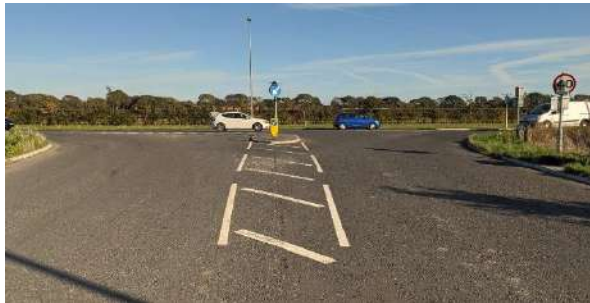
A.3.2	PROBLEM
Location:	Newgate Lane East
Summary:	Drivers may attempt to circulate the roundabout into opposing traffic
Acc Type:	Sideswipes and loss of control type collisions
<p>The proposals that are subject to this Stage 1 Road Safety Audit include the provision of a four-arm 50 metre Inscribed Circle Diameter (ICD) roundabout along Newgate Lane East that is formed with a 28 metre physical central island with a 2 metre area of hatching overrun area and 9 metre circulatory carriageway. The scheme drawings provided with the Audit Brief illustrate splitter islands on each arm of the proposed roundabout which are aligned such that traffic is guided around the circulatory in a clockwise direction, however, no signage is provided to highlight that traffic must turn left onto the circulatory. Foreign drivers may attempt to turn right onto the circulatory and travel in an anti-clockwise direction into the path of opposing traffic leading to head-on collisions.</p>

RECOMMENDATION:	
It is recommended that chevron and one-way signs are provided on the central island	
Location Plan:

DESIGN ORGANISATION RESPONSE provided by i-Transport on the 2nd December 2021 following formal issue of this Stage 1 Road Safety Audit on the 22nd November 2021	
Agreed – chevron and one-way signs to be provided at detailed design stage.	
AUDITOR'S VIEW OF DESIGN ORGANISATION RESPONSE dated 6th December 2021	
<i>Confirmation that chevron and one-way signs are to be provided, addresses the road safety concern raised at this stage.</i>	
A.4	WALKING CYCLING AND HORSE
A.4.1	PROBLEM
Location:	Newgate Lane
Summary:	Pedestrians may enter the live carriageway when it is not safe to do so
Acc Type:	Vehicle pedestrian collisions
<p>Newgate Lane benefits from a footway along the western side of the carriageway that provides a link between Fareham to the north and Lee-on-the-Solent to the south. The proposals that are subject to this Stage 1 Road Safety Audit include the provision of a roundabout along Newgate Lane East that accommodates a shared footway cycleway between the eastern and western arms</p>

A.3.2 - Drivers may attempt to circulate the roundabout into opposing traffic	It is recommended that chevron and one-way signs are provided on the central island	Agreed – chevron and one-way signs to be provided at detailed design stage.		
A.4.1 - Pedestrians may enter the live carriageway when it is not safe to do so	It is recommended that the tactile paving extends for a minimum depth of 1200mm at crossing points that are inline	Agreed – tactile paving has been revised to provide 1200mm depth at crossing points identified. Drawing ITB10353-GA-102 Rev A has been updated to reflect these design changes.		
A.4.2 - Existing street lighting column is situated within the proposed footway	It is recommended that the existing street lighting column is relocated outside the proposed footway	Agreed – existing street lighting column to be relocated outside of the proposed footway. Final details to be discussed and agreed with HCC at detailed design stage.

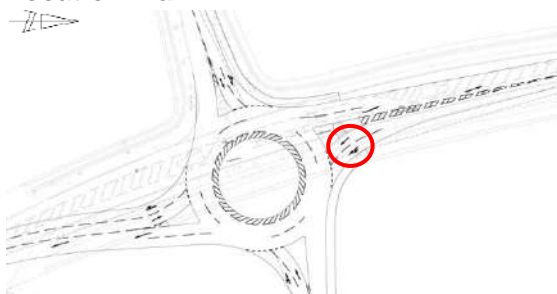
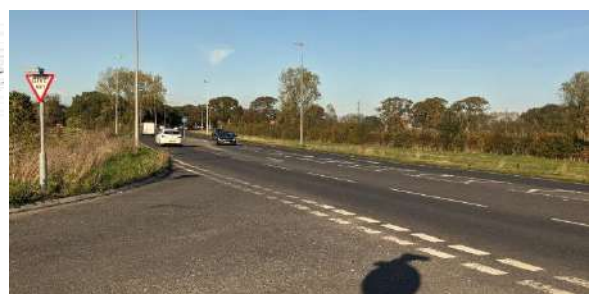
RECOMMENDATION:	
It is recommended that the road markings are marginally relocated outside the uncontrolled pedestrian crossing.	
Location Plan:

<p>DESIGN ORGANISATION RESPONSE provided by i-Transport on the 2nd December 2021 following formal issue of this Stage 1 Road Safety Audit on the 22nd November 2021</p>	
<p>Agreed – the road markings have been removed outside of the uncontrolled crossing and updated design presented in Drawing ITB10353-GA-102 Rev A.</p>	
<p>AUDITOR’S VIEW OF DESIGN ORGANISATION RESPONSE dated 6th December 2021</p>	
<p>Confirmation that the road markings have been marginally relocated, addresses the road safety concern raised at this stage.</p>	
A.5.2	PROBLEM
Location:	Newgate Lane East
Summary:	No details of the proposed street lighting have been provided
Acc Type:	Vehicle overshoot and loss of control type collisions
<p>The local highway network in proximity of Newgate Lane East benefits from street lighting with columns situated within the verge both sides of the carriageway. The proposals that are subject to this Stage 1 Road Safety Audit include the provision of 50 metre ICD roundabout along Newgate Lane East. The proposed works have an impact on the existing street lighting columns, however, no street lighting details have been provided at this stage. An insufficient level of street lighting in proximity to a roundabout could result in drivers not becoming aware of the junction at a safe distance and traffic approaching at in-appropriate speeds leading to heavy braking and resulting in overshoot and loss of control type collisions.</p>

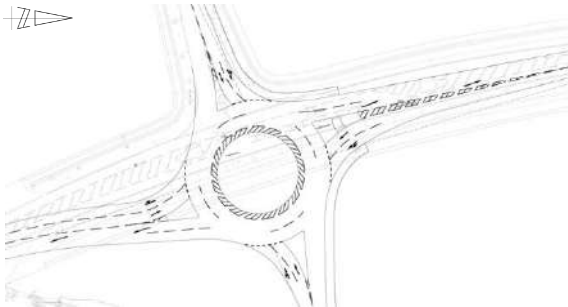
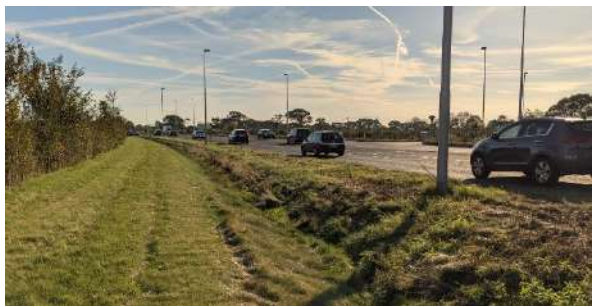
<p>RECOMMENDATION:</p>	
<p>It is recommended that the proposed roundabout junction is illuminated sufficiently</p>	
<p>Location Plan:</p>

<p>DESIGN ORGANISATION RESPONSE provided by i-Transport on the 2nd December 2021 following formal issue of this Stage 1 Road Safety Audit on the 22nd November 2021</p>	
<p>Agreed – a lighting strategy will be discussed and agreed with HCC at detailed design stage.</p>	
<p>AUDITOR’S VIEW OF DESIGN ORGANISATION RESPONSE dated 6th December 2021</p>	
<p>Confirmation that the proposed junction will illuminated sufficiently with a street lighting strategy developed during the detail design stage, addresses the road safety concern raised at this stage.</p>

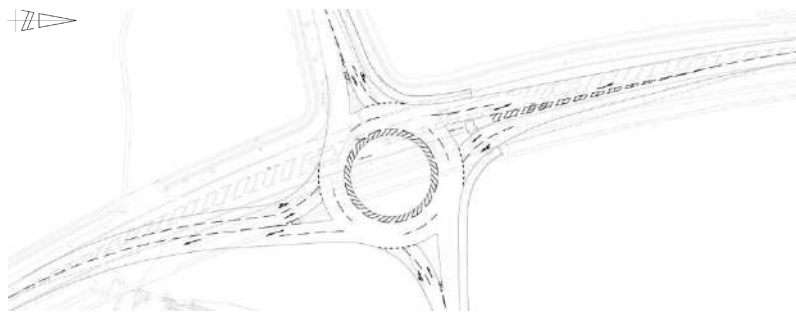
A.5.3	PROBLEM
Location:	Newgate Lane East
Summary:	No details of the proposed signage have been provided
Acc Type:	Vehicle sideswipe and shunt type collisions
<p>Newgate Lane East is a link between Fareham and Lee-on-the-Solent and currently accommodates a priority junction with Newgate Lane that benefits from a right turn lane with appropriate signage. The proposals that are subject to this Stage 1 Road Safety Audit include the provision of 50 metre ICD four-arm roundabout along Newgate Lane East that provides access to development land to the east and Newgate Lane to the west. Whilst the scheme drawings illustrate the proposed junction, no details of the proposed signage have been provided at this stage. Insufficient signage of the roundabout ahead, could result in drivers not becoming aware of the junction or routes through at a safe distance and traffic undertaking late lane changes, leading to loss of control and sideswipe type collisions.</p>

RECOMMENDATION:	
It is recommended that the proposed roundabout and destinations are signed appropriately.	
Location Plan:

<p>DESIGN ORGANISATION RESPONSE provided by i-Transport on the 2nd December 2021 following formal issue of this Stage 1 Road Safety Audit on the 22nd November 2021</p>	
<p>Agreed – The proposed roundabout and destinations will be signed appropriately. Exact details to be discussed and agreed with HCC at detailed design stage.</p>	
<p>AUDITOR'S VIEW OF DESIGN ORGANISATION RESPONSE dated 6th December 2021</p>	
<p>Confirmation that the appropriate signage will be provided, addresses the road safety concern raised at this stage.</p>

A.5.3 - No details of the proposed signage have been provided	It is recommended that the proposed roundabout and destinations are signed appropriately.	Agreed – The proposed roundabout and destinations will be signed appropriately. Exact details to be discussed and agreed with HCC at detailed design stage.
