OFFICER REPORT FOR COMMITTEE

P/24/0801/TO

FELL ONE LIME AND ONE OAK TREE PROTECTED BY TPO 629 – T9 & T10

33 HEATH LAWNS, FAREHAM

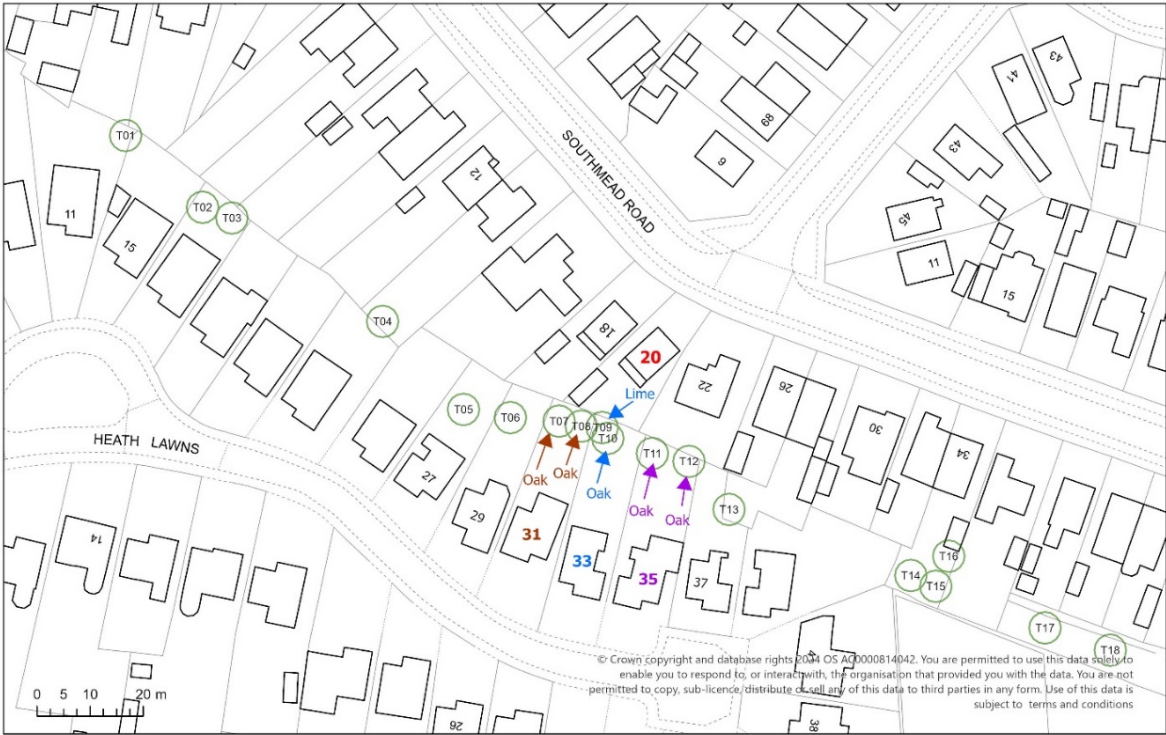
Appendix A – Site plan

<p>TOWN & COUNTRY PLANNING ACT 1990 FAREHAM BOROUGH COUNCIL TREE PRESERVATION ORDER NUMBER 629 IMPLICATED TREES REAR GARDENS OF 31, 33 & 35 HEATH LAWNS, TITCHFIELD</p>	<p>FAREHAM BOROUGH COUNCIL</p>	<p>Title: FTPO 629 Date: 11 Sep 2024</p>	<p>Ref: 1 Scale 1:750</p>	<p>© Crown copyright and database rights 2024 OS AC0000814042. You are permitted to use this data solely to enable you to respond to, or interact with, the organisation that provided you with the data. You are not permitted to copy, sub-licence, distribute or sell any of this data to third parties in any form.</p>
